Sediment and Stormwater Construction Site Compliance Review

DNREC Approval No. 2009-001 **Approval Agency:** DNREC **NOI #:** 7295

Project/Site Name: DNREC Park Improvements

Location (Address): 154 Water St **Town:** Dover **Zip:** 19901

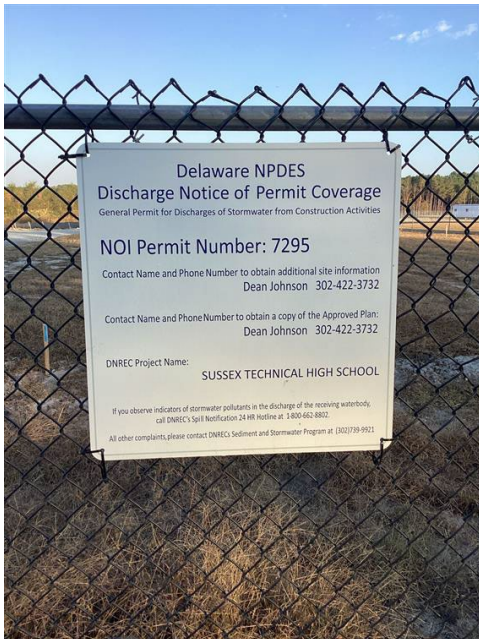
Documentation and Signage

Posted at entrance of jobsite with a clear visual driving in.

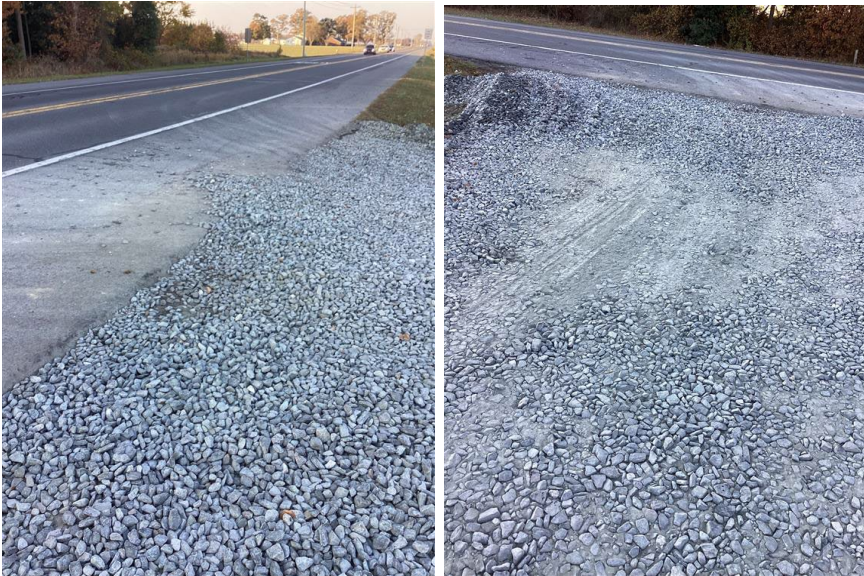
Construction Entrance & Tracking

SCE- Re-work stone / replace with new to minimize the tracking onto main road. Contractor instructed to fix within 7 days due to minimal tracking.

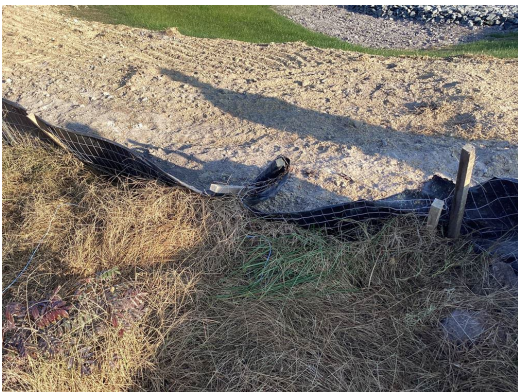
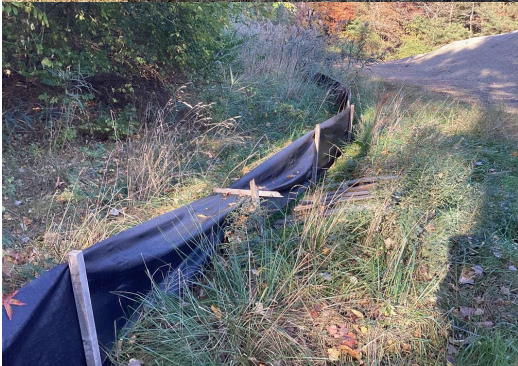
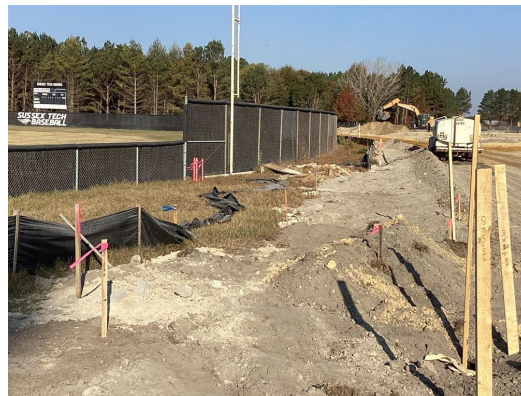
Silt Fence & Perimeter Controls

Silt fence sufficient throughout most of jobsite. Corrective action needed within 24 hours in certain areas pointed out to Site superintendent near the ball fields and Pond G. Will monitor.

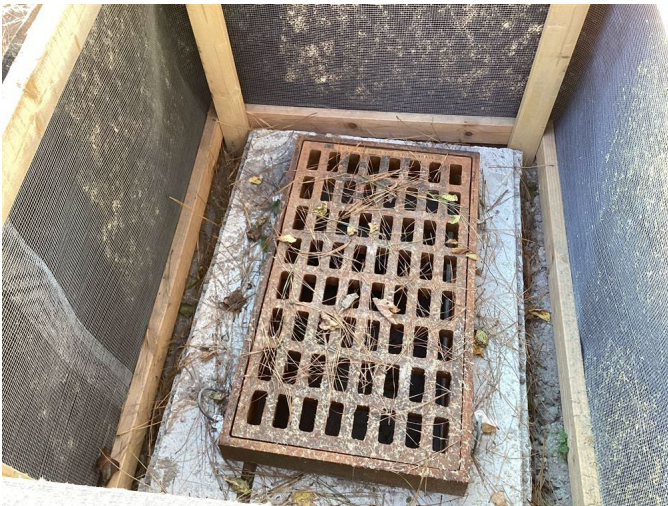
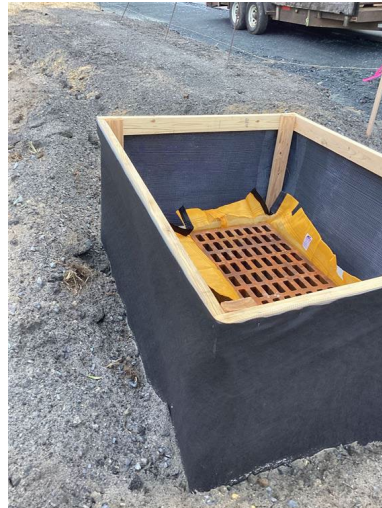
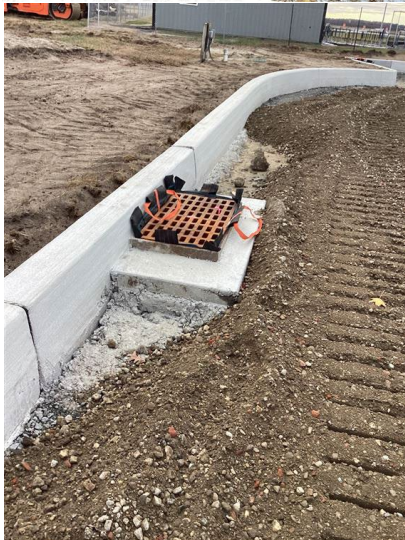
Catch Basins & Inlets

IP-1 and IP-2s all meet requirements of the approved plans and functioning properly. Suggestion was made to add IP-2 to some basins as a precautionary measure.

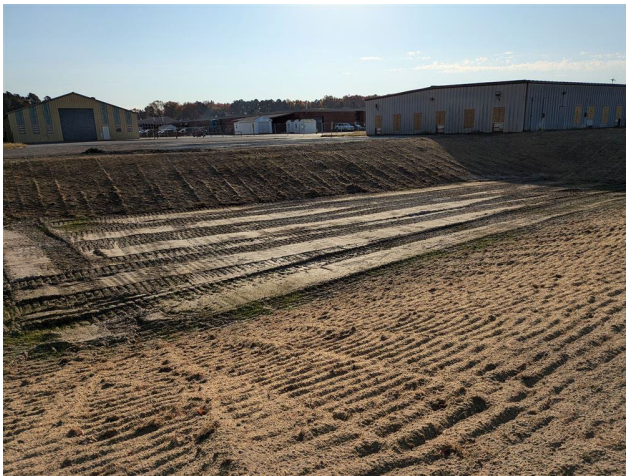
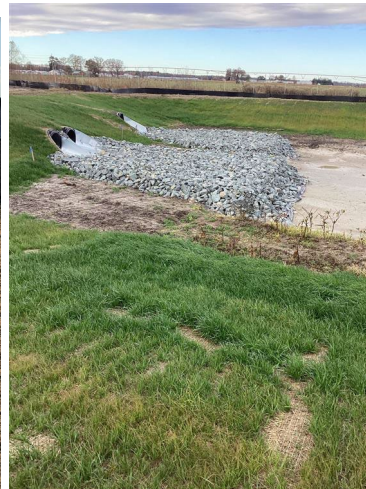
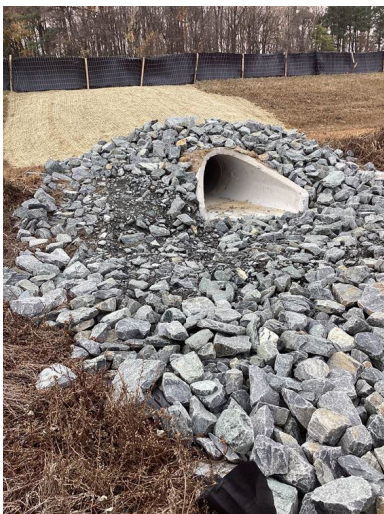
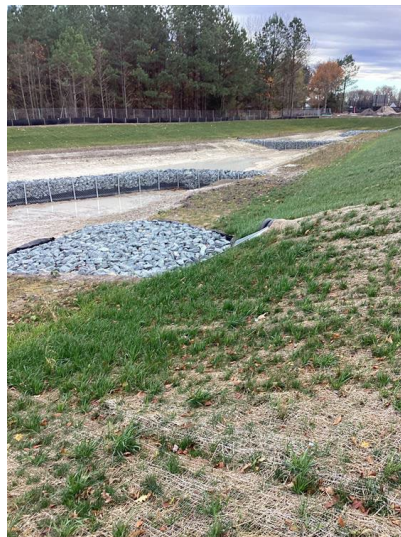
Sediment Basins & Outlet Structures

PST-G2 actively functioning with erosion control measures in place. Tracking and hydro-seeding sufficient.

Outfall structures all appear to be in good shape.

No action needed.

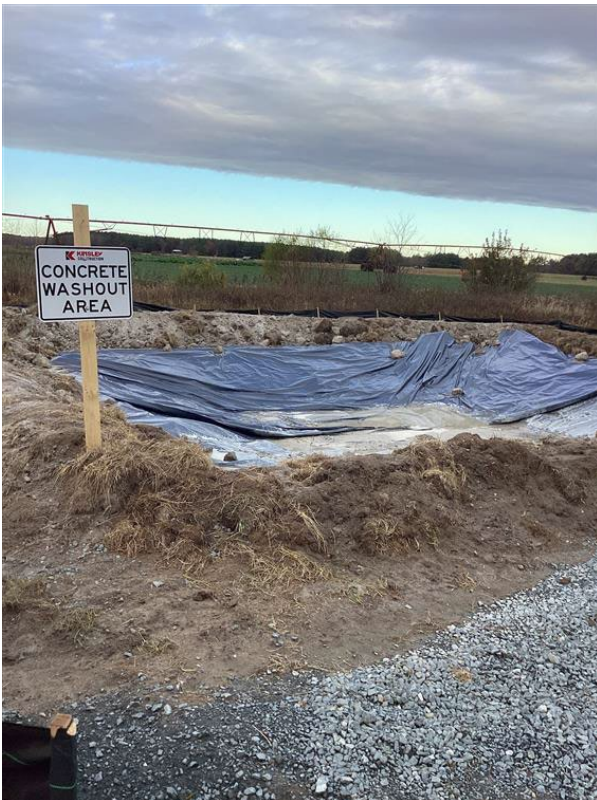
Concrete Washouts

CWO has been implemented. Was built to spec with posting of sign. Location is per the SSMP.

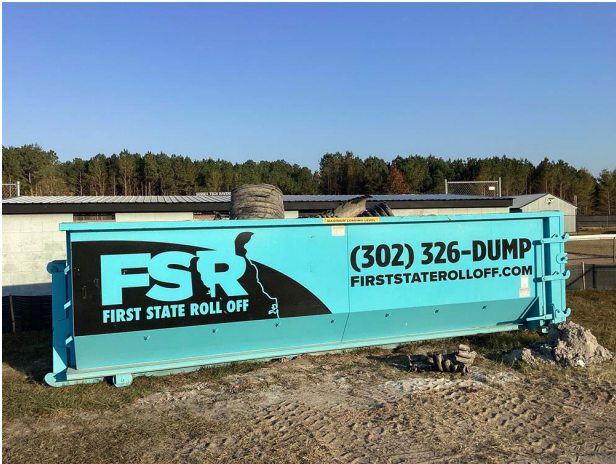
Trash, Debris & Solid Waste

Trash contained in cans/dumpsters. No issues. It was recommended to empty the dumpster as soon as possible.

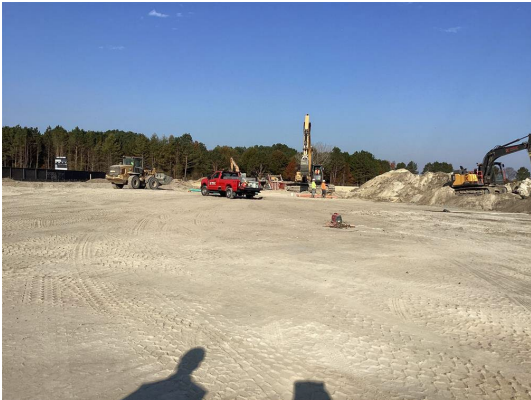
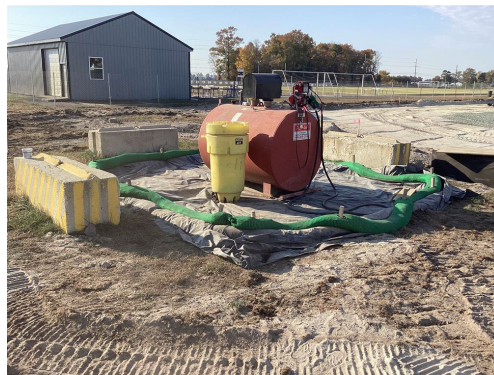
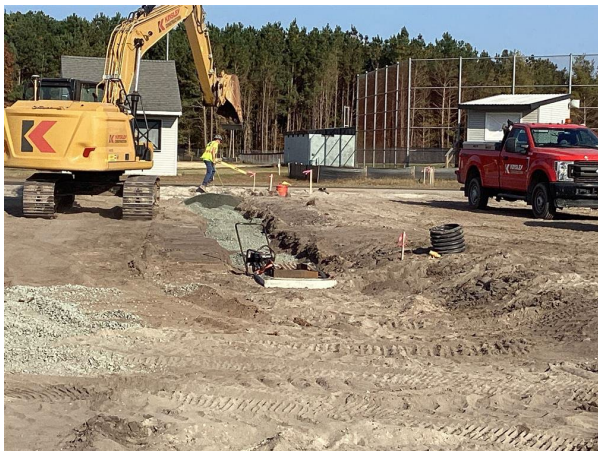
Chemical Storage & Containment

Fueling station on site compliant. Spill kit in place. 5-gallon fuel cans throughout jobsite. These need to be contained in the future for possible leaks and contamination of soil. Contractor instructed to fix within 24 hours.

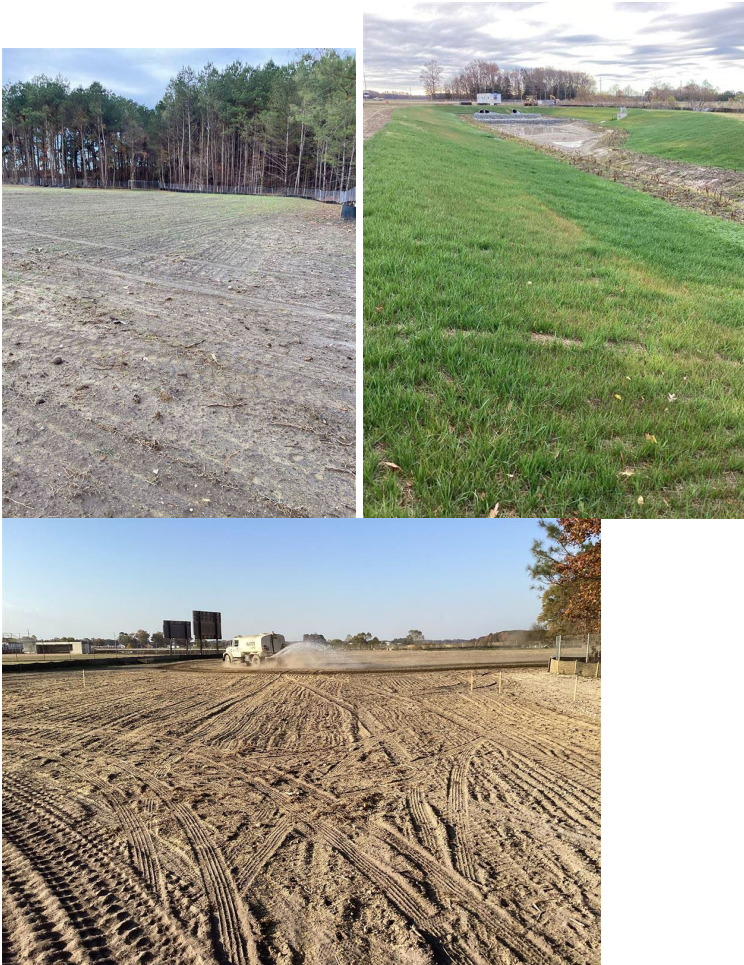
Stabilization throughout site has been implemented at different times which shows different growth patterns, but all is slowly showing signs of populating. Will continue to monitor all areas.

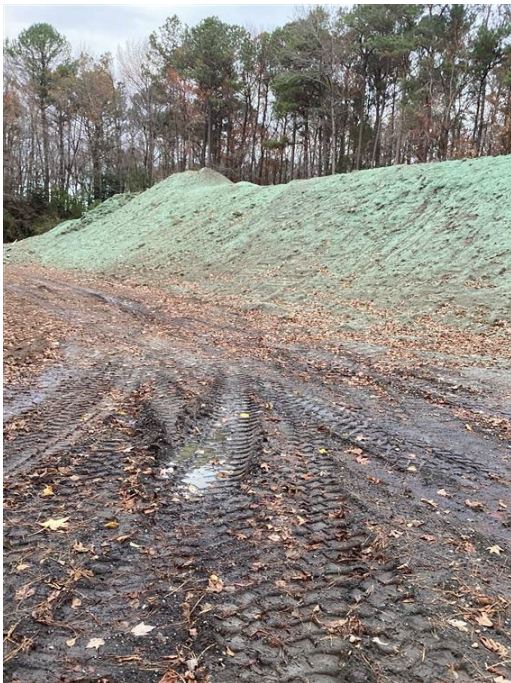
Soil Stockpiles

Stockpile hydroseeded. This will be the permanent stockpile left for later use. No action needed.

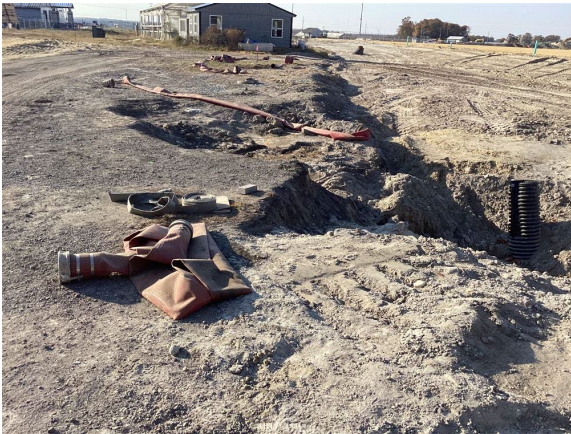
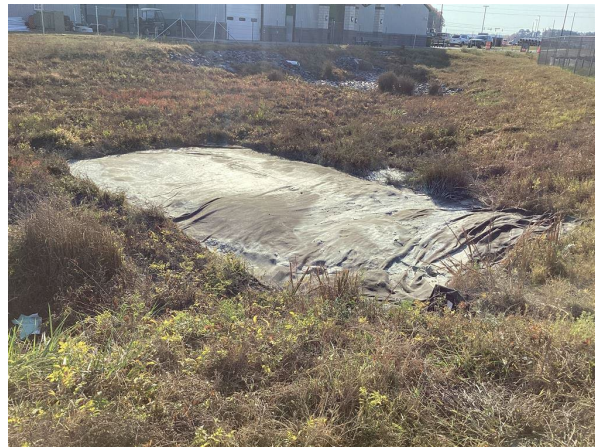
Dewatering & Other Discharges

Site contractor not actively dewatering. Temporarily remove the old dewatering bags and hoses left throughout jobsite. Contractor instructed to fix within 24 hours.

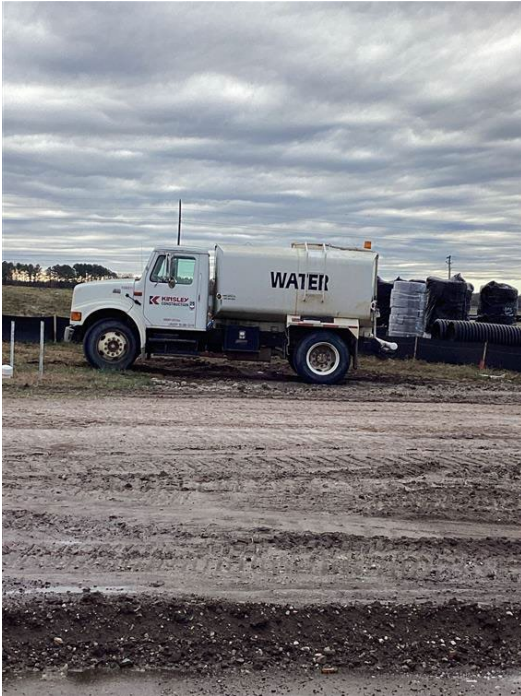
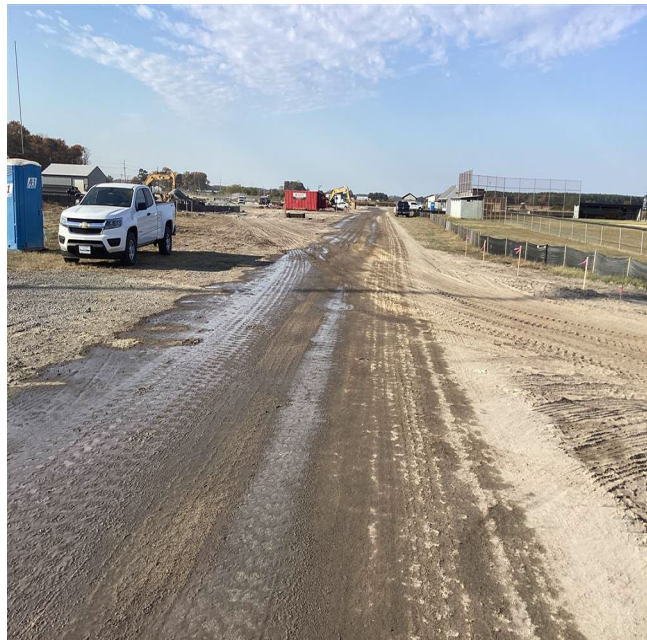
Dust Control

Dust was present but water truck on site actively trying to rectify the problem.

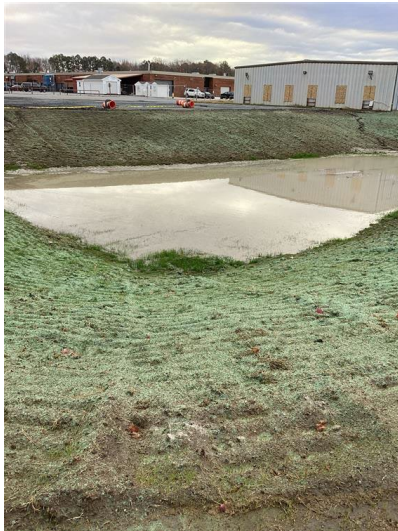
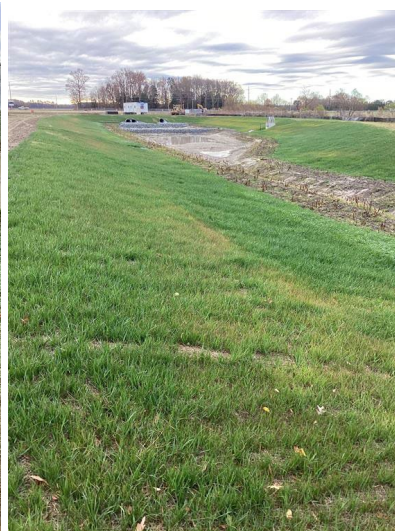
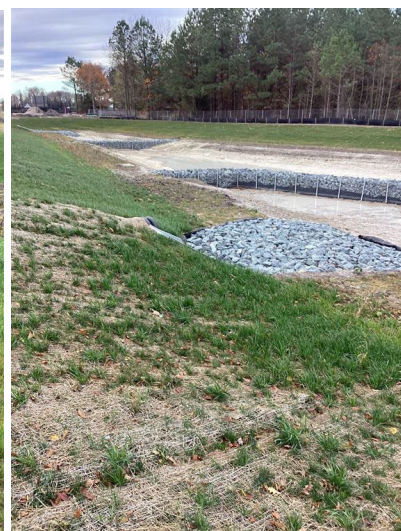
PCBMPs

Pond-I is in good shape with stabilization on all side slopes. Gabion wall and skimmer device installed.

Pond-H is also in good shape with side slopes fully stabilized. Gabions and skimmer device installed.

Pond-G has been installed with side slopes just being hydroseeded. Will monitor going forward.
