PCB Mass Loading Phase II
Former Dagsboro Substation
SIRS ID: DE-1287
Dagsboro, Delaware

Appendix 14

FORMER DAGSBORO SUBSTATION

SIRS ID: DE-1287

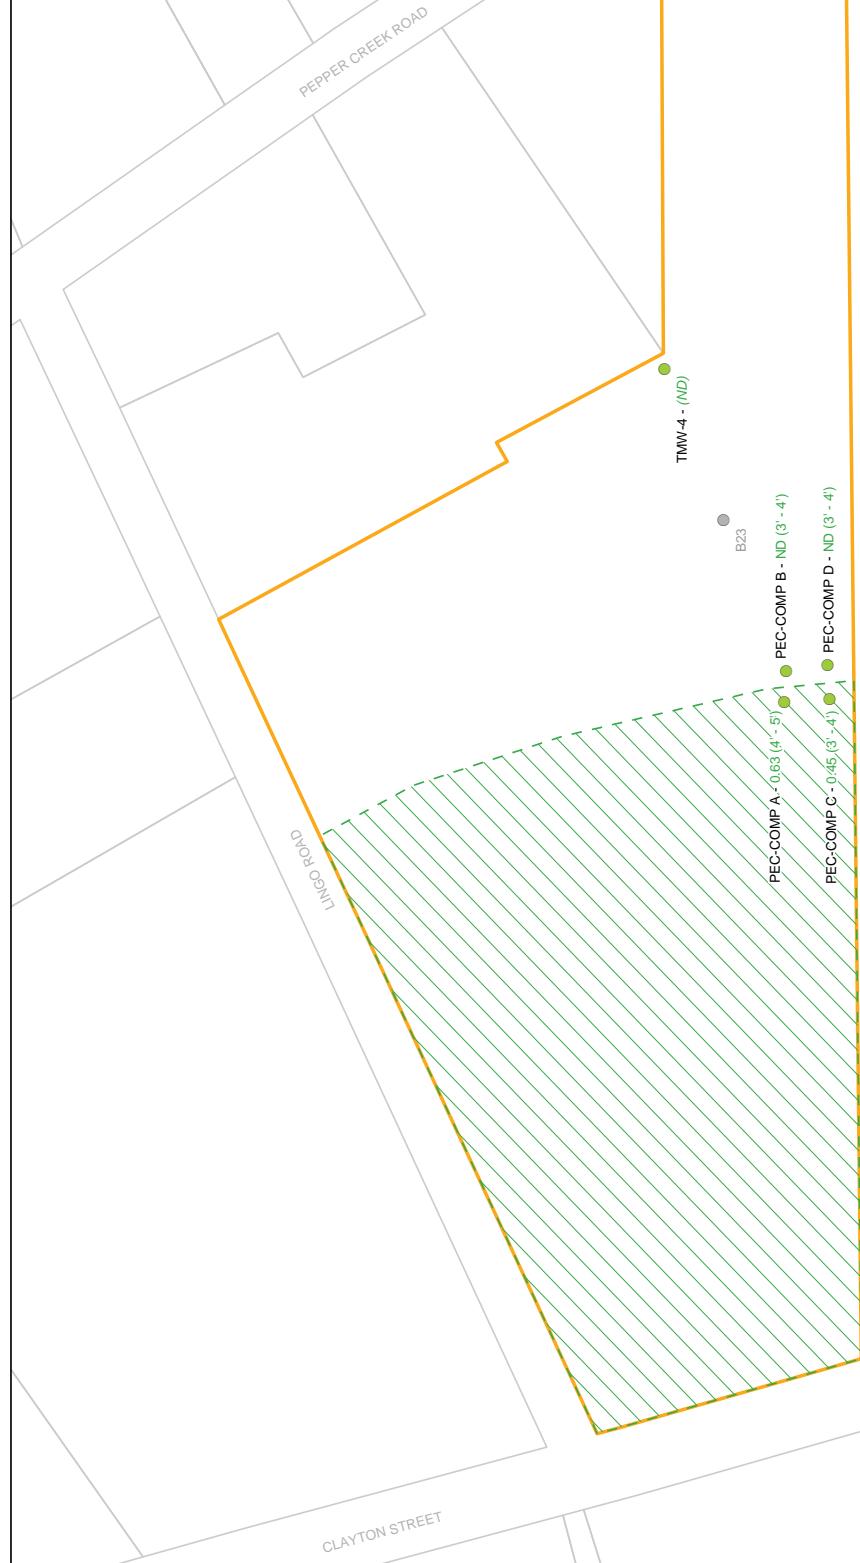
PCB Distribution in Subsurface Saturated Soil
Former Dagoboro Substation
Dagoboro, Delaware

PCBs were detected in two saturated zone borings at concentrations of 0.63 mg/kg and 0.45 mg/kg. This calculation yielded a pore water PCB range of 0.099 to 0.69 µg/L (Table B).

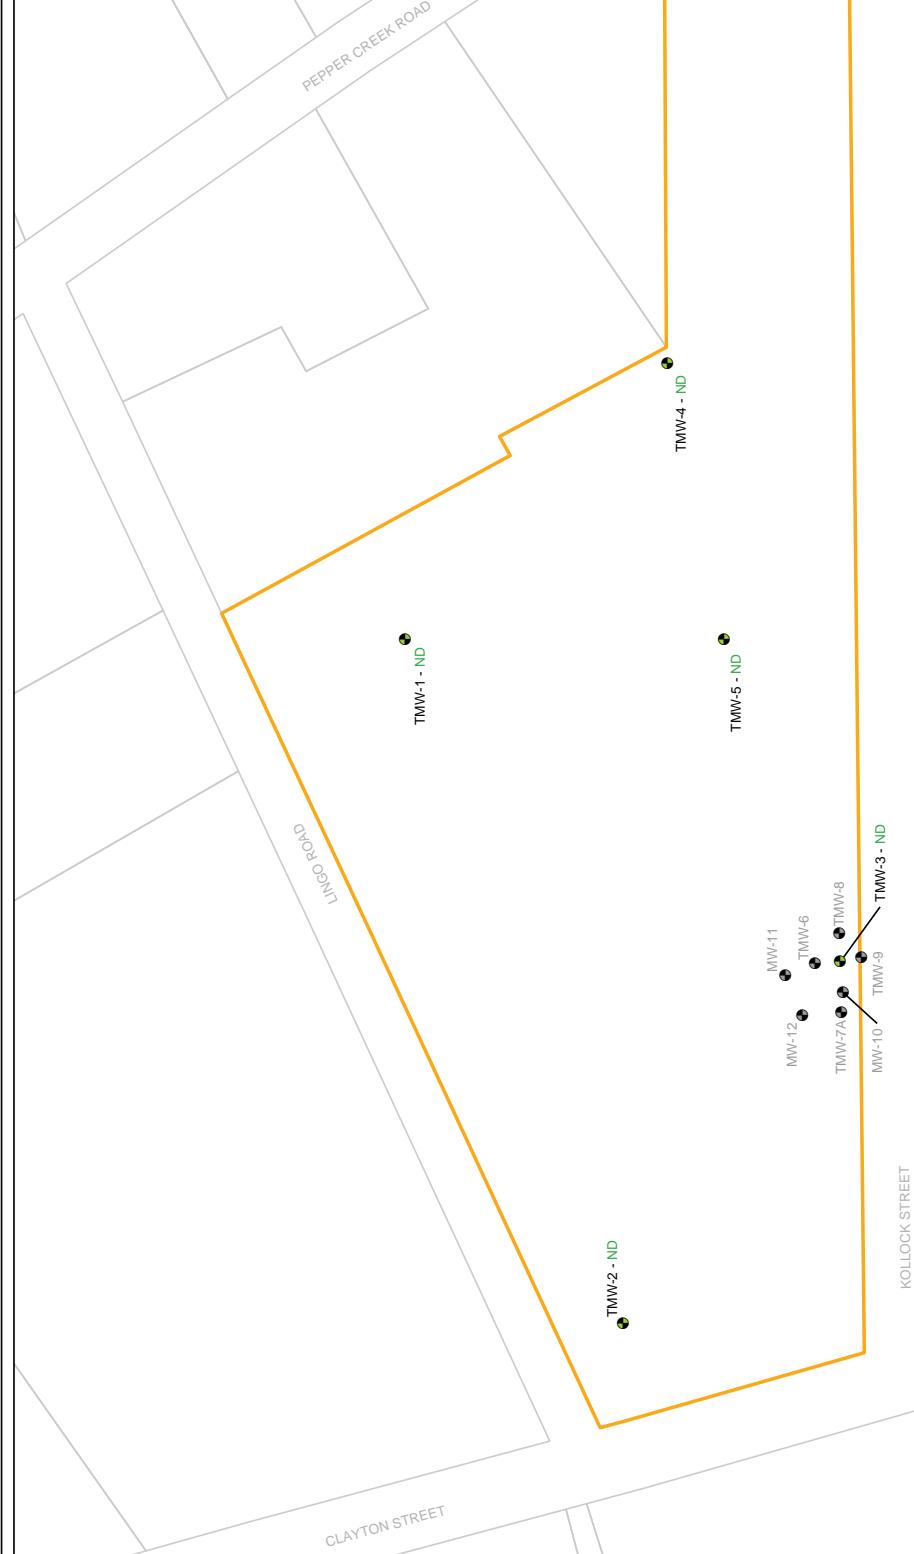
PCB Distribution in Groundwater
Former Dagoboro Substation
Dagoboro, Delaware

The estimated surface soil area impacted by PCBs is 0.65 acres (Figure 2). The estimated subsurface unsaturated soil impacted by PCBs is 0.21 acres (Figure 3). The estimated subsurface saturated soil impacted by PCBs is 2.05 acres (Figure 4). Based on the data available and reviewed by BrightFields, the groundwater is not impacted by PCBs.

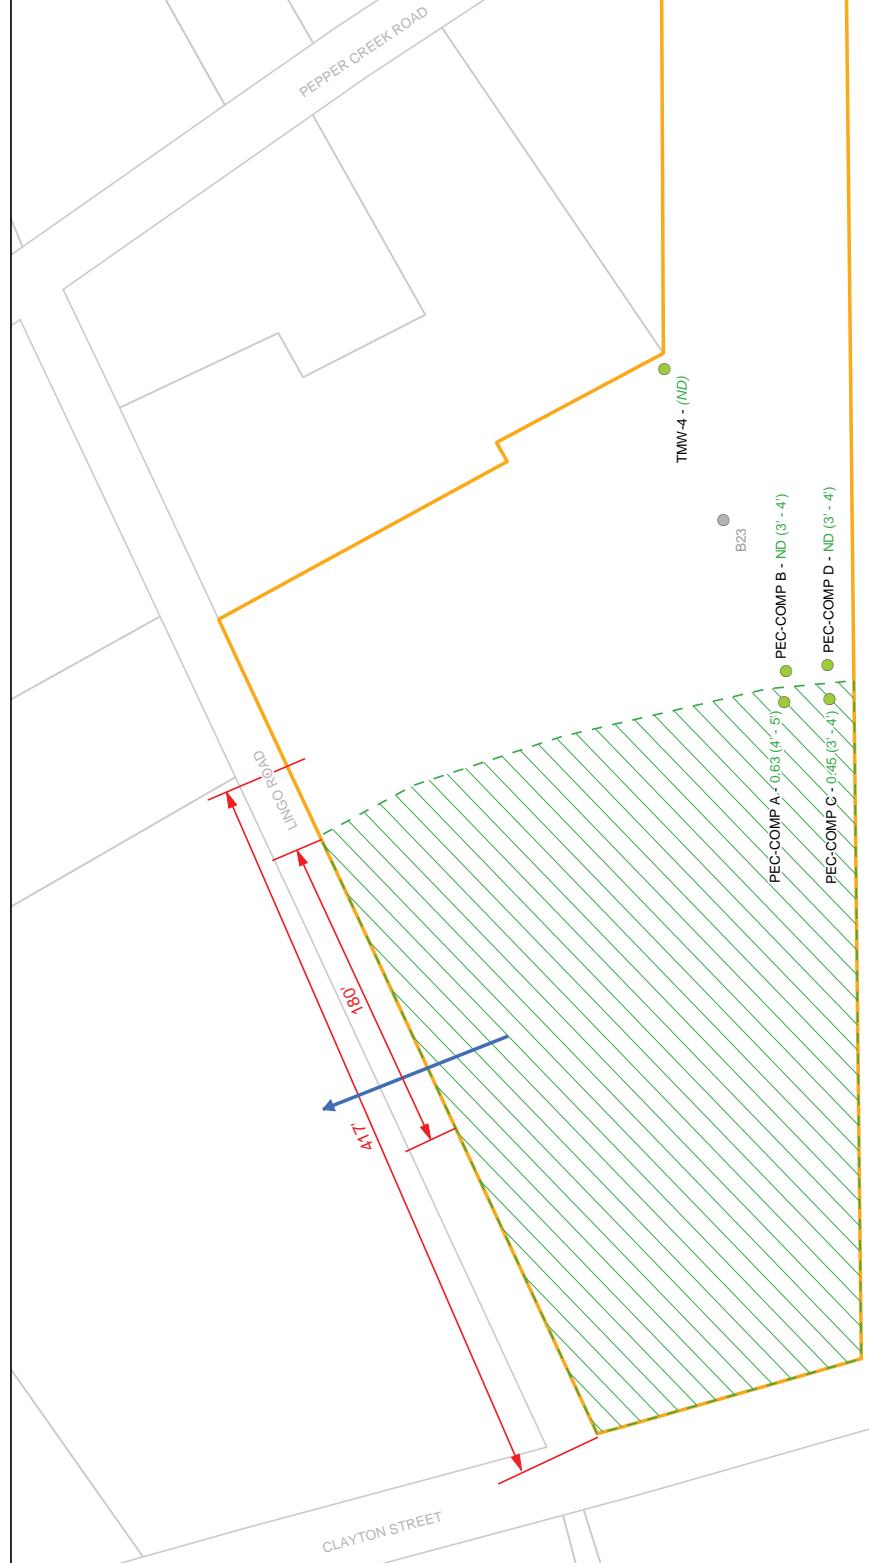
Figure 7

Groundwater discharge is based on the hydraulic conductivity of the soil, the groundwater gradient, and the cross-sectional area of the aquifer. A breakdown of the individual factors used in the Darcy equation is presented below. A groundwater discharge map is included as Figure 7.

Using the data from EA, the groundwater discharge is between 5,460 and 59,000 L/day (see attached Table A). The flow rate is based on medium-grained sand.

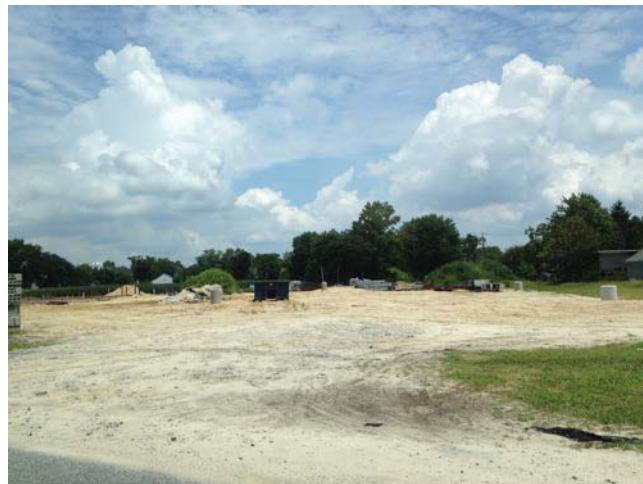
Midway along the western site boundary (Kollock Street) where the construction area and grass meet.

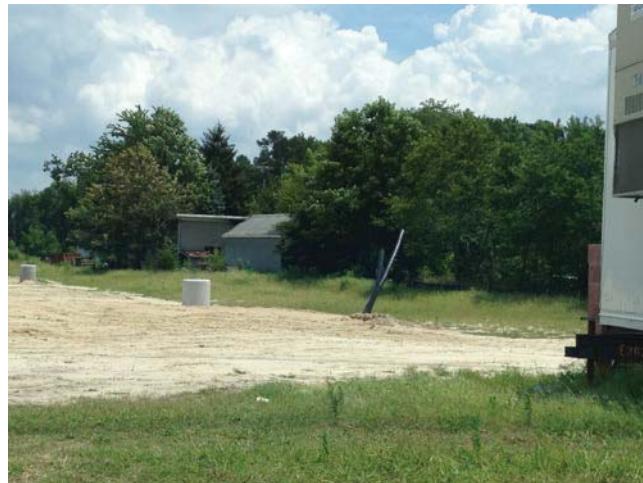
Along Kollock Street where the bare construction area and grass meet with tall trees in the background.

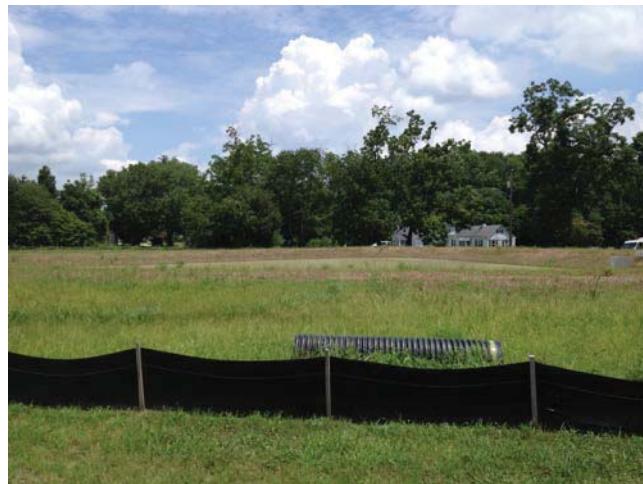
Based on the aerial photography evaluation and review of site documents it appears that the Site contains a retention pond in the southeastern portion of the Site, which prevents the migration of some sediment from departing the Site. In addition, during the site assessment, a silt fence was located around the perimeter of the Site for sediment and erosion control during construction. In an effort to be as conservative as possible, a support factor of 1, indicating no engineering controls, was utilized in the calculations to predict the maximum PCB mass loading that may leave the Site.

The area around the retention pond located in the southern extent of the Site is sloped upwards and is higher than the surrounding elevation.

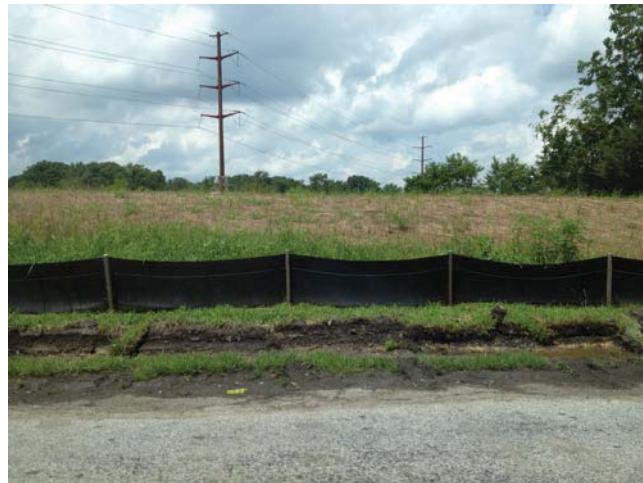
The retention pond wall from the southeast on Pepper Creek Road.

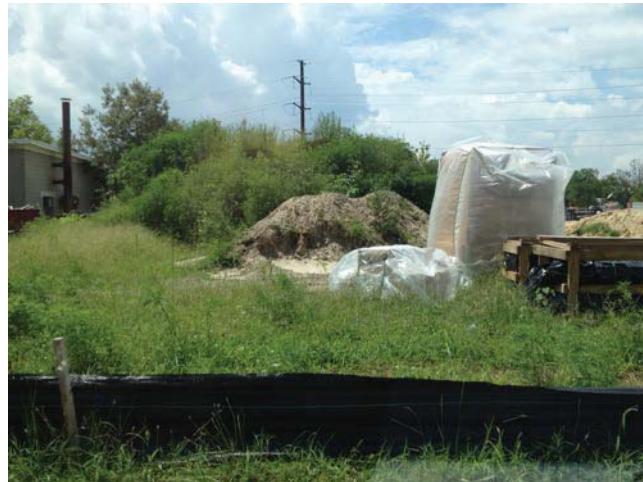
A dirt mound with large weeds sits on the eastern corner of the site and tall weeds line Lingo Road, which runs northeast of the site.
