Condition of Wetlands in the Christina River Watershed

Published: November 2014

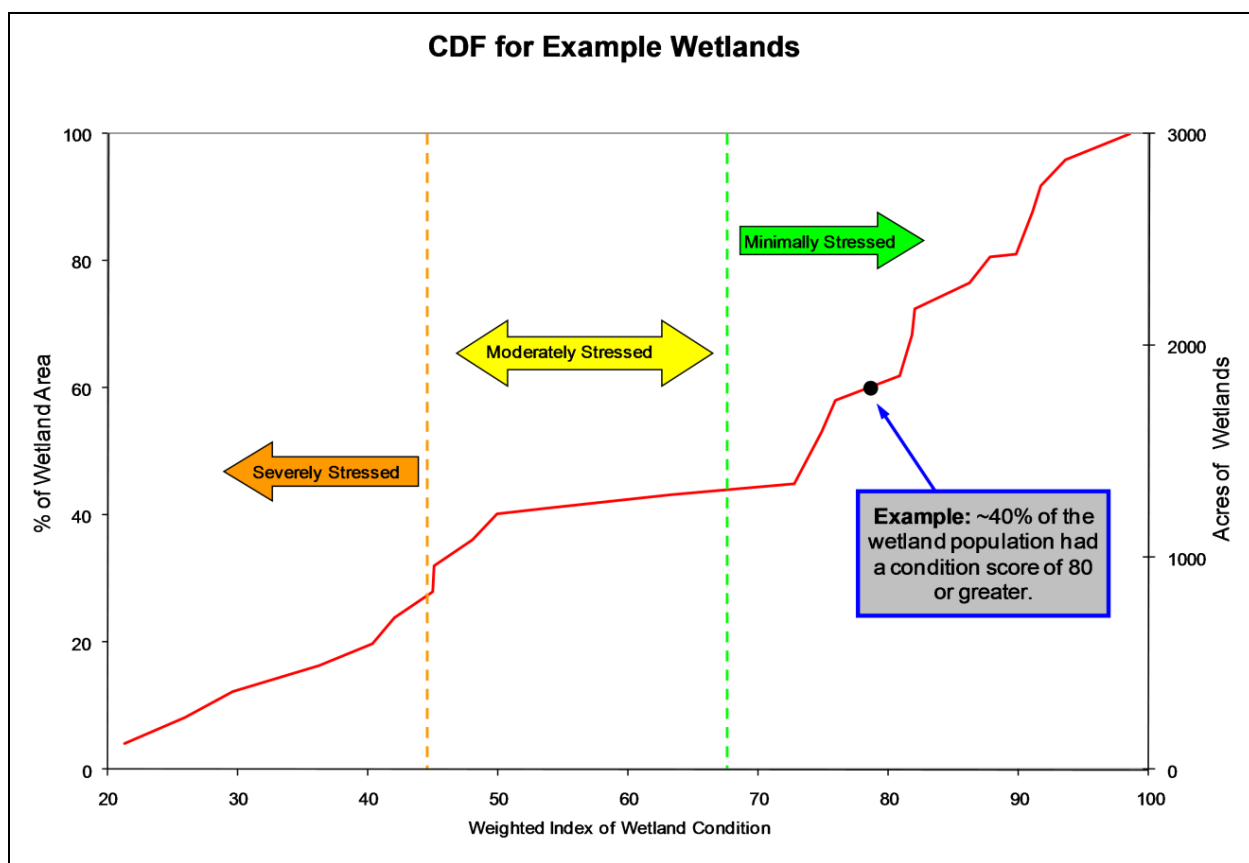
Figure 7. An example CDF showing wetland condition. The red line is the population estimate. The orange and green dashed lines show the breakpoints between condition categories.

We used a cumulative distribution function (CDF) to display wetland condition on the population level. A CDF is a visual tool to extrapolate assessment results to the entire population and can be interpreted by drawing a horizontal line anywhere on the graph and reading that as: 'z' proportion of the area of tidal wetlands in the watershed falls above (or below) the score of 'w' for wetland condition. The advantage of these types of graphs is that they can be interpreted based on individual user goals, and break points can be placed anywhere on the graph to determine the percent of the population that is within the selected conditions. For example, in Figure 7 roughly 40% of the wetland area scored above an 80 for wetland condition. A CDF also highlights clumps or plateaus where either a large or small portion of wetlands are in similar condition. In the example, there is a condition plateau from 50 to approximately 75, illustrating that only a small portion of the population had condition scores in this range.

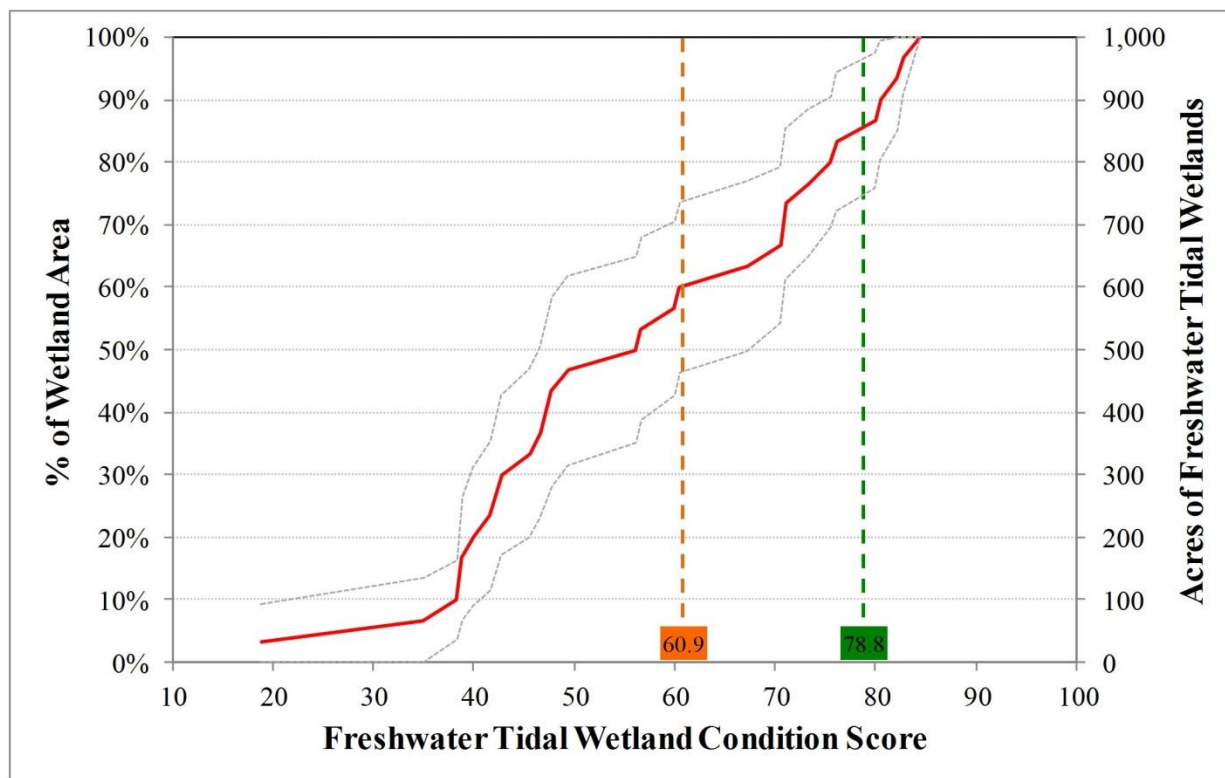
Figure 13. The cumulative distribution function for tidal wetlands in the Christina watershed. The orange and green dashed lines signify the condition category breakpoints dividing severely stressed from moderately and minimally stressed portions of the tidal wetland population.

The cumulative distribution function graph for tidal wetlands in the Christina watershed shows that 50% of the watershed's wetlands scored a condition within 20 points of each other (40-60), indicated by a steep incline, with a small portion in the worst condition (<40; Fig. 13). MidTRAM data from the 30 freshwater tidal wetland assessment sites can be found in Appendix D.

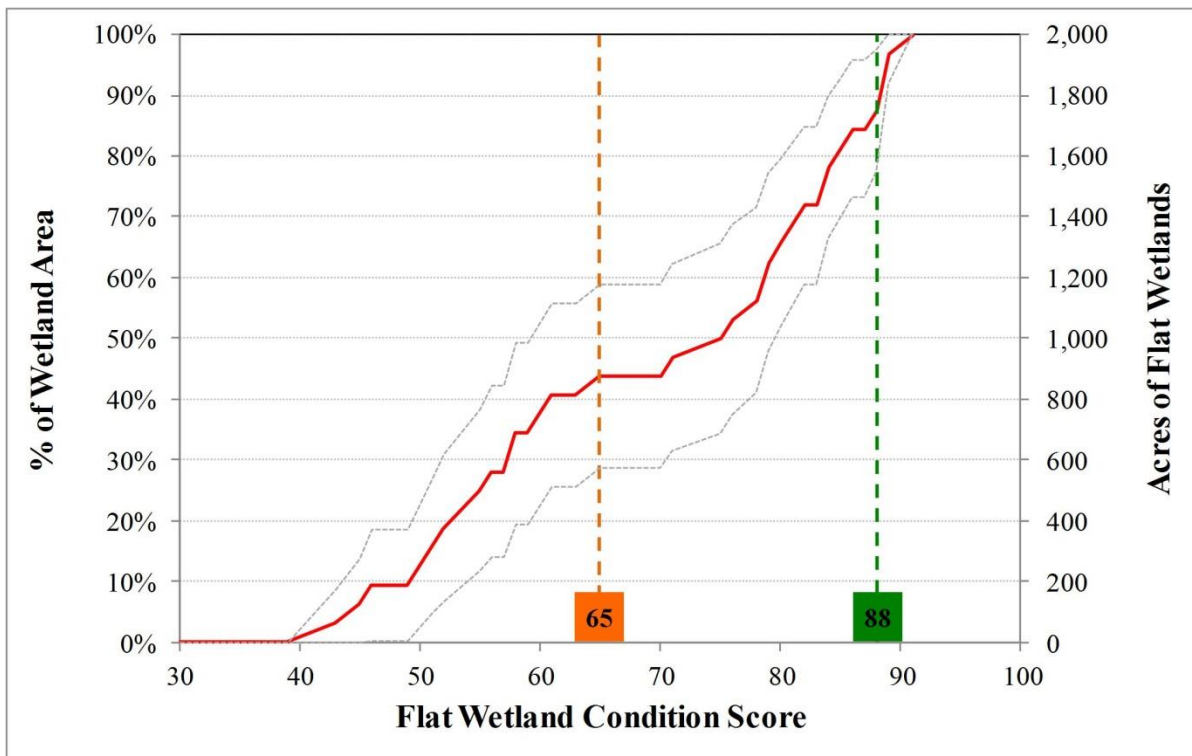
Figure 14. Cumulative distribution function for non-tidal flat wetlands in the Christina River watershed. Condition scores for the wetland population are represented as the red line with 95% confidence intervals (gray dashed lines). The orange and green dashed lines designate condition category breakpoints dividing severely stressed, moderately stressed, and minimally stressed wetlands.

The cumulative distribution function for flat wetlands in the Christina River watershed shows a wetland population skewed towards lower condition classes (Figure 14). A plateau in the middle marks a gap in flats scoring 60-70. Approximately 900 acres of flat wetlands in the Christina watershed are functioning in a severely stressed condition. Generally, these wetlands have been extensively cleared or thinned of trees and contain plant communities with moderate to extensive coverage of invasive plant species. A majority of these sites have also been ditched and partially filled, and have multiple stressors in the surrounding landscape. Only 200 acres of flat wetlands in the watershed are estimated to be in a minimally stressed state. These wetlands have a low occurrence of invasive plants and selective forest thinning, intact hydrology, little to no fill material, and relatively intact buffers. The DERAP stressor checklist from the 32 flat wetland assessment sites in the Christina River watershed are provided in Appendix E.

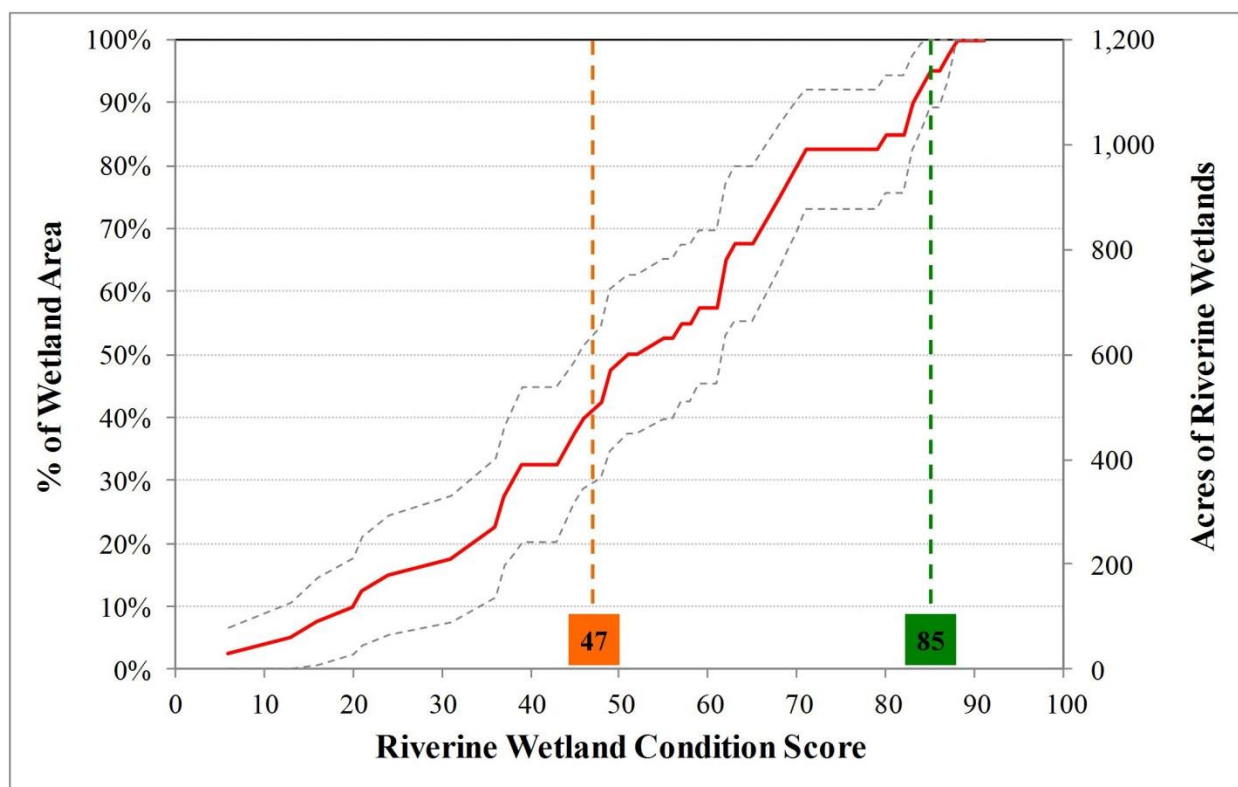
Figure 15. Cumulative distribution function for non-tidal riverine wetlands in the Christina River watershed. Condition scores for the wetland population are represented as the red line with 95% confidence intervals (gray dashed lines). The orange and green dashed lines designate condition category breakpoints dividing severely stressed, moderately stressed, and minimally stressed wetlands.

Fewer than 50 acres of minimally stressed riverine wetlands remain in the Christina River watershed based on cumulative distribution function estimates (Figure 15). These wetlands were absent of forest cutting, stream alterations, and fill material. However, these wetlands vary in the amount of invasive plant species present and the intensity of impacts to the surrounding buffer. Conversely, approximately 500 acres of riverine wetlands in the Christina River watershed were severely stressed. Invasive plant species were found in each of the severely stressed riverines, with invasives as the dominant plant cover in 69% of these wetlands. Stream morphology and wetland hydrology was also significantly altered, including channelization or incision (100%), fill material (81%), and constricted or impounded streamflow (63%; Table 7). Impervious landcover was also found in the buffers around each of the severely stressed riverine wetlands. The DERAP stressor checklist from the 40 riverine wetland assessment sites in the Christina River watershed are provided in Appendix F.
