# Design, Implementation, and Evaluation of Three Living Shoreline Treatments in Lewes and Inland Bays, DE

A technical report submitted to Delaware Department of Natural Resources and Environmental Control in partial fulfillment of Contract No. 12404-Monitoring: Coastal Wetland Monitoring Stations and Living Shoreline

Partnership for the Delaware Estuary  
110 South Poplar Street, Suite 202  
Wilmington, DE 19801

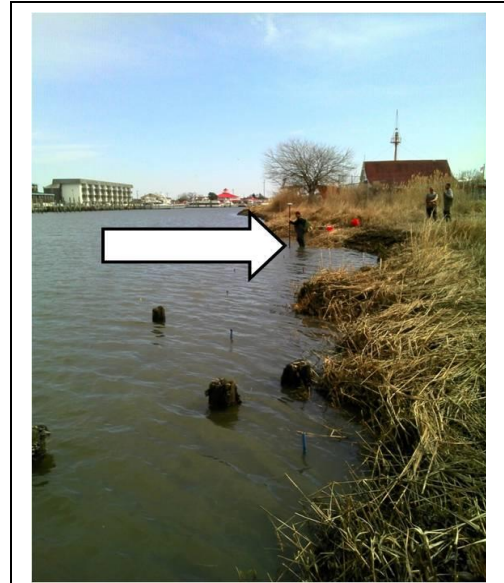
Figure 2 Eroding marsh edge in the Lewes Marsh site treatment area. The large cusp behind the white arrow is located directly across the canal from a marina boat ramp.

The Lewes location consisted of one living shoreline site (Marsh) for which a paired treatment and control, ~26m in length, were selected and delineated (Fig. 3). The paired treatment and control are separated by a small drainage creek that bisects the AOI. The existing vegetation community consisted of a ~2m band of tall-form *Spartina alterniflora* along the waterward margin, grading to short and mid-form *S. alterniflora* moving inland to the upland vegetation boarder. The treatment area exhibited a large, landward indentation along the contiguous vegetated edge located directly across the canal from the boat ramp at the Lewes Harbor Marina (Figs. 2 and 3). The width of the tall form *S. alterniflora* band decreased along the indentation from the outward extent and was completely absent at the cusp's center-replaced by short form *S. alterniflora*. This eroding shoreline was beginning to

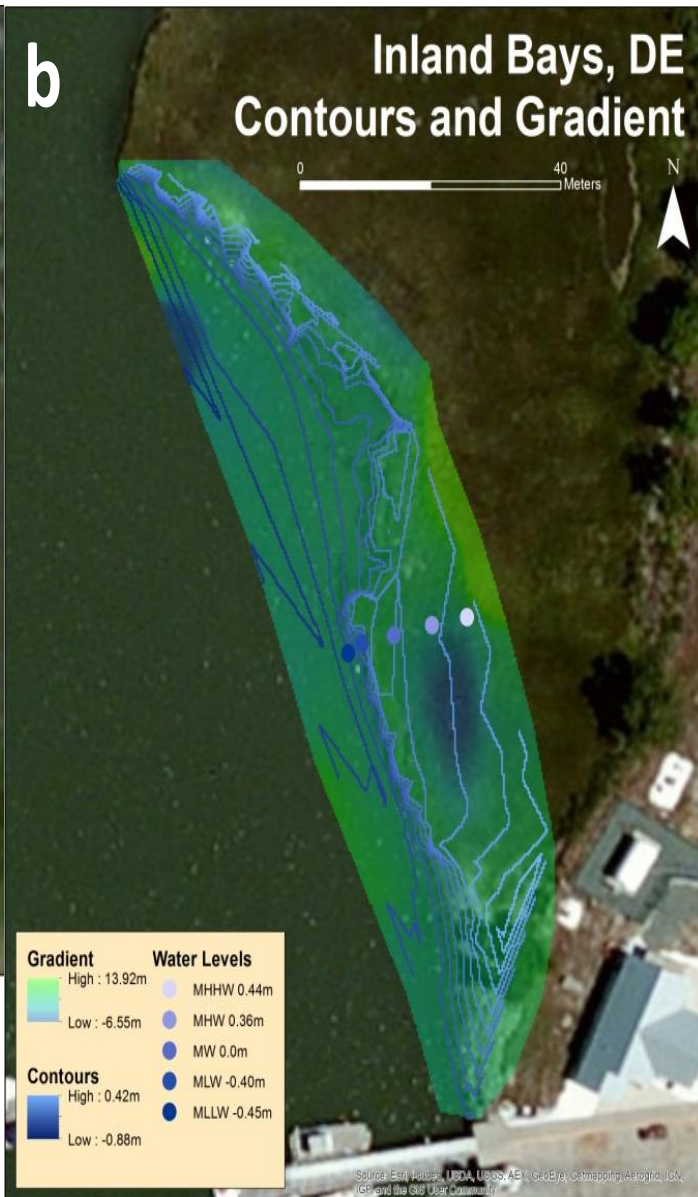
Figure 6 Contour and gradient profiles along the Lewes (a) and Inland Bays (b) locations. Contour lines and gradient polygon spanned the area between mean lower low water and mean higher high water. Local tidal datum elevation represented as points.

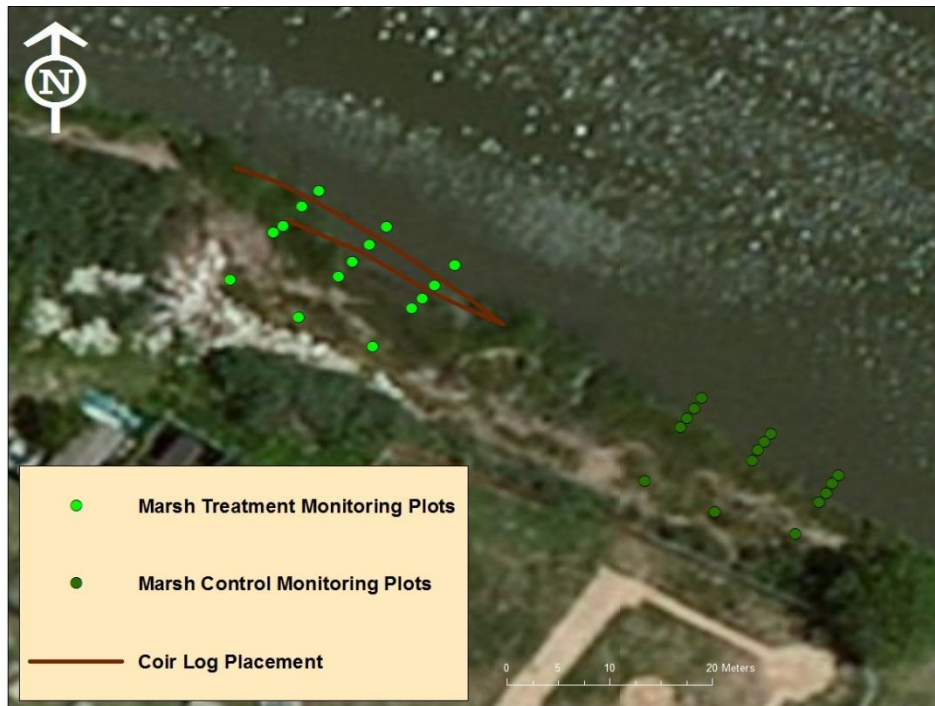
Figure 9 Position of monitoring plots and coir log treatments within the paired treatment and control areas at the Lewes living shoreline location. Monitoring plot locations and log positions collected using RTK-GPS.

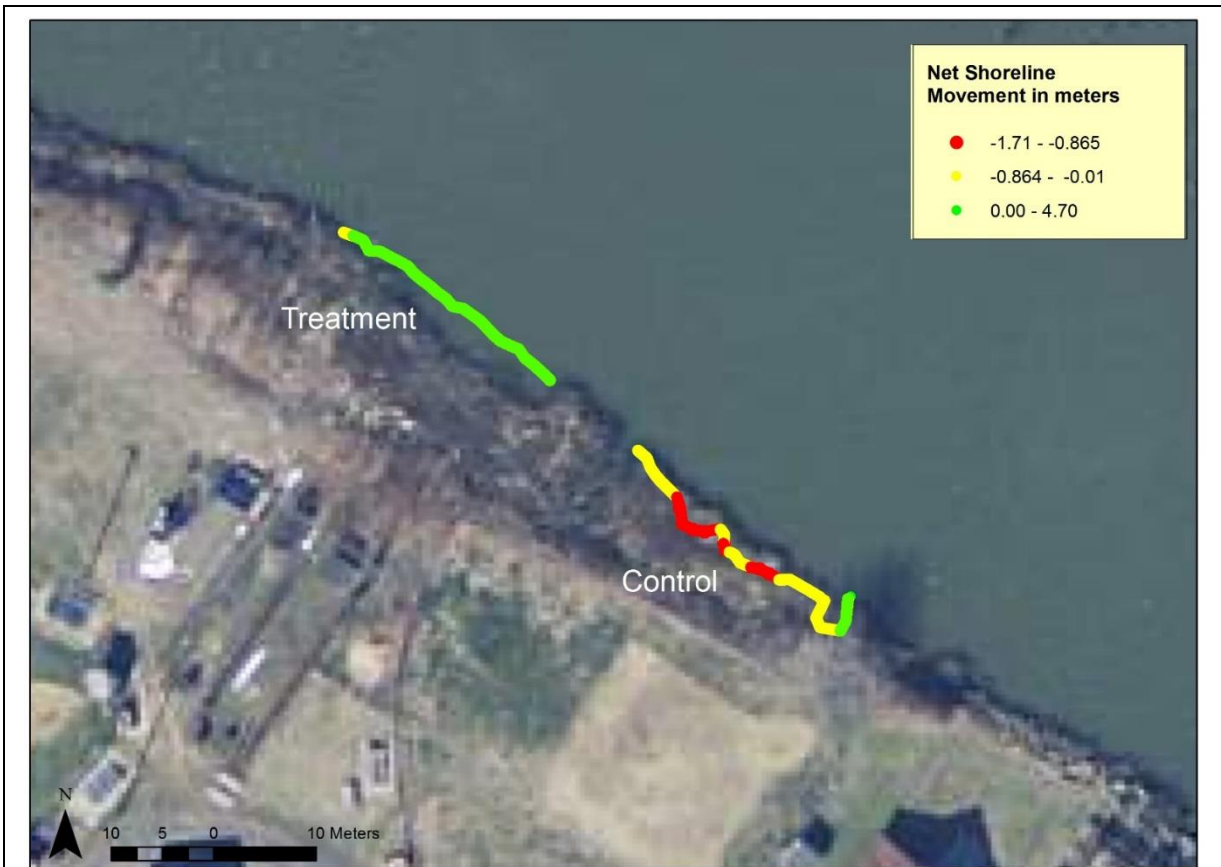
Figure 11 Net Shoreline Movement is overall movement of the shoreline between the oldest shoreline measurement and the most recent shoreline measurement. Areas in green reflect a net waterward shoreline movement (i.e. gain of marsh area). Red and yellow represent areas where there was net landward shoreline movement (i.e. loss of marsh area). The difference in red and yellow was based on the mean of the overall net shoreline movements across all sites. The area at the end of the control shoreline, although showing positive movement, upon closer inspection, was most likely caused by a mis-measurement by DSAS transects around a curve.

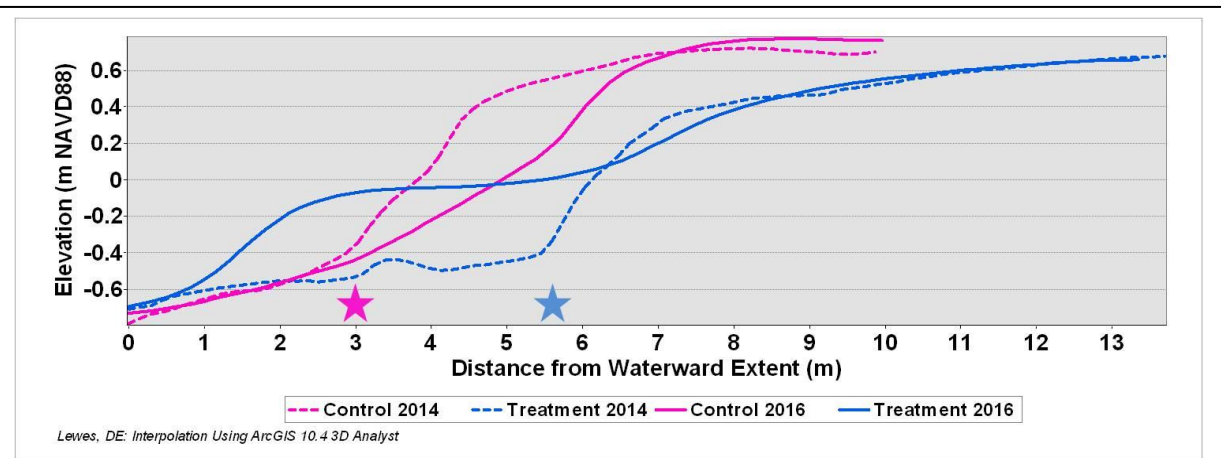
Figure 12 Elevation profile of the Lewes Marsh site along Transect 3. The control is denoted by pink lines and treatment is denoted by blue lines. Dashed lines indicate elevations and positions that were measured in 2014, and solid lines denote measurements from 2016. Stars denote the lateral position of the contiguous vegetated shoreline in 2014, color coded as noted above. All measurements were taken with a Trimble R6 RTK-GPS unit.

along transect 3 between 2014-2016 (pink star and peak of solid pink line respectively) reflects the maximum landward marsh movement (-1.71m, Table 3). The convergence of the dashed and solid blue lines on the marsh platform and in the high marsh (7.5-13m along x-axis; plots 4 and 5) and foreshore (0-1m along x-axis; plot 1) indicated that the living shoreline had little effect on the elevation at these locations.

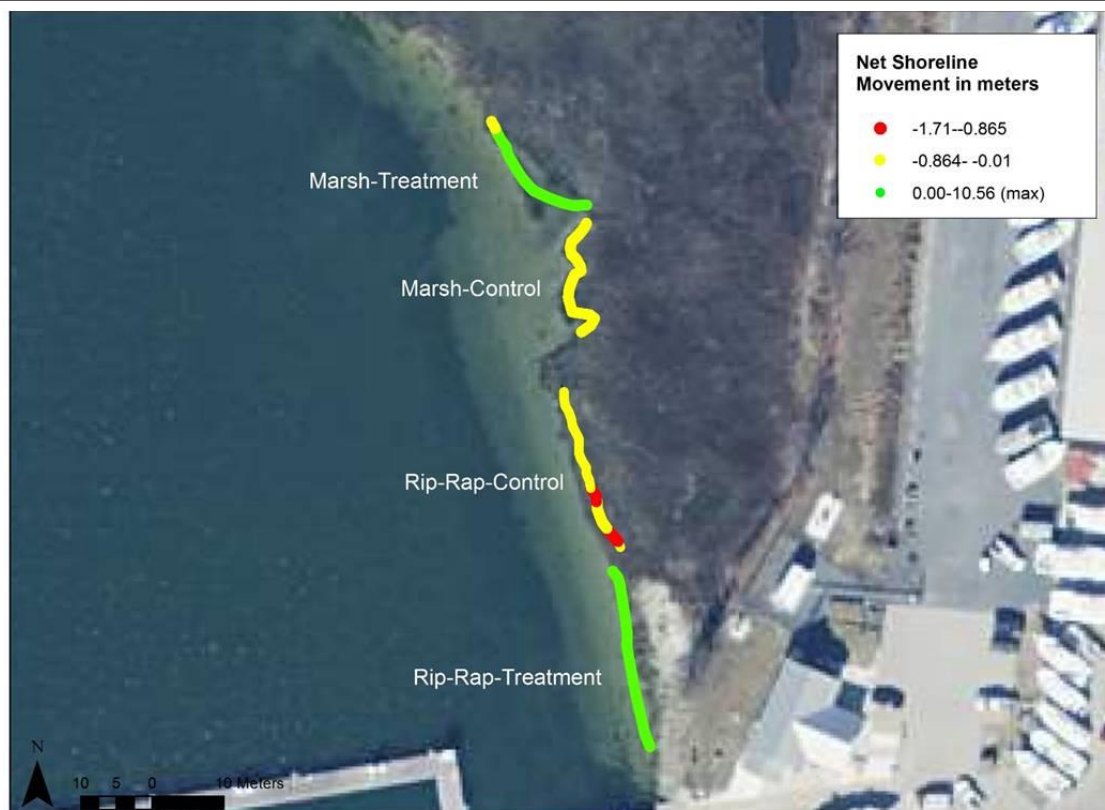
Figure 15 Net Shoreline Movement is overall movement of the shoreline between the oldest shoreline measurement and the most recent shoreline measurement. Areas in green reflect a net waterward shoreline movement (i.e. gain of marsh area). Red and yellow represent areas where there was net landward shoreline movement (i.e. loss of marsh area). The difference in red and yellow was based on the mean of the overall net shoreline movements across all sites.

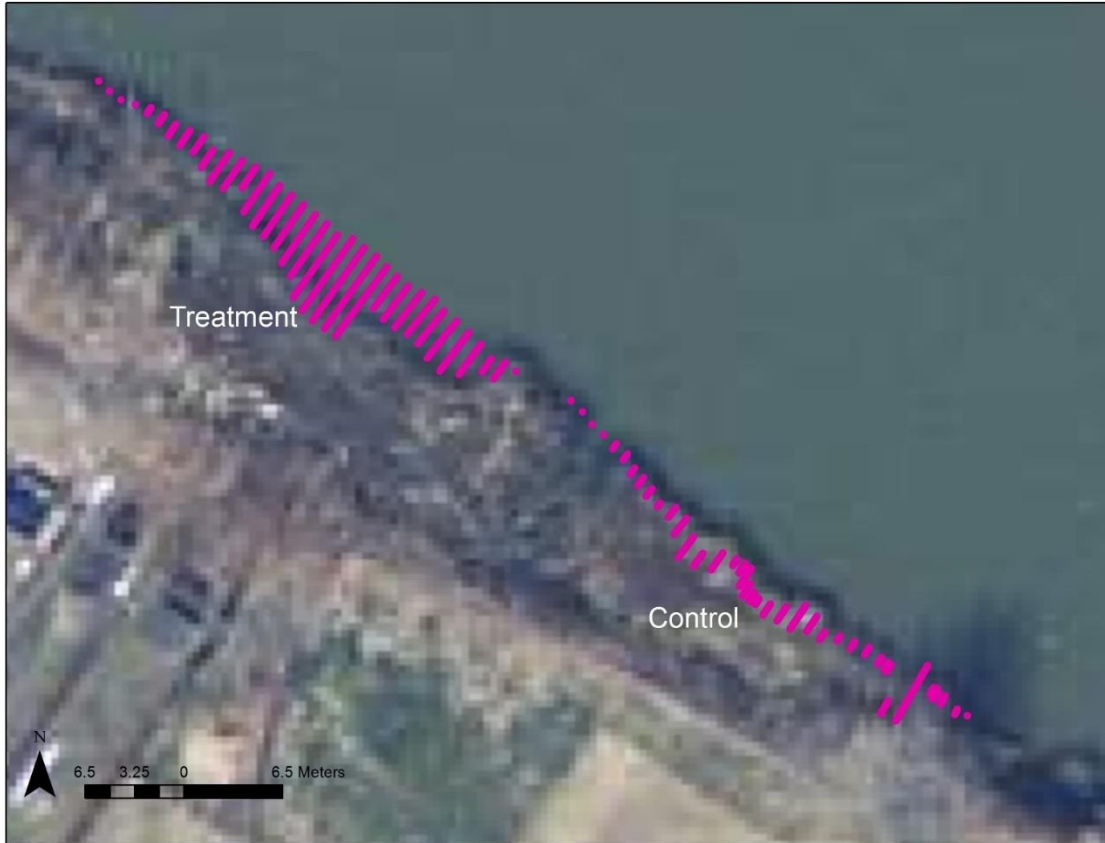
Figure C1. Transect locations and lengths (between most waterward and landward vegetation lines) generated from DSAS for the Lewes study location.

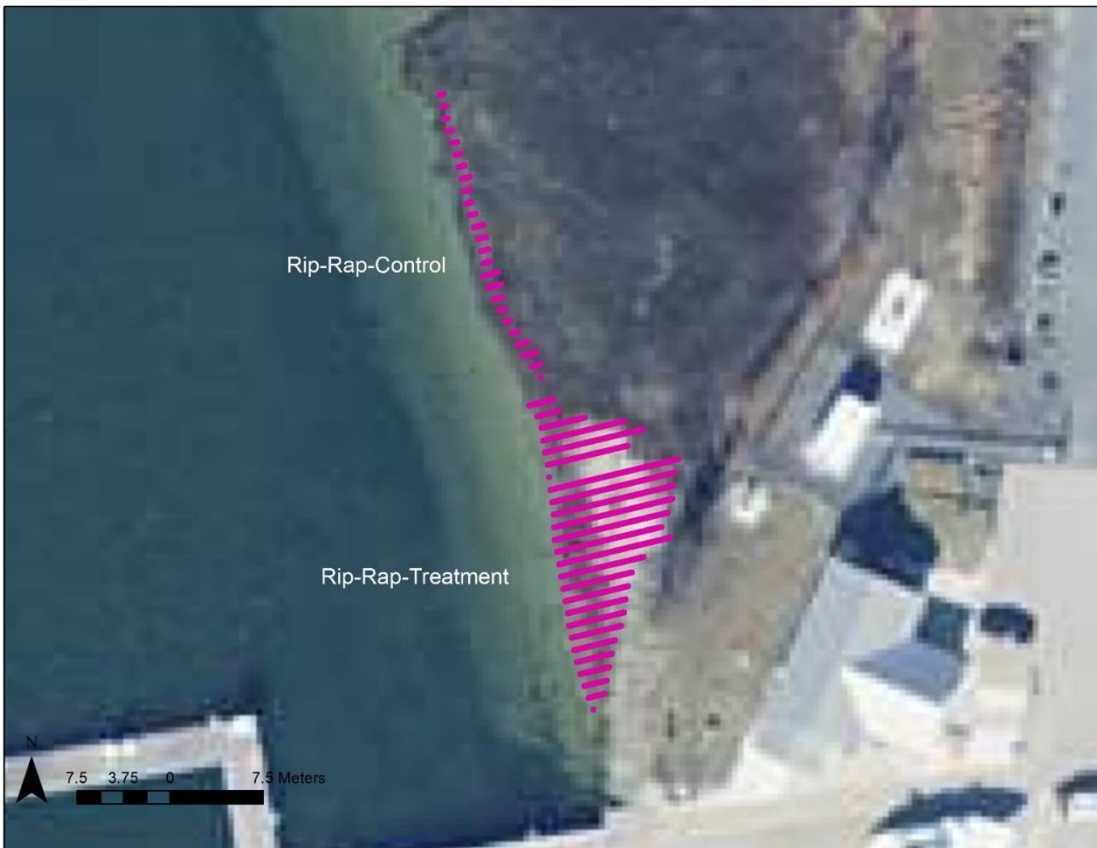
Figure C2. Transect locations and lengths (between most waterward and landward vegetation lines) generated from DSAS for Inland Bays Rip-Rap study location.

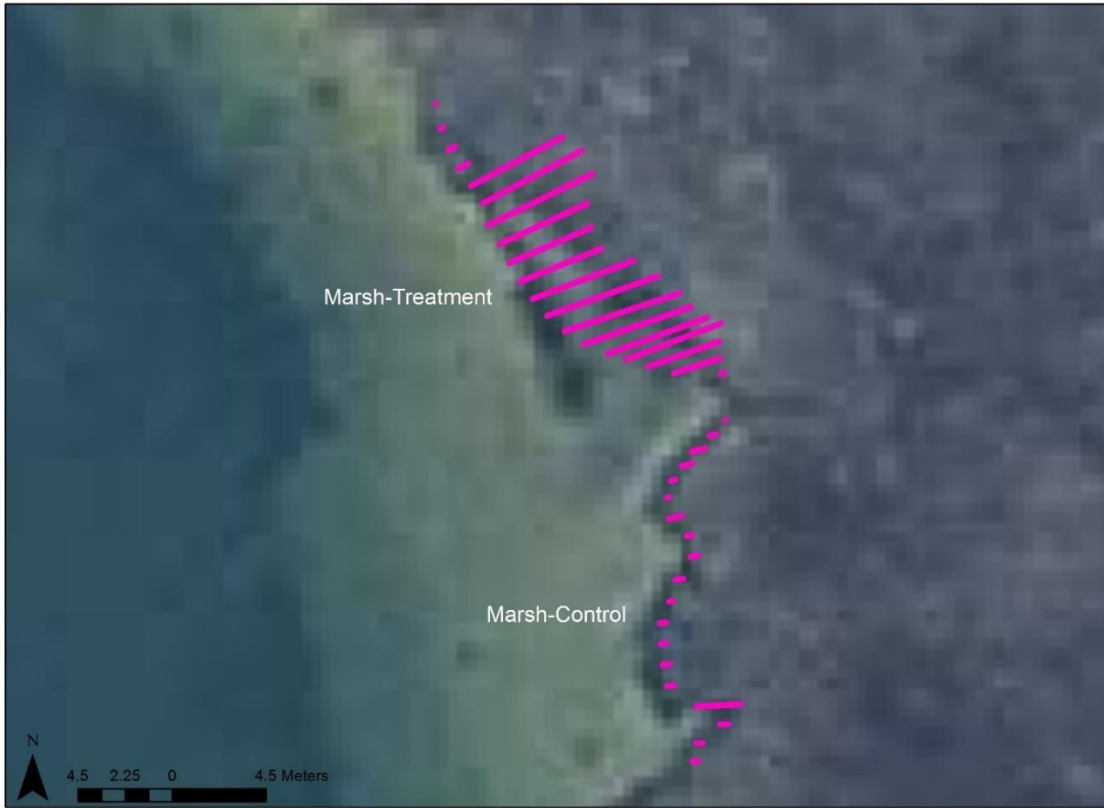
**Figure C3. Transect locations and lengths (between most waterward and landward vegetation lines) generated from DSAS for the Inland Bays Marsh study location.**

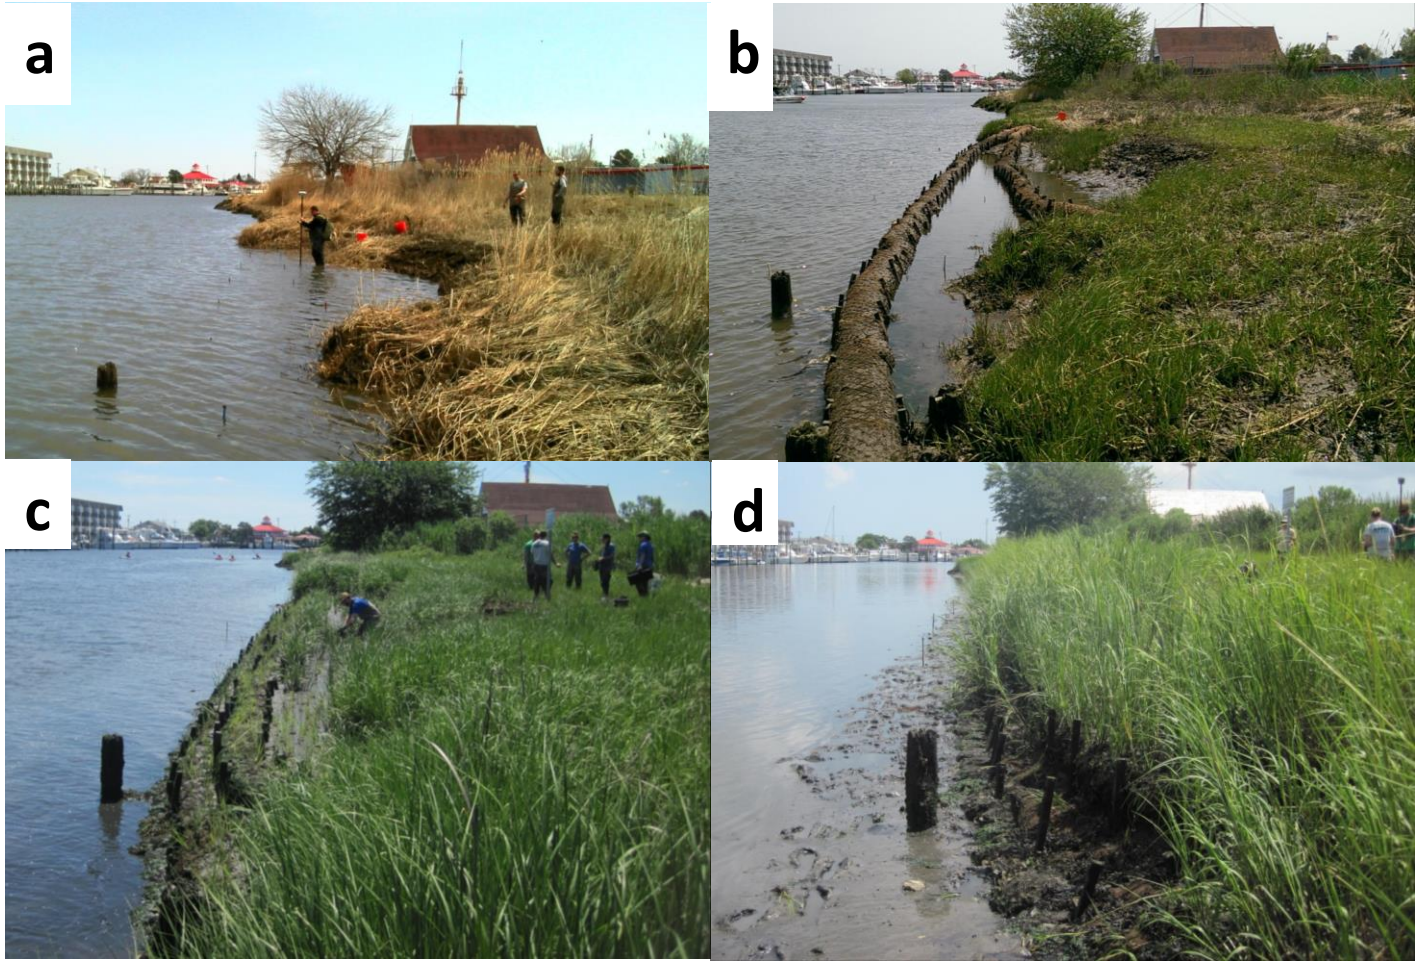
Figure D1. Time series for Lewes Marsh site living shoreline looking southeast: a) pre-installation, April 2014; b) post-installation June 2014; c) June, 2015; d) August, 2016.
