STATE OF DELAWARE  
**DEPARTMENT OF TRANSPORTATION**  
800 BAY ROAD  
P.O. BOX 778  
DOVER, DELAWARE 19903

Enclosed you will find a copy of the Subaqueous Lands Permit Application for the **BR 1-447 on N449 Taylors Bridge Road over Blackbird Creek Bridge Replacement, Contract #T201907102**, in New Castle County, Delaware. This project involves the removal of existing Bridge 1-447 and construction of a new structure.

**Re: Finding of Wetlands Letter**  
**Bridge 1-447 on Taylors Bridge Road (SR 9) over Blackbird Creek**  
**Bridge Replacement Project (Project No. T201907102; Agreement 1813F)**  
**Middletown, New Castle County, Delaware**

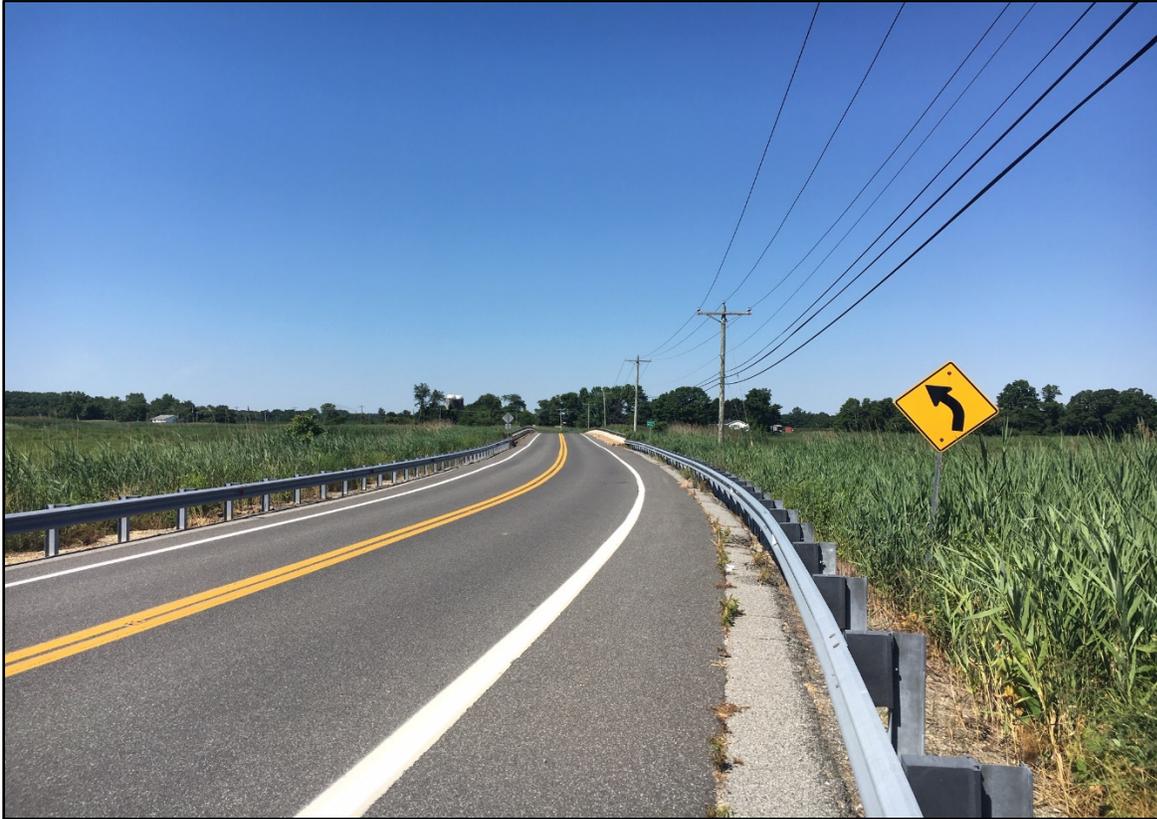
**Photograph 1.** Looking west across Taylors Bridge along Estuarine Tidal Wetlands (Wetland 1). Photo taken 6-26-2020.

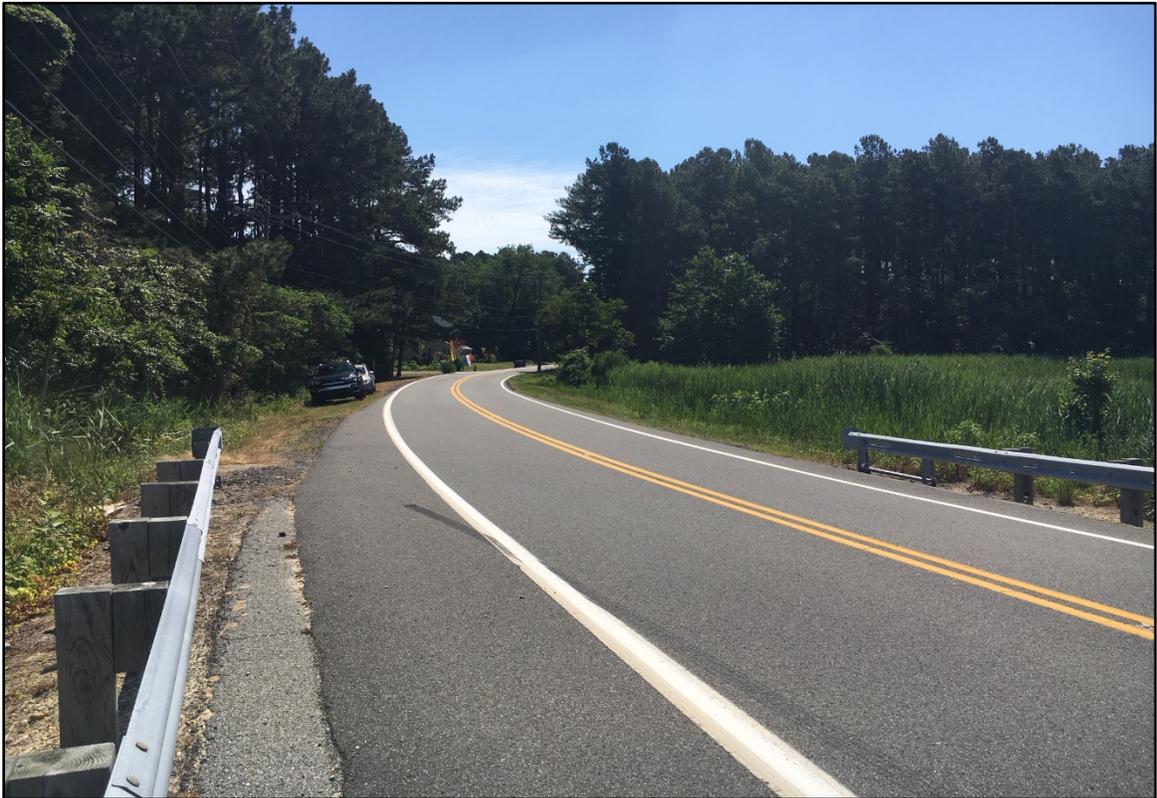
**Photograph 2.** View to the east along SR 9 (Taylors Bridge Road) toward forested areas delineated as upland. Photograph Taken 6-26-2020.

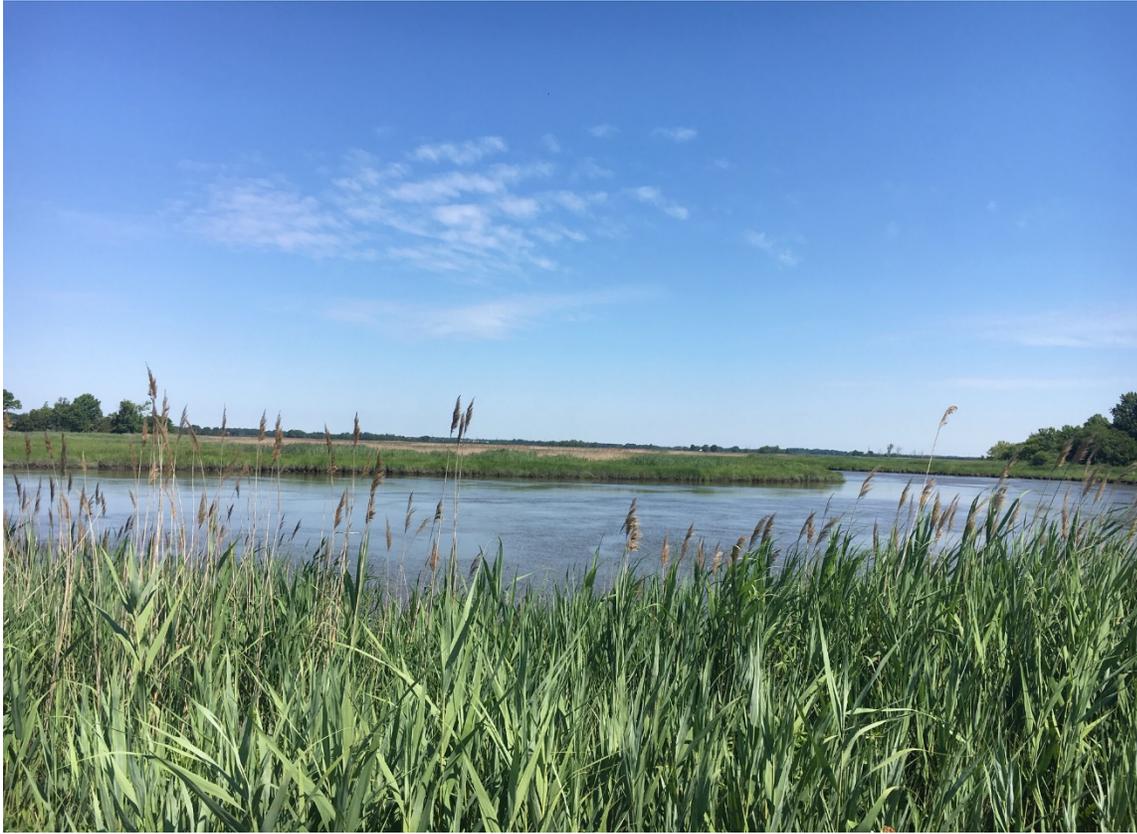
Photograph 3. View across Estuarine Tidal Wetlands (Wetland 1) toward Blackbird Creek. Photo taken 6-26-2020

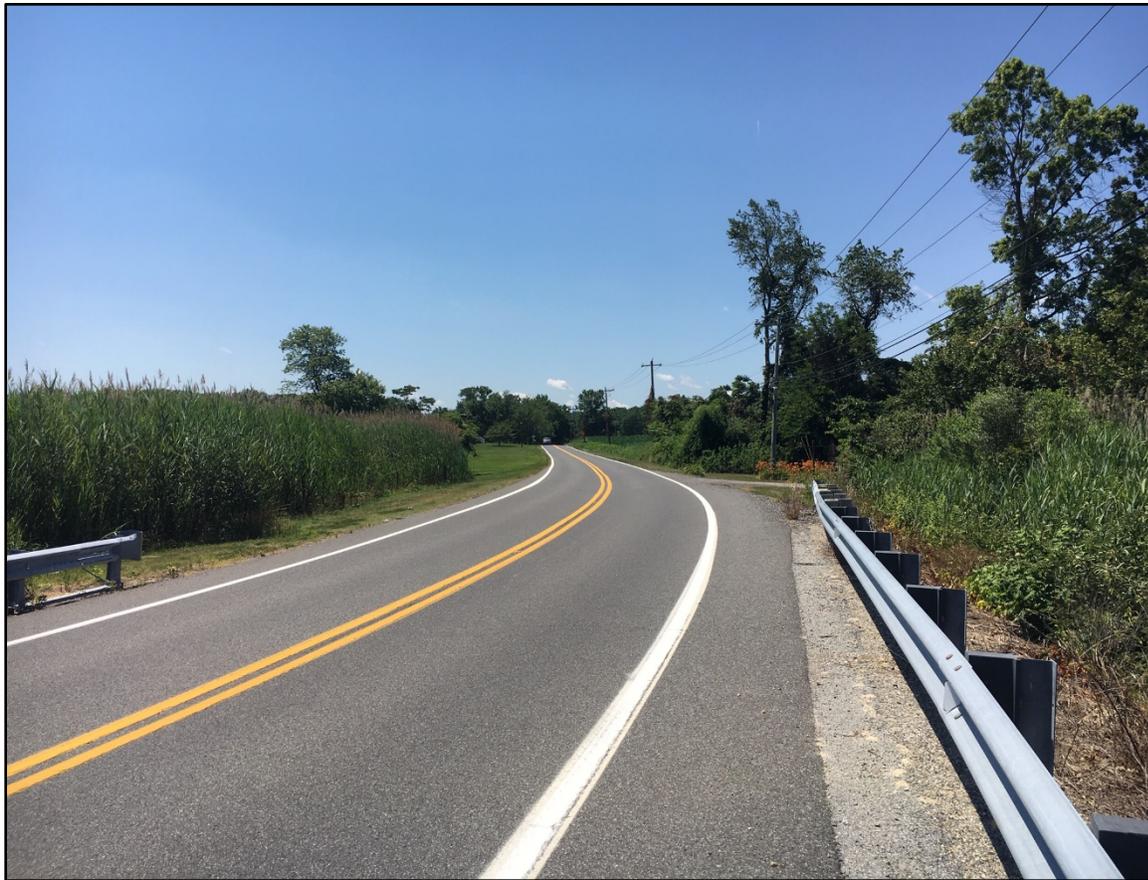
Photograph 4. View to the west along the western approach of Taylor's Bridge. Photo taken 6-26-2020

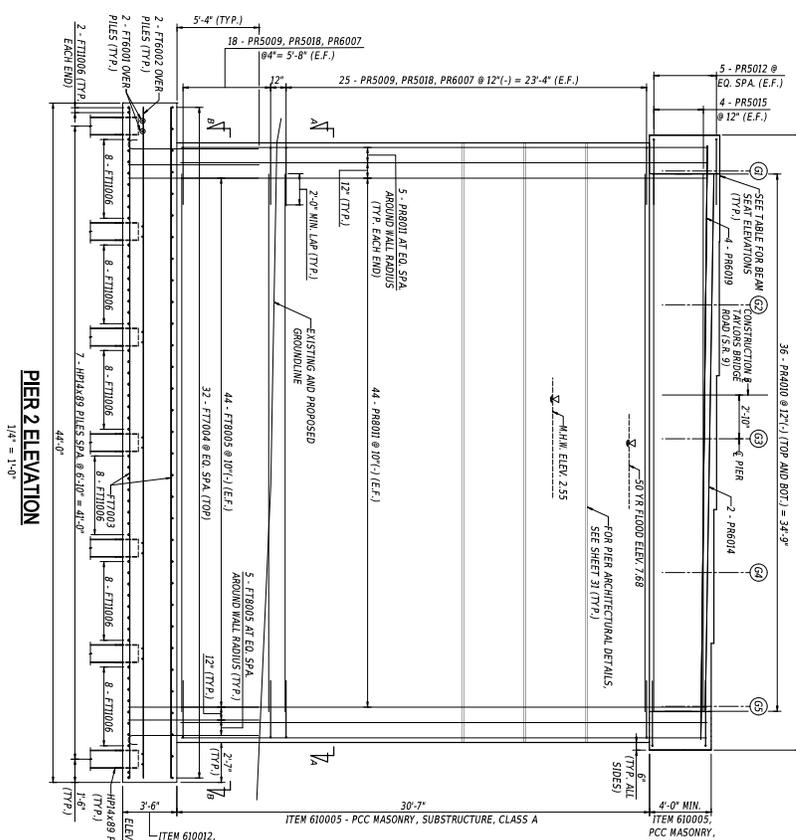
**PIER 2 BEAM SEAT ELEVATIONS**

GIRDER NO.	ELEVATION (FT)
G1	13.36
G2	13.32
G3	13.15
G4	12.98
G5	12.80

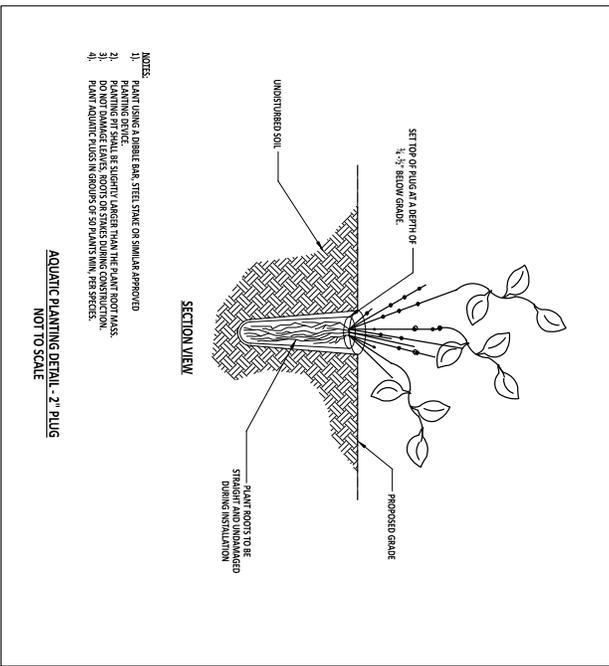
- NOTES:
- 1) PLANT USING A DOUBLE BAR STEEL STAKE OR SIMILAR APPROVED PLANTING DEVICE.
  - 2) PLANTING DEVICE SHALL BE SLIGHTLY LARGER THAN THE PLANT ROOT MASS.
  - 3) DO NOT DAMAGE LEAVES, ROOTS OR STEMS DURING CONSTRUCTION.
  - 4) PLANT AQUATIC PLUGS IN GROUPS OR SO PLANTS MIN. 1 YEAR SPECIES.

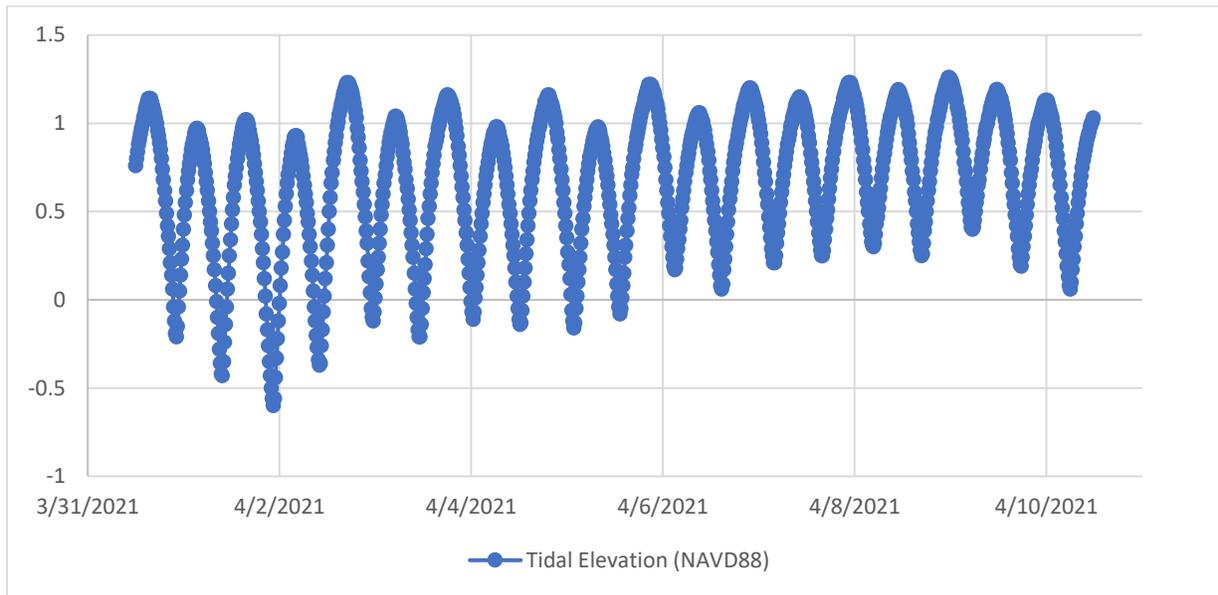
Figure 3: The above figure details the expected tidal values of an area over a 10-day span.

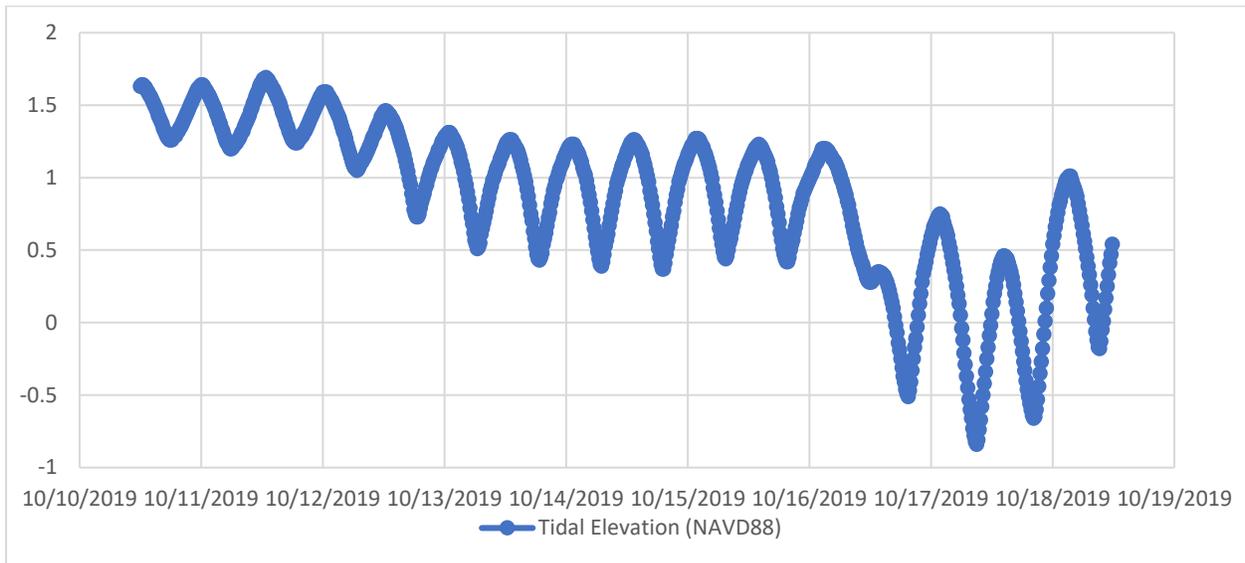
Figure 4: This figure details the irregular tidal activity of the area wherein the project will be taking place. As can be noted against Figure 1, the tidal irregularities are clear to see.

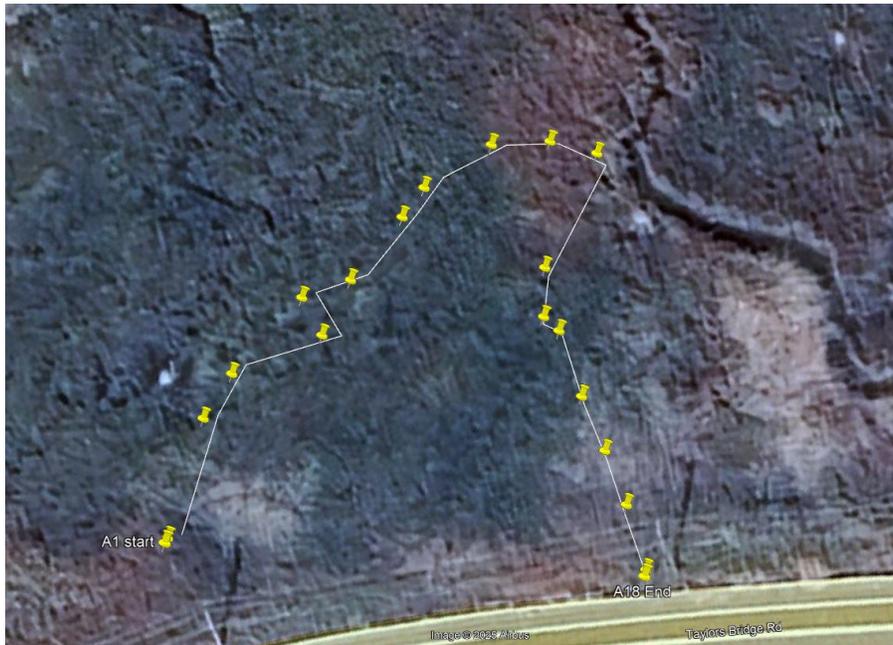
Figure 4: The above image depicts Quadrant A and the Bio-Bench markers that were determined at the location.

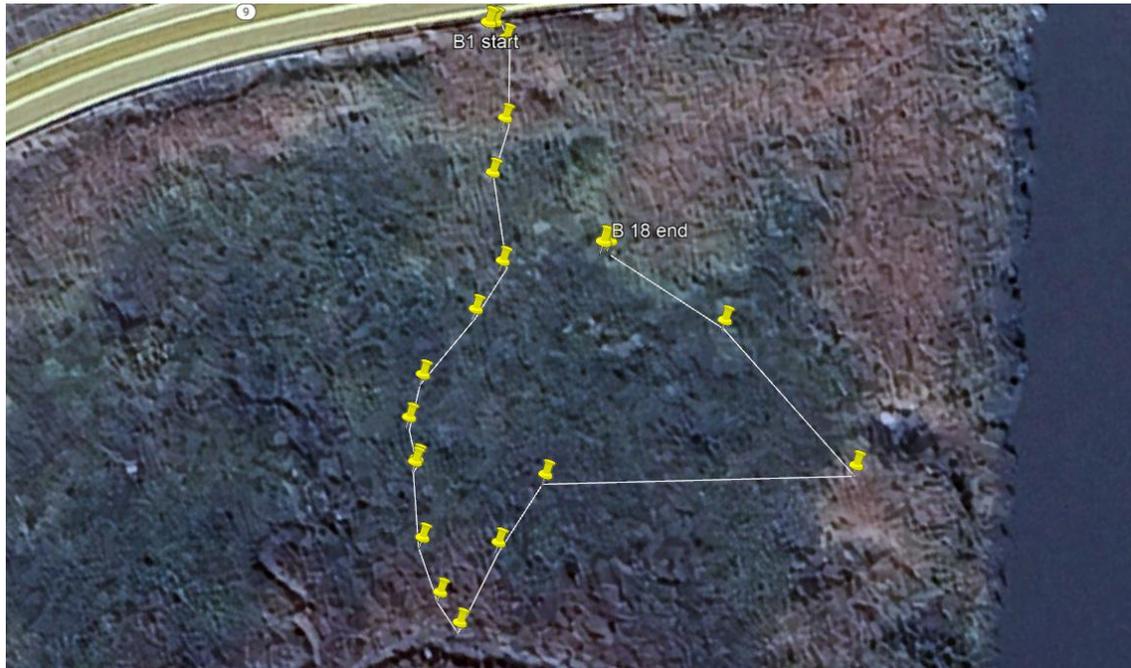
Figure 5: The above image depicts *Quadrant B* and the *Bio-Bench* markers that were determined at the location.

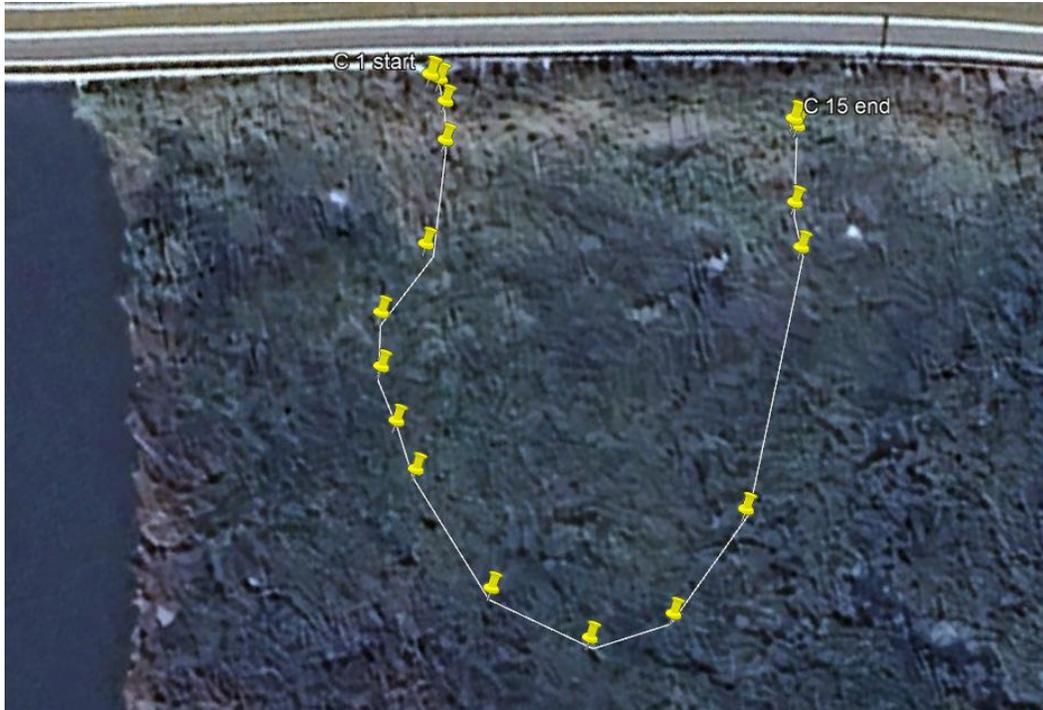
Figure 5: The above image depicts Quadrant C and the Bio-Bench markers that were determined at the location.

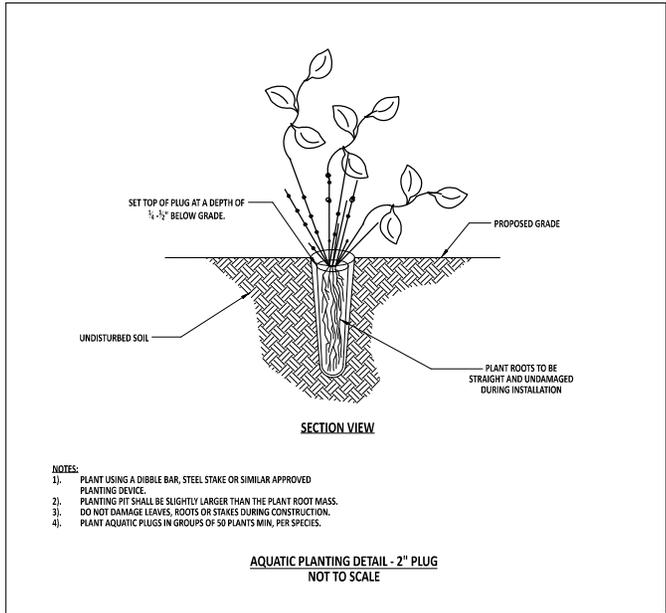
- NOTES:
1. PLANT USING A DIBBLE BAR, STEEL STAKE OR SIMILAR APPROVED PLANTING DEVICE.
  2. PLANTING PIT SHALL BE SLIGHTLY LARGER THAN THE PLANT ROOT MASS.
  3. DO NOT DAMAGE LEAVES, ROOTS OR STAKES DURING CONSTRUCTION.
  4. PLANT AQUATIC PLUGS IN GROUPS OF 50 PLANTS MIN, PER SPECIES.

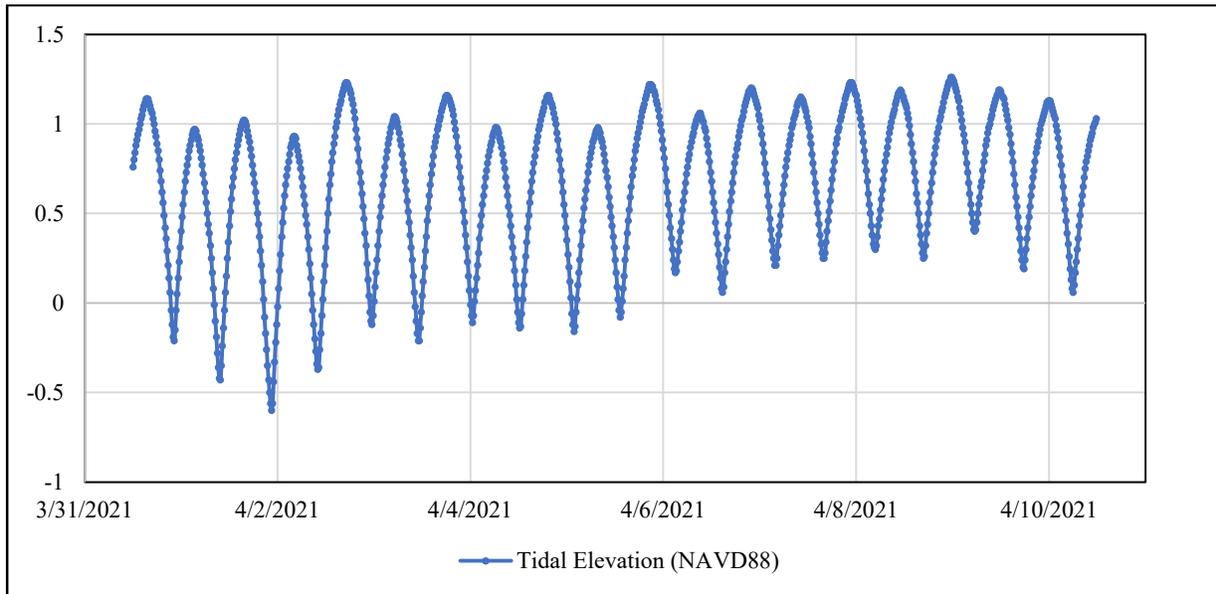
The tide patterns at this location are irregular since the site does not experience a typical slack low tide period. The high tide elevation and full tidal range is frequently erratic throughout the data record. **Figure 2** shows an example of irregularities that occur throughout the data.

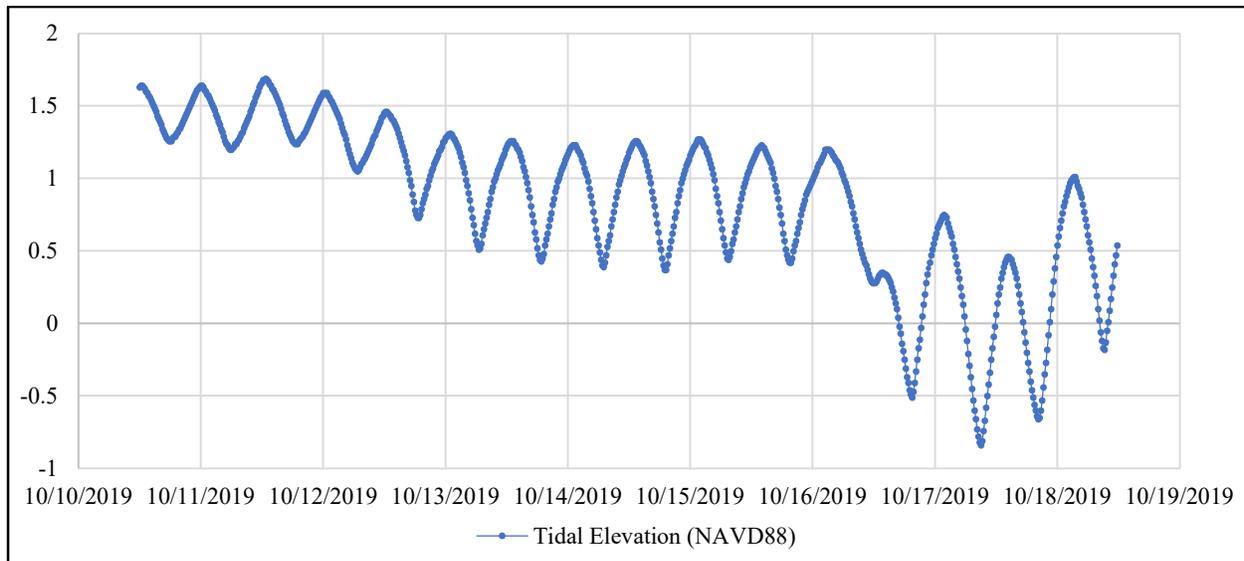
The tide irregularity at this location is likely caused by the narrow channel servicing a large drainage area located relatively far away from the larger tidal waterbody (the Delaware Bay). The use of bio-benchmark elevation data in addition to tidal data is recommended to determine target tidal restoration elevations at this location due to the tidal pattern irregularity.
