**DNREC SUBAQUEOUS LANDS  
PERMIT APPLICATION: CIRCUIT  
6720 – INDIAN RIVER TO  
MILLSBORO CORRECTIVE  
MAINTENANCE PROJECT**

**DELMARVA POWER**

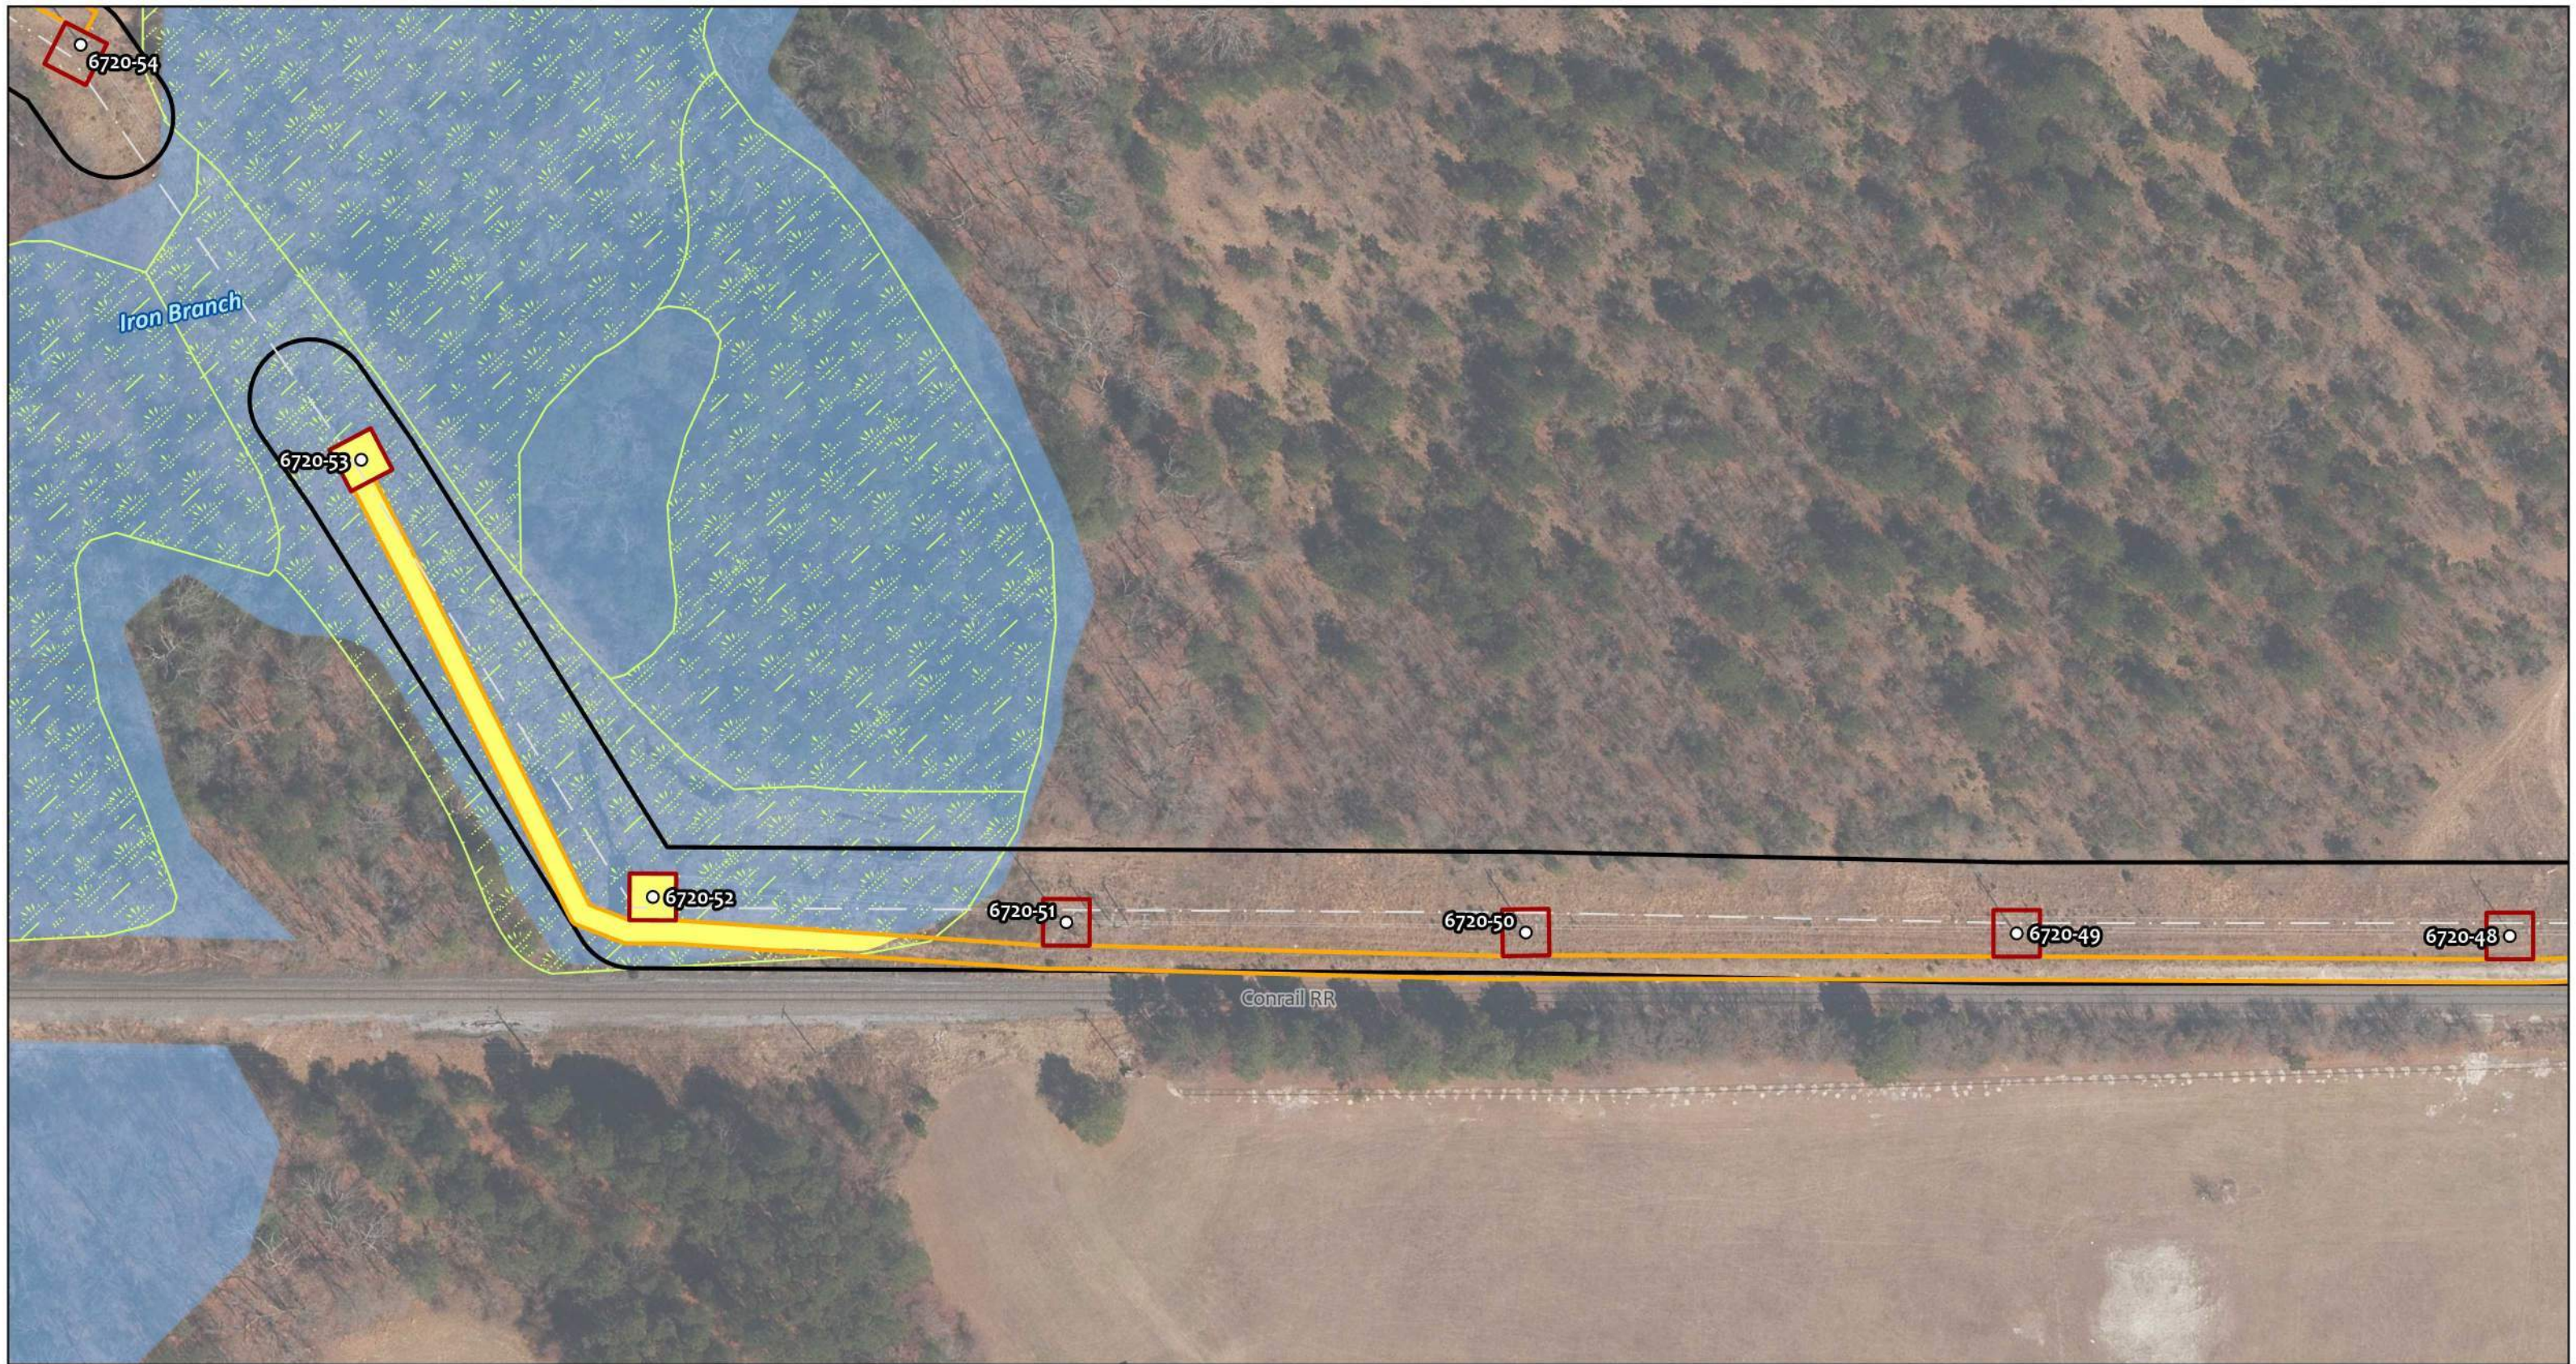
Page 5 of 15

Indian River to Millsboro Impact Table			
Plate Number	Temporary Wetland Impacts - Tidal	Permanent Floodplain Impacts	Temporary Floodplain Impacts
	SF	SF	SF
5	0	0	9,189

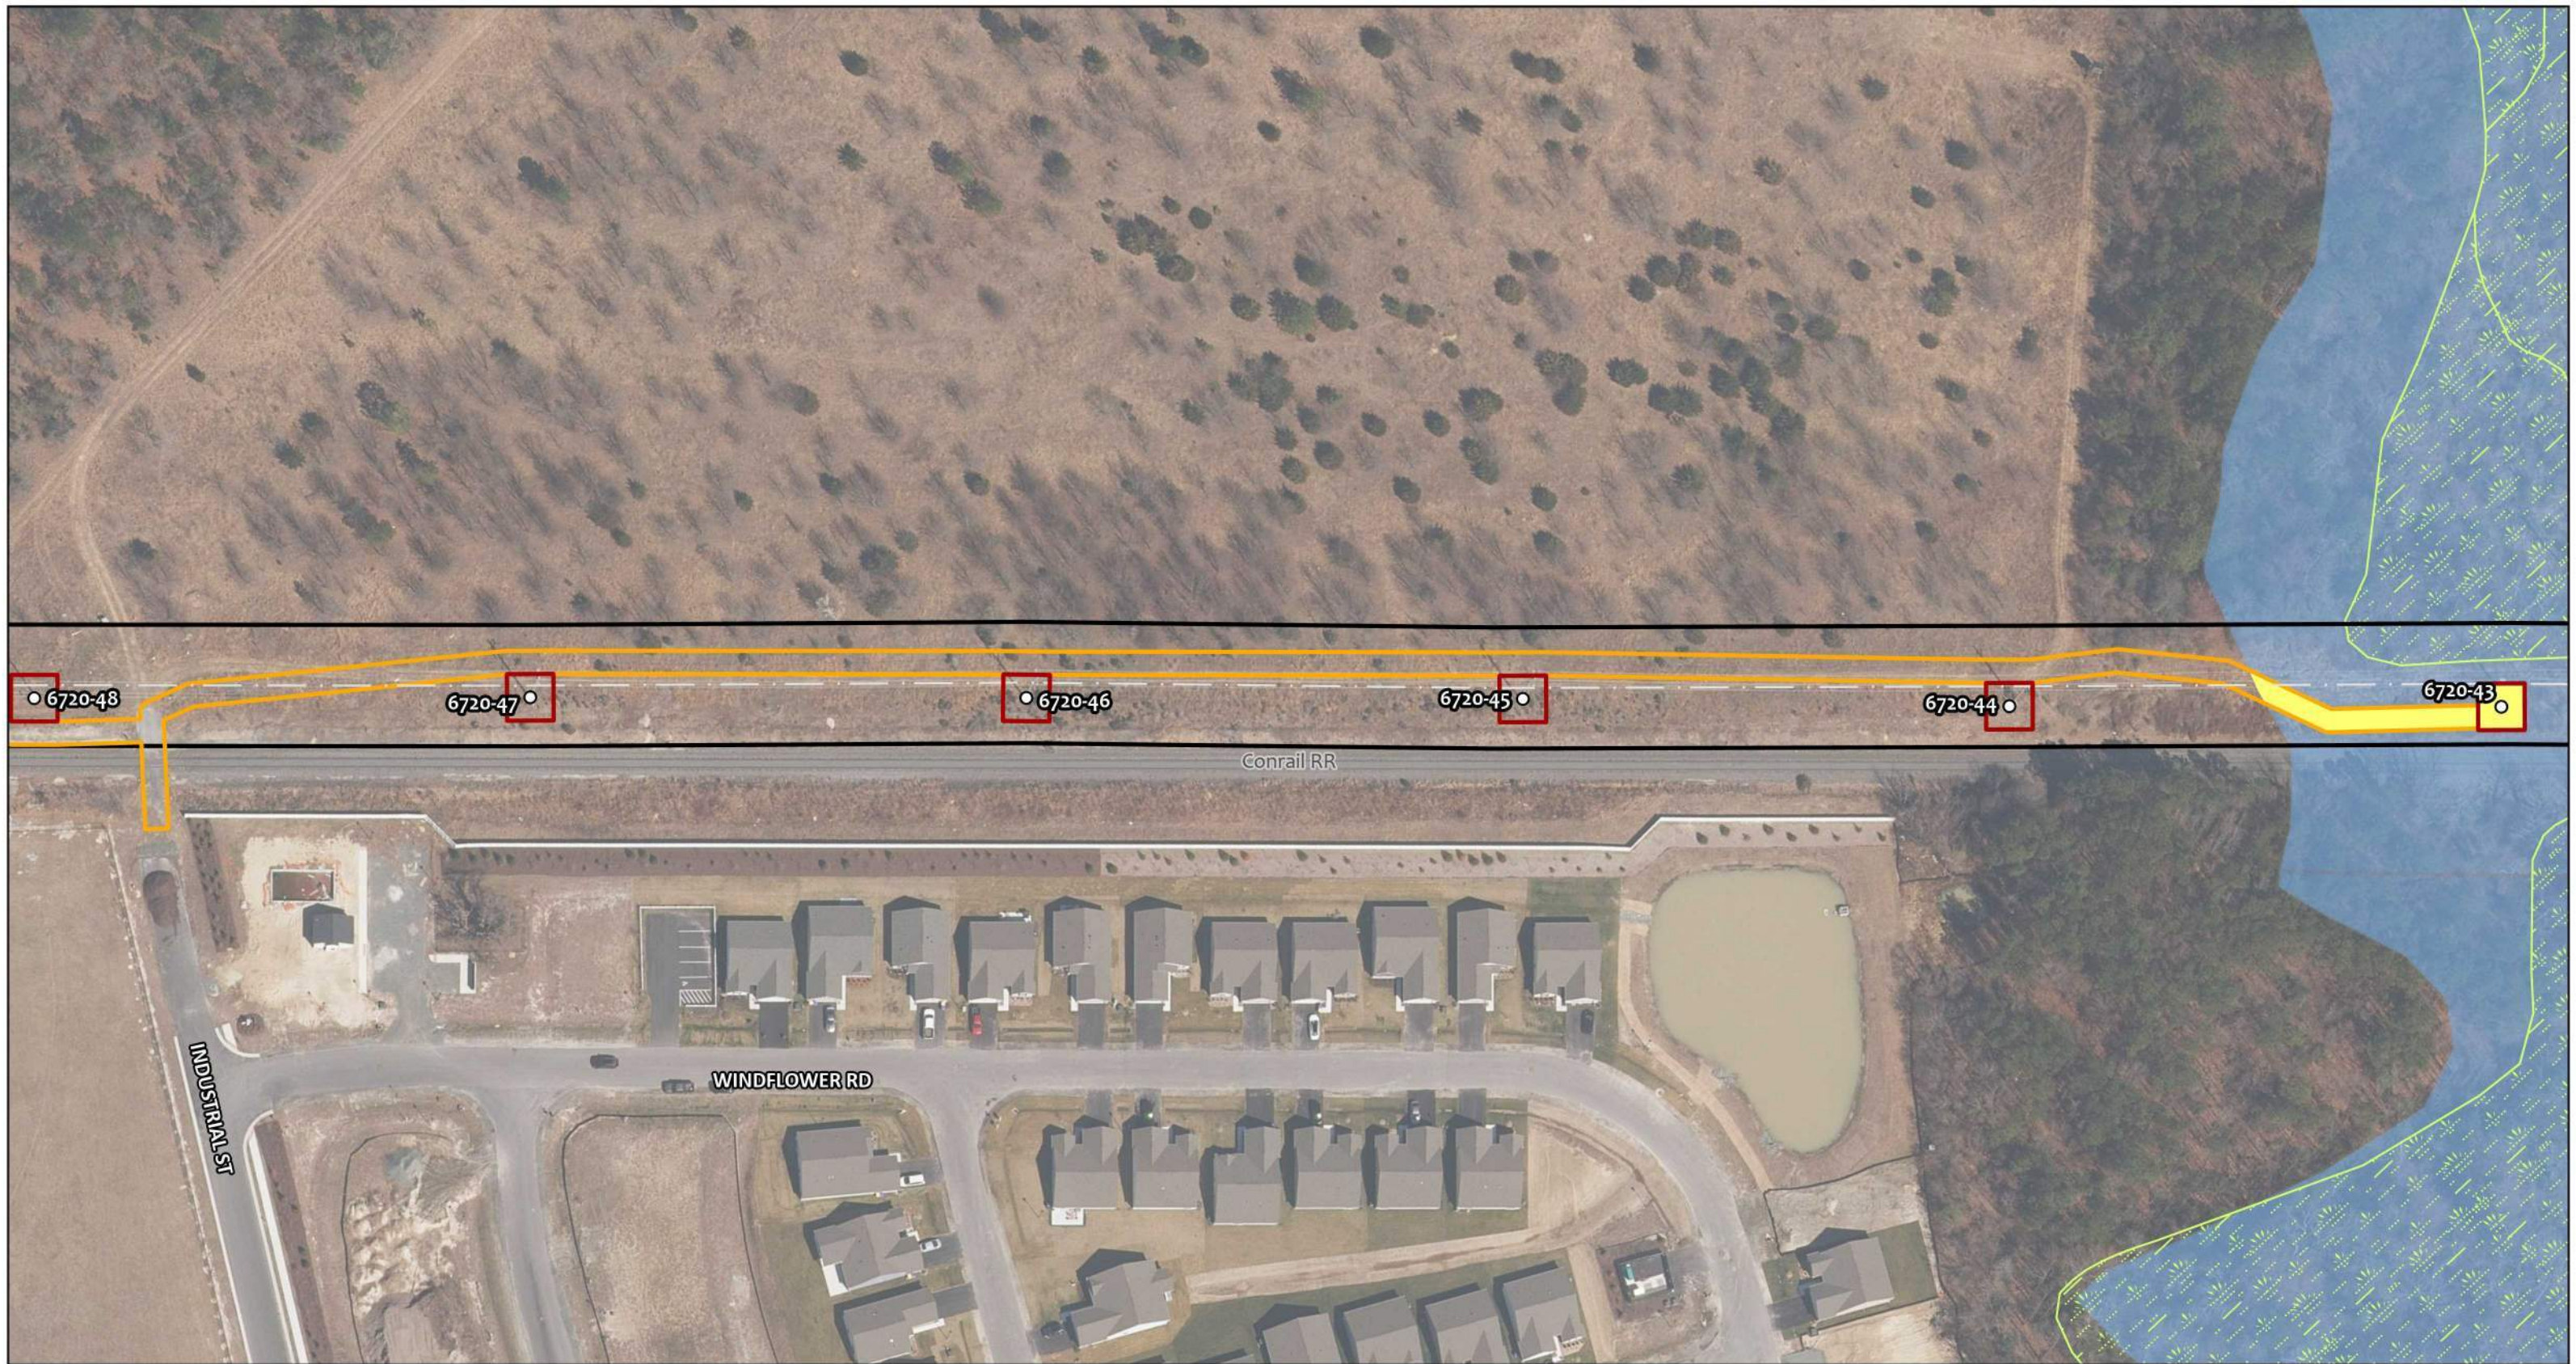
Page 6 of 15

Indian River to Millsboro Impact Table			
Plate Number	Temporary Wetland Impacts - Tidal	Permanent Floodplain Impacts	Temporary Floodplain Impacts
	SF	SF	SF
6	0	0	3,117

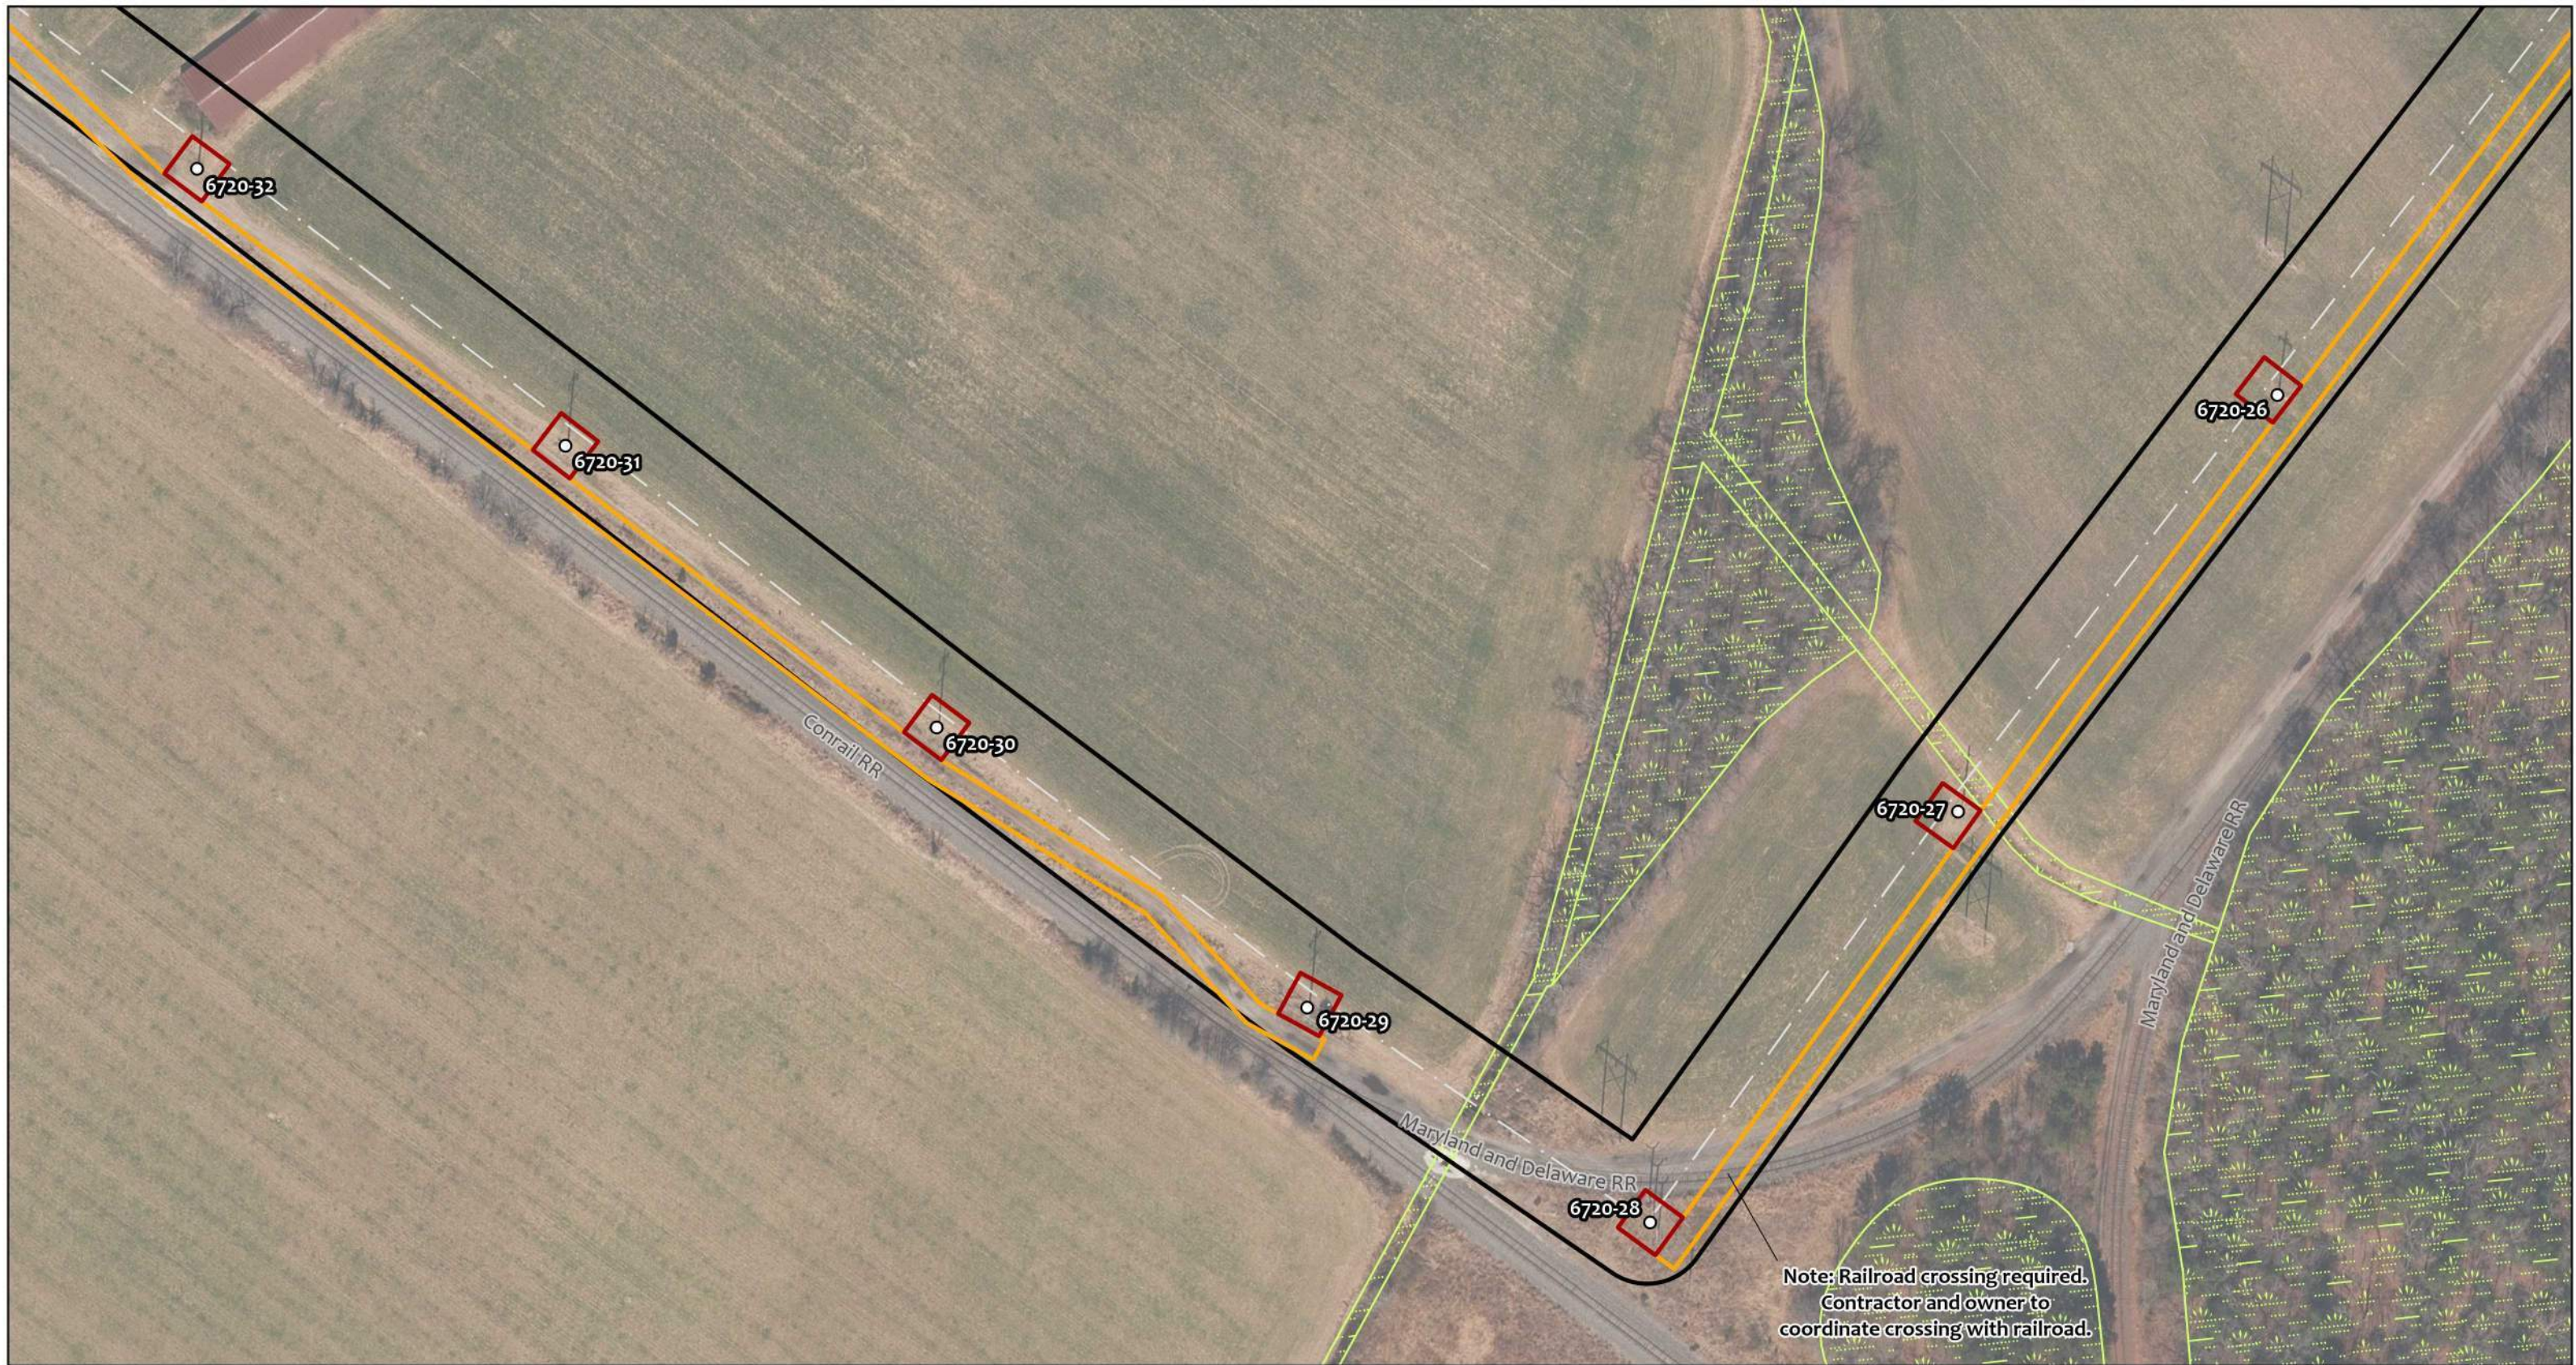
Page 9 of 15

Note: Railroad crossing required.  
Contractor and owner to coordinate crossing with railroad.

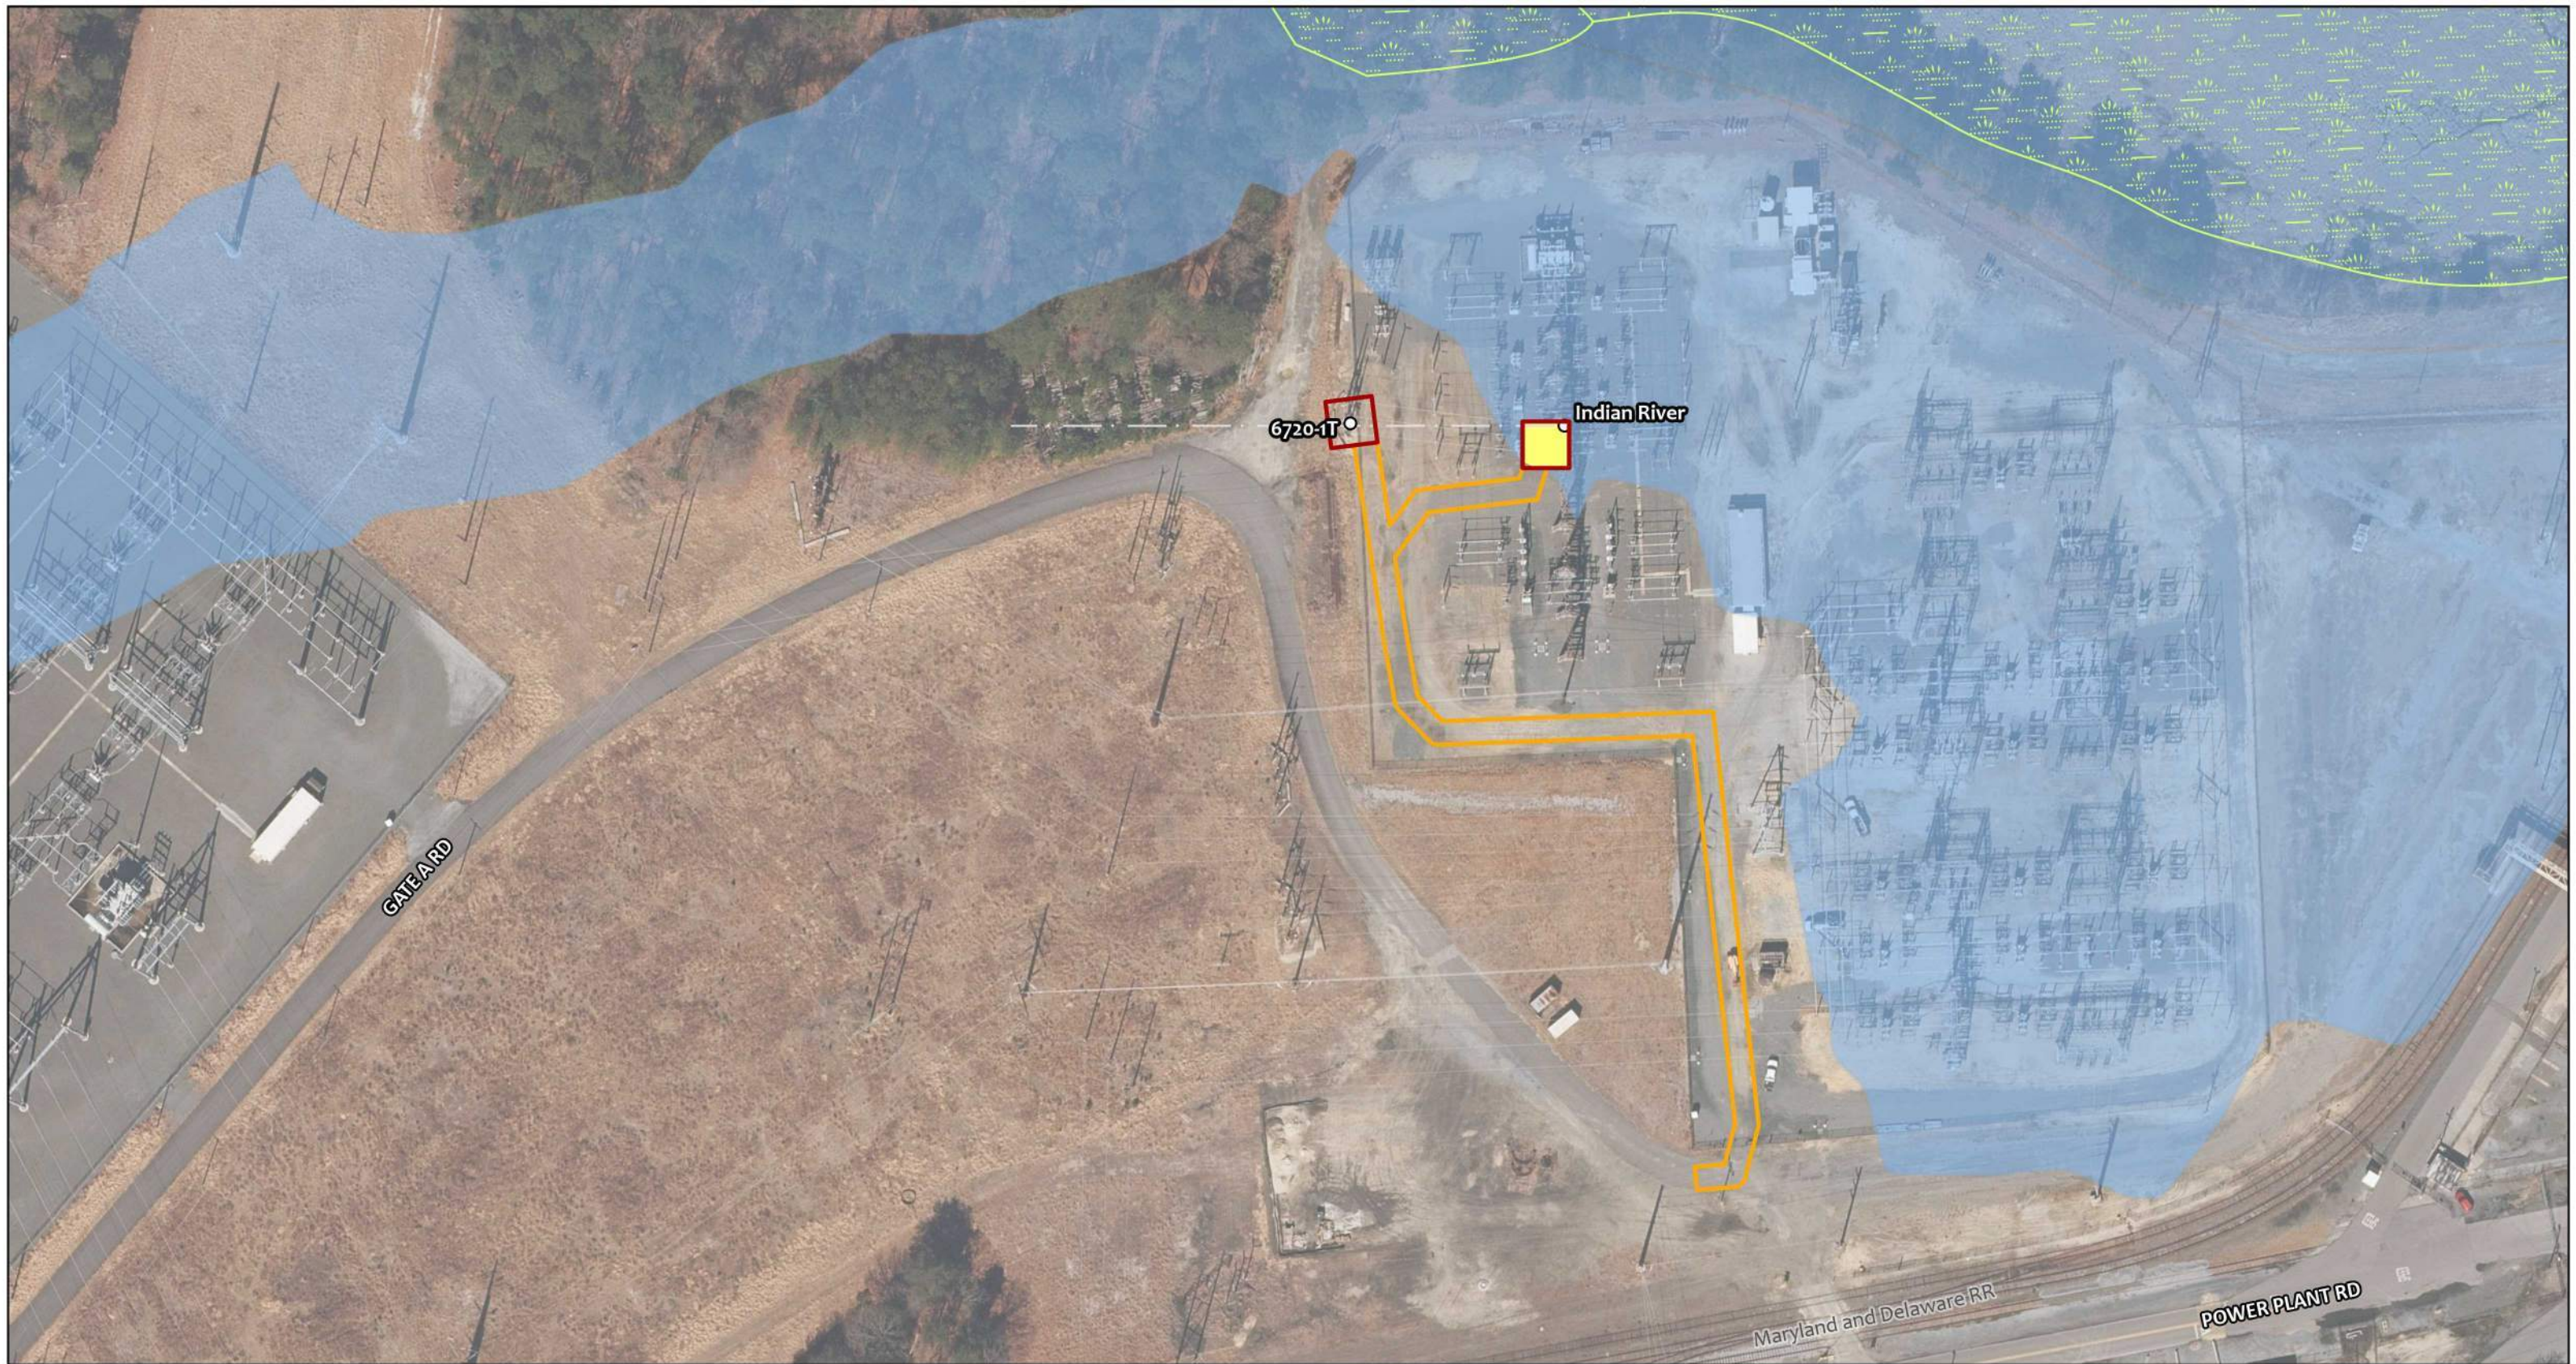
Indian River to Millsboro Impact Table			
Plate Number	Temporary Wetland Impacts - Tidal	Permanent Floodplain Impacts	Temporary Floodplain Impacts
	SF	SF	SF
15	0	0	882

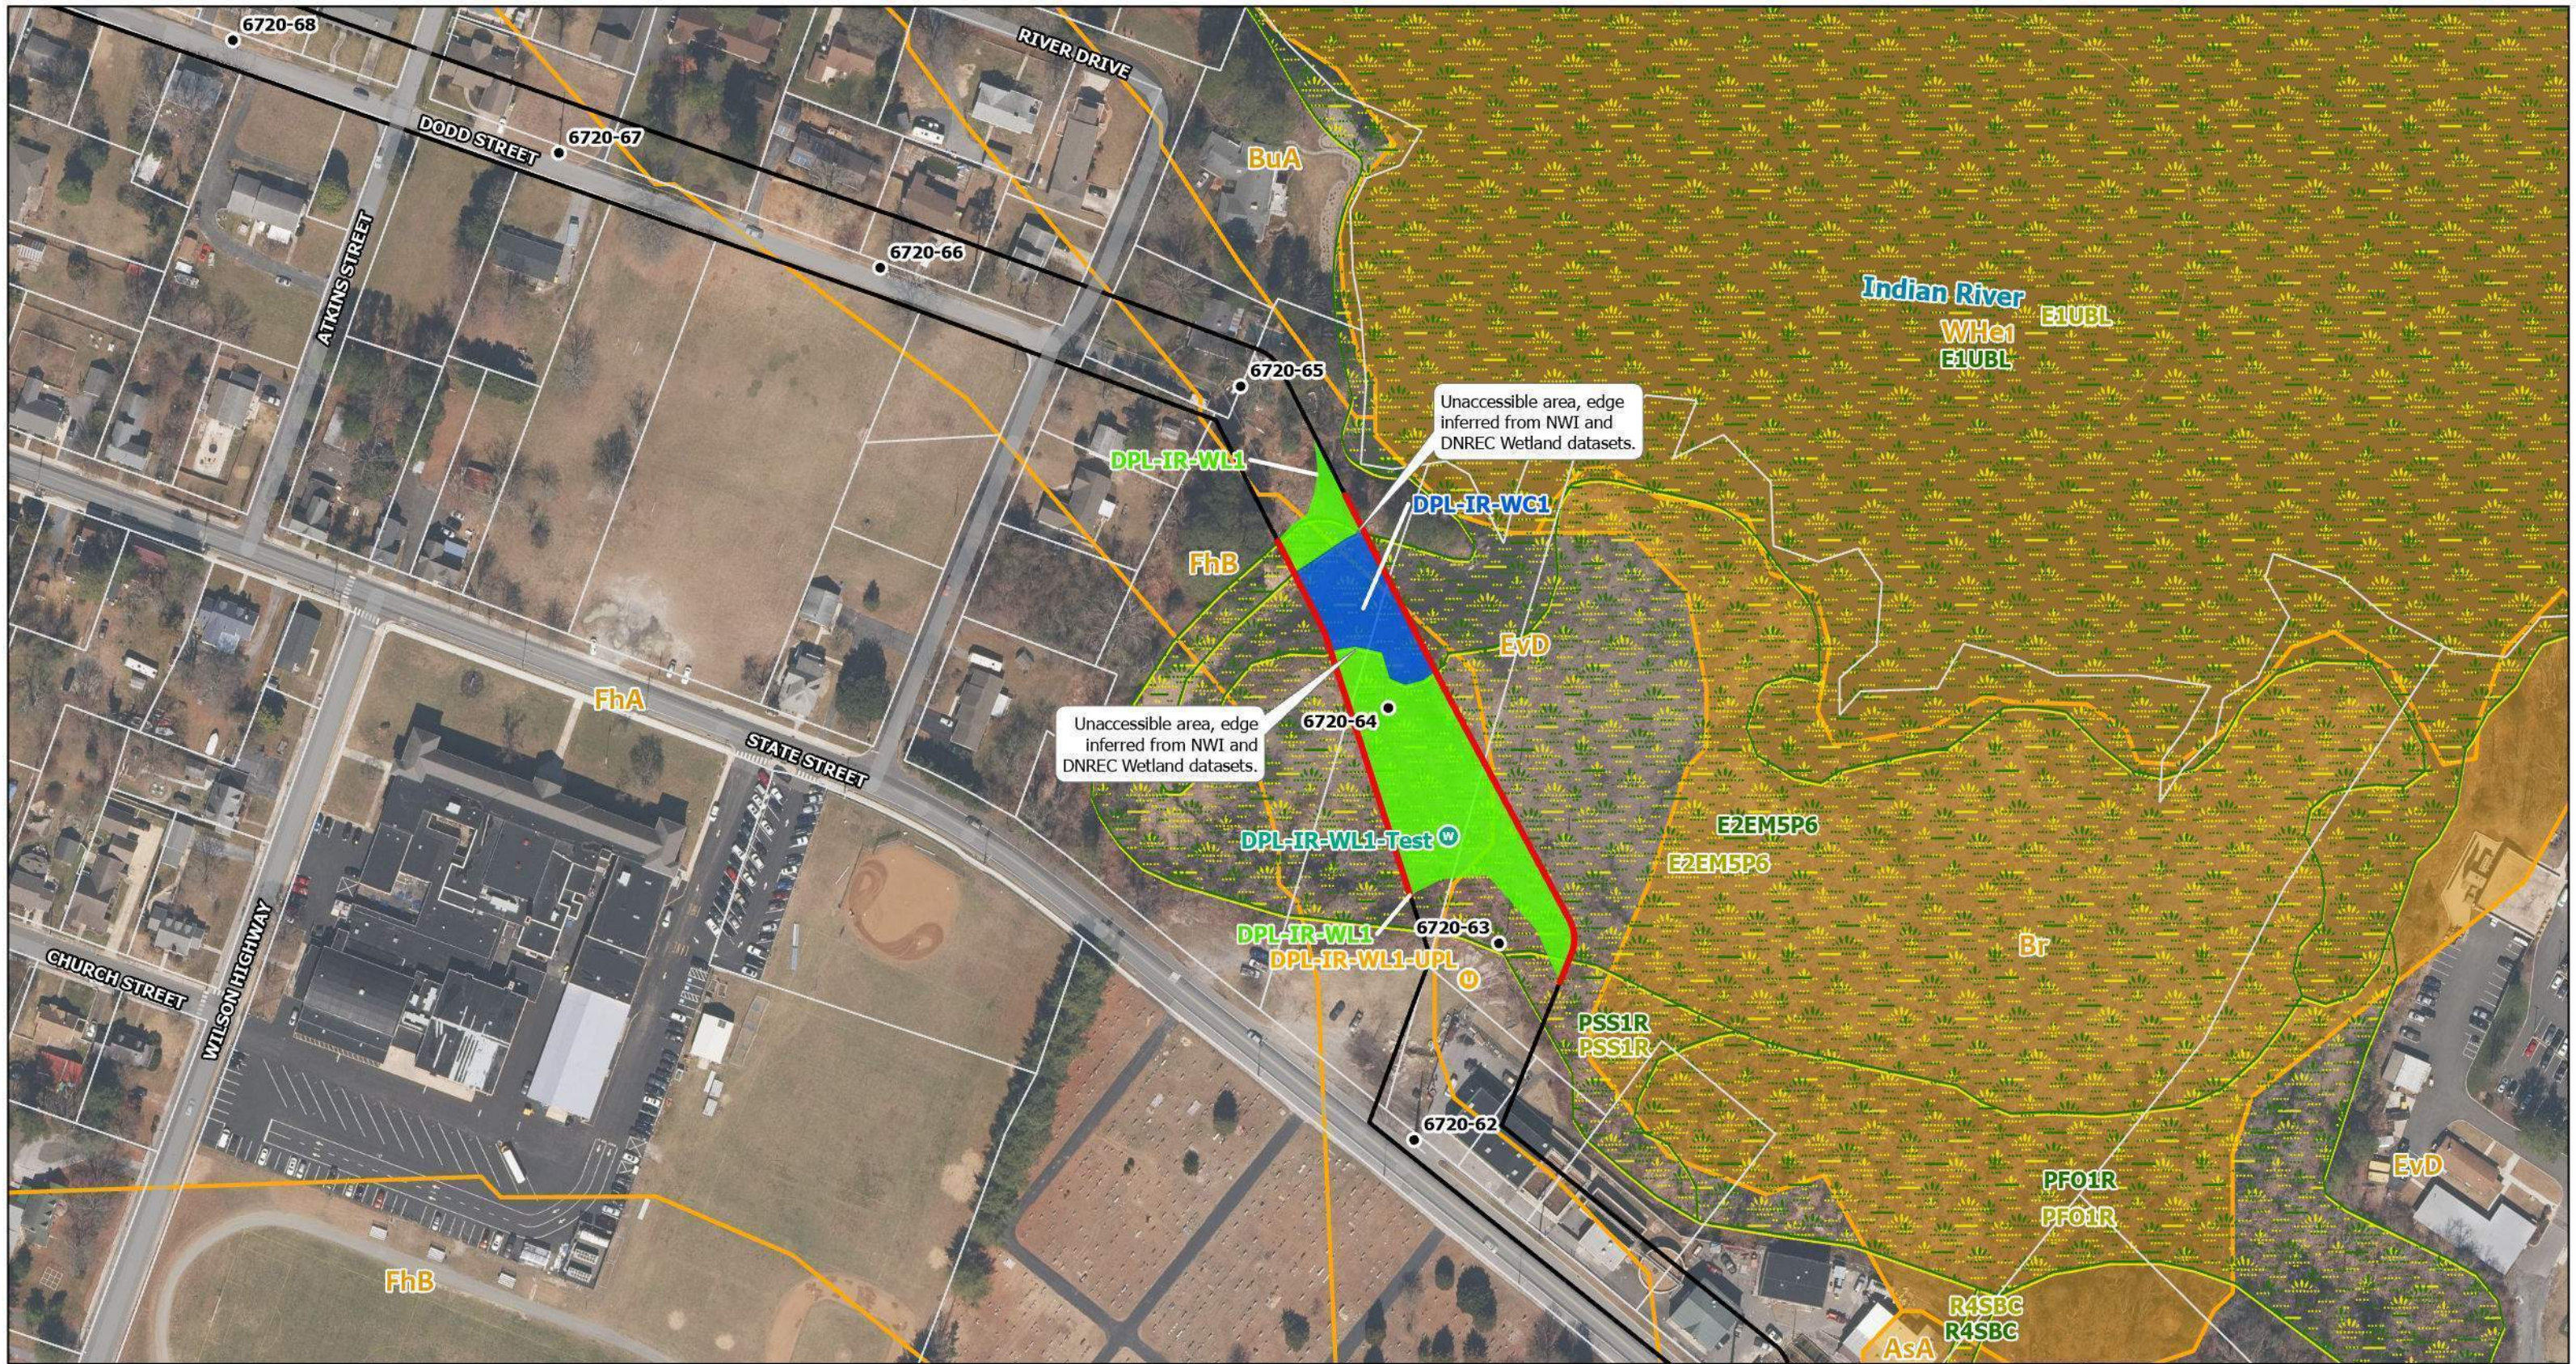
Unaccessible area, edge inferred from NWI and DNREC Wetland datasets.

Mapping has been limited to portions of the study area where delineated features are present. The wetland and watercourse delineation was restricted to tidal features where impacts are proposed.

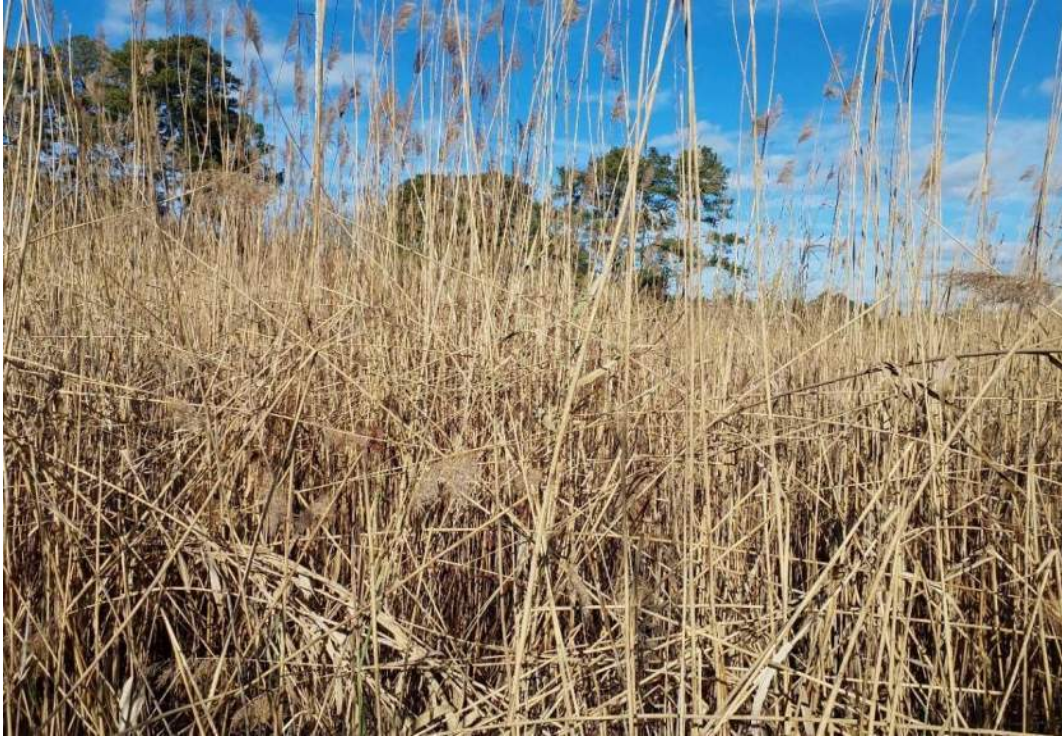
WL1-WLP1: E2EM5P6 wetland facing northeast.

**Wetland 1 (WL1)** is an estuarine, intertidal, emergent, common reed (*Phragmites australis*) dominated, irregularly flooded, oligohaline wetland (E2EM5P6), characterized by test plot WL1-WLP1-test. Soil borings within this wetland revealed the presence of hydric soil conditions evidenced by a 4-inch layer, starting at the surface, with a matrix color of 10YR 2/2, with a significant accumulation of organic material, meeting the Organic Bodies (A6) and Depleted Below Dark Surface (A11) hydric soil indicators. Hydrology indicators include High Water Table (A2), Saturation (A3), Inundation Visible on Aerial Imagery (B7), Drainage Patterns (B10), Saturation Visible on Aerial Imagery (C9), Geomorphic Position (D2), and FAC-Neutral Test (D5). Vegetation within the wetland is dominated by common reed, meeting the rapid test for hydrophytic vegetation.

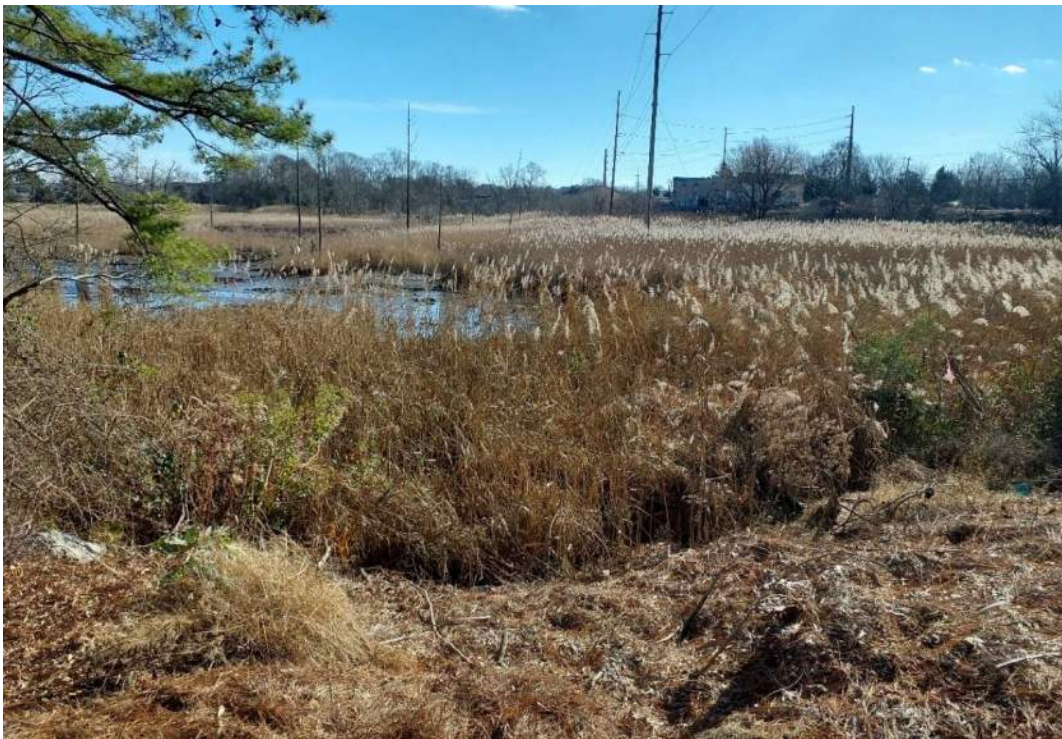
WL1-WLP1: E2EM5P6 wetland facing southeast.

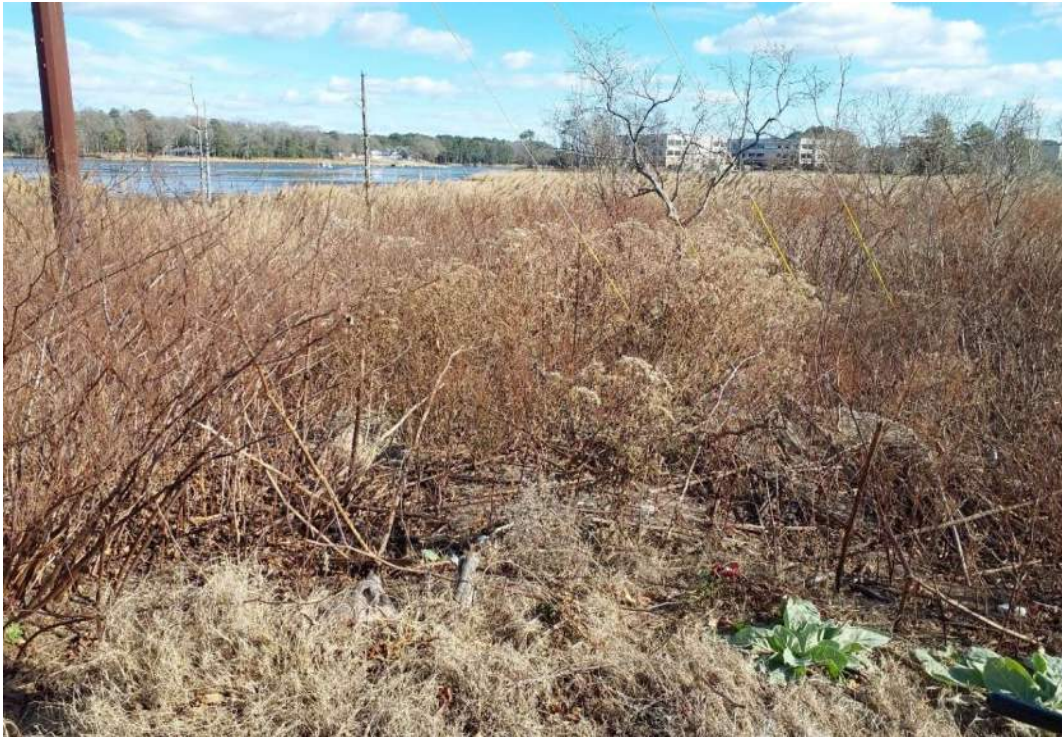
WL1-UPL1: Upland area facing northeast.

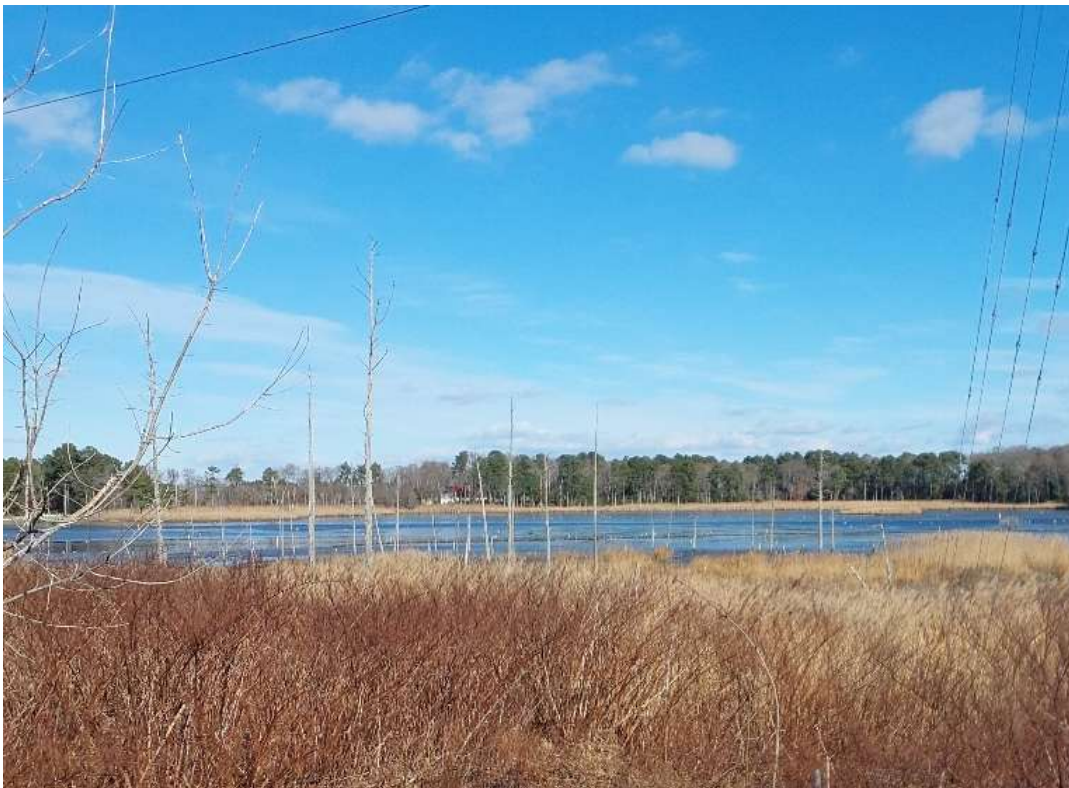
DPL-IR-WC1: Facing northwest showing the E1UBL watercourse.

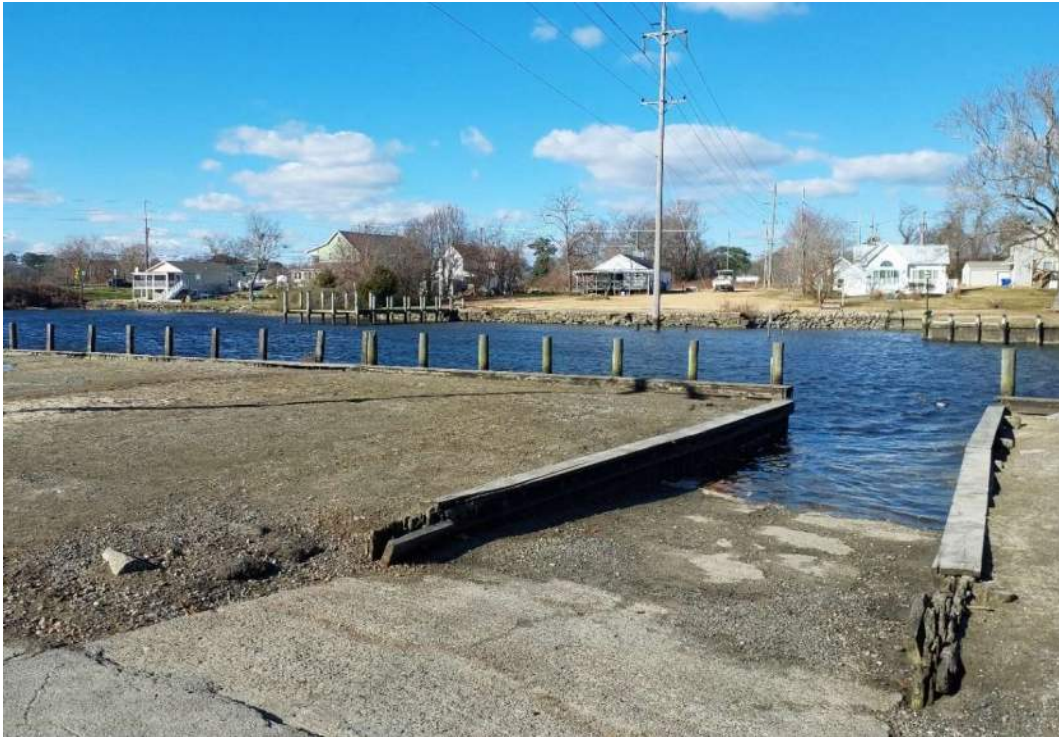
DPL-IR-WC2: Facing northwest showing the E1UBL watercourse and the bulkhead near Pole 72.
