## New Castle Conservation District

On behalf of New Castle Conservation District (NCCD), enclosed for your review is a Wetlands and Subaqueous Lands Section Permit Application for the Little Mill Creek Tributary 2 Stream Restoration in Wilmington, Delaware (**Attachment A**). This project will restore an unnamed tributary to Little Mill Creek (Tributary 2) beginning at the intersection of Centerville Road and Faulkland Road and extending downstream to Armstrong Avenue (**Attachment B**). The project purpose, description, impacts, and other details follow.

The project entails restoring approximately 750 linear feet of an unnamed tributary to Little Mill Creek (Tributary 2) within Woodland Run Park. The design consists of an integrated stream and wetland restoration approach that will lower the existing stream banks and adjacent floodplain to create a sustainable stream/floodplain system within the limits of the park property. The restoration will provide the following benefits: bank and bed stabilization, channel plan form improvements, floodplain reconnection, flood storage and gradual release of flood flows for reduction of shear stresses and velocities, sediment and carbon ret

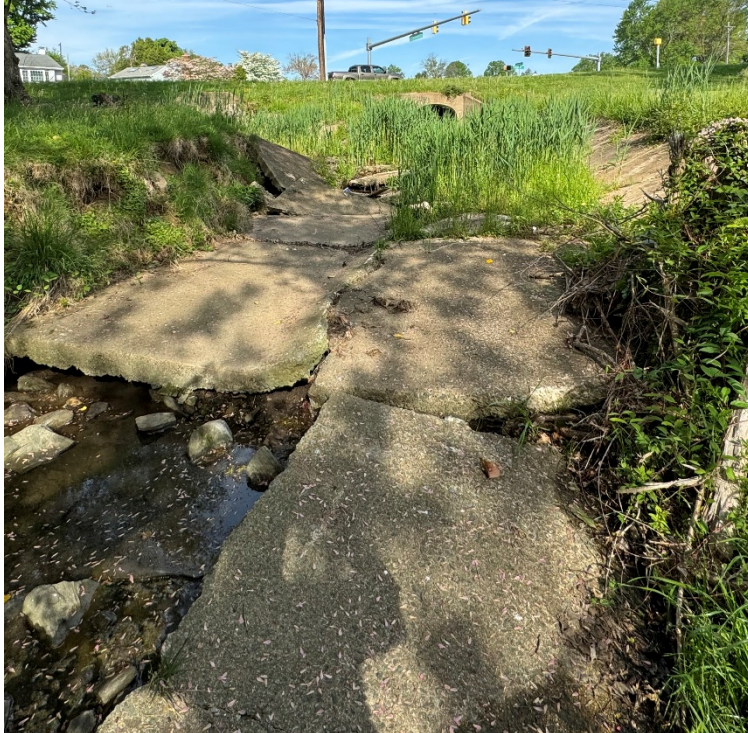
**PHOTO 6: FAILED CONCRETE FLUME WITHIN THE EXISTING CHANNEL**

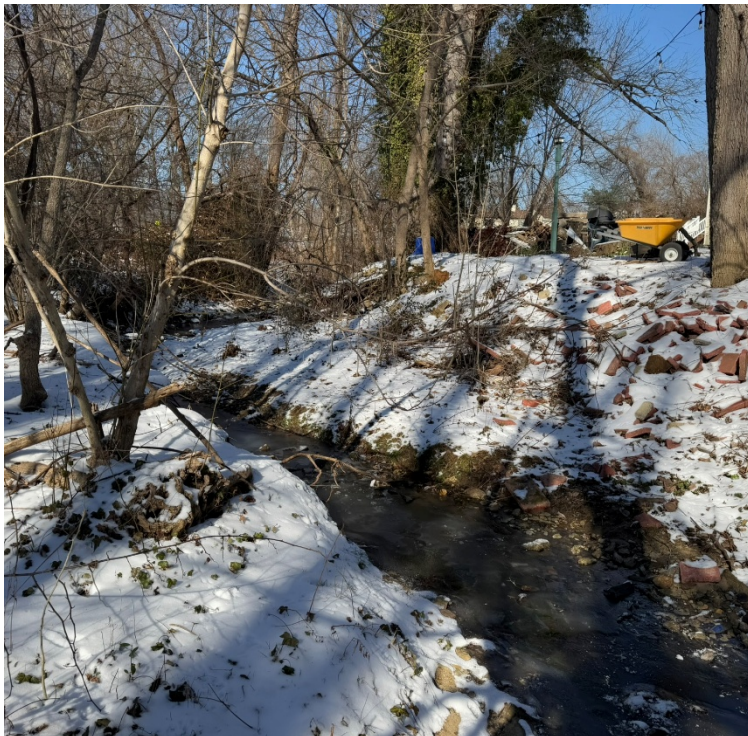
**PHOTO 7: ANTHROPOGENIC INFLUENCE WITHIN STREAM CORRIDOR**

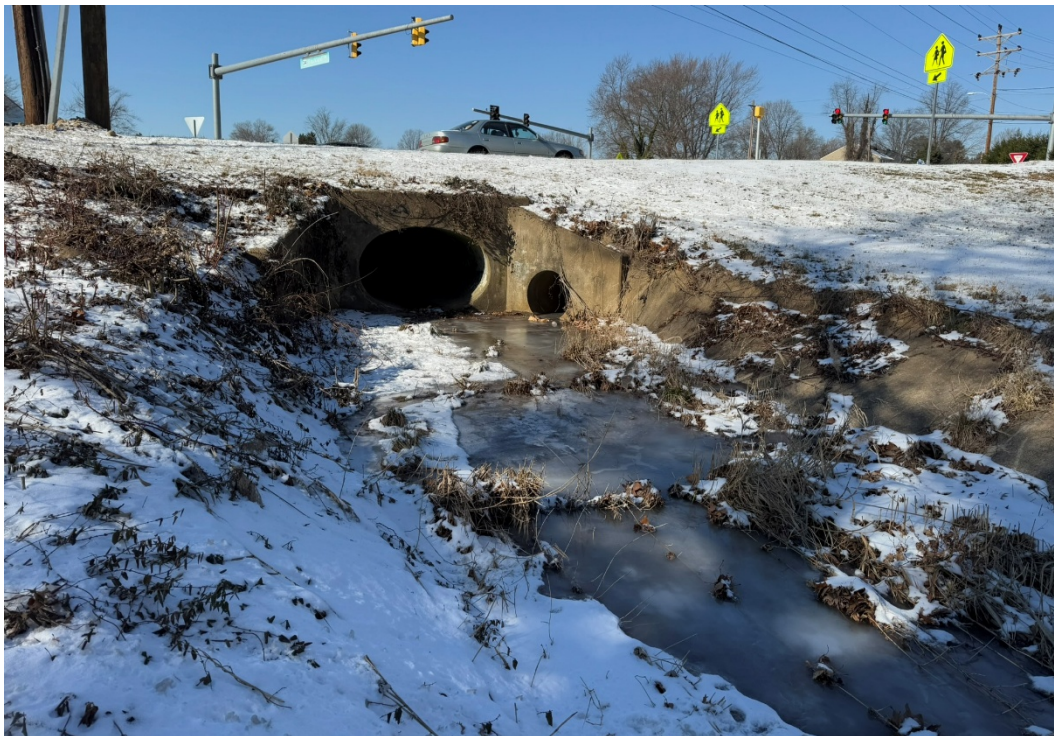
Storm Drain Outfall 1a (DeIDOT ID #0111199427) – Outfall 1a is located at the upstream limit of the reach and discharges directly into Tributary 2. The storm drain is a 30-inch RCP that discharges through the wingwall of the outfall associated with storm drain outfall 1b. The outfall drainage network consists of a significant amount of roadway and residential neighborhood to the north and east.

Storm Drain Outfall 1b (DeIDOT ID #0111199431) – Outfall 1b is located at the upstream limit of the reach and discharges directly into Tributary 2. The storm drain is a 48-inch x 76-inch horizontal elliptical RCP (HERCP). Outfall 1b is the main outfall in this location with Outfall 1a discharging through a wingwall. The outfall drainage network consists of a significant amount of roadway and residential neighborhood to the north and west. Outfall 1a and 1b both discharge to a degraded concrete flume that has broken and/or missing panels.

**PHOTO 8: OUTFALL 1A AND 1B**
