WILLIAMS POND WATERSHED MANAGEMENT PLAN

**WILLIAMS POND
WATERSHED MANAGEMENT
(SUBWATERSHED OF THE
NANTICOKE RIVER)**

**Delaware Department of Natural Resources and Environmental
Control
Sediment and Stormwater Program
89 Kings Highway
Dover, DE 19901**

July 2014

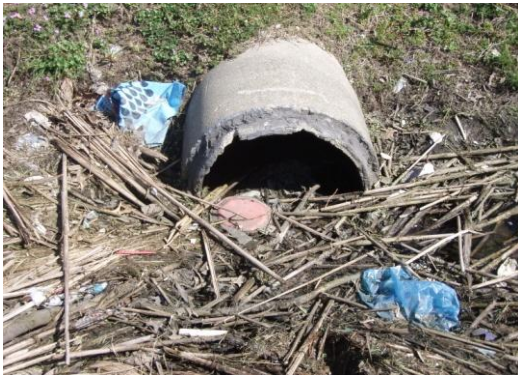
Many of the culverts along Route 13 appeared to be partially or near fully clogged with debris, and small sinkholes were noted adjacent to some of the drainage inlets. This prevented the collection of system-wide culvert inverts necessary to perform a hydraulic analysis to evaluate the capacity of drainage system. Below are two representative photos of the clogged culverts.

Outfall on northbound Route 13 on the property south of Food Lion

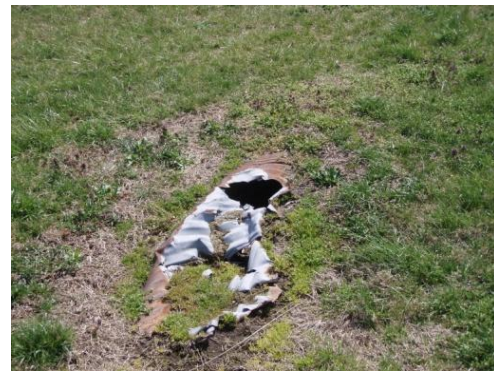
Completely collapsed culvert on Southbound Route 13 at Herr's Foods
