Delaware Annual Beach Change Report: Ocean Coast

Delaware Department of Natural
Resources and Environmental Control

Description of 2020-2021 Season

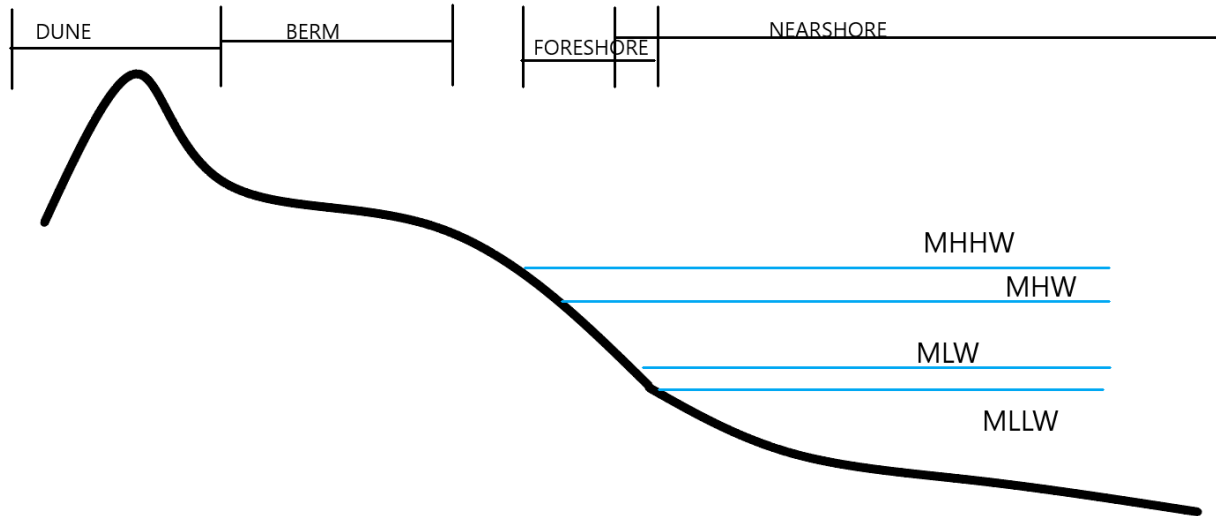
Figure 1: Beach profile definitions sketch

Dune – Natural or man-made geological feature that is shoreward of the berm and is characterized by a steep slope to the highest elevations along the beach profile.

Berm – The relatively flat portion of the beach profile directly seaward of the dune that is typically above the MHHW elevation.

Foreshore Slope – The foreshore slope is the natural slope directly seaward of the berm that is caused by tides and up rushing waves.

Intertidal Zone – The portion of the foreshore slope and nearshore that is between the MHHW and MLLW elevations.

Nearshore – For the purposes of this report, the nearshore is considered to extend from the lower portions of the intertidal zone out beyond the surf zone where waves break but onshore of most boating traffic.

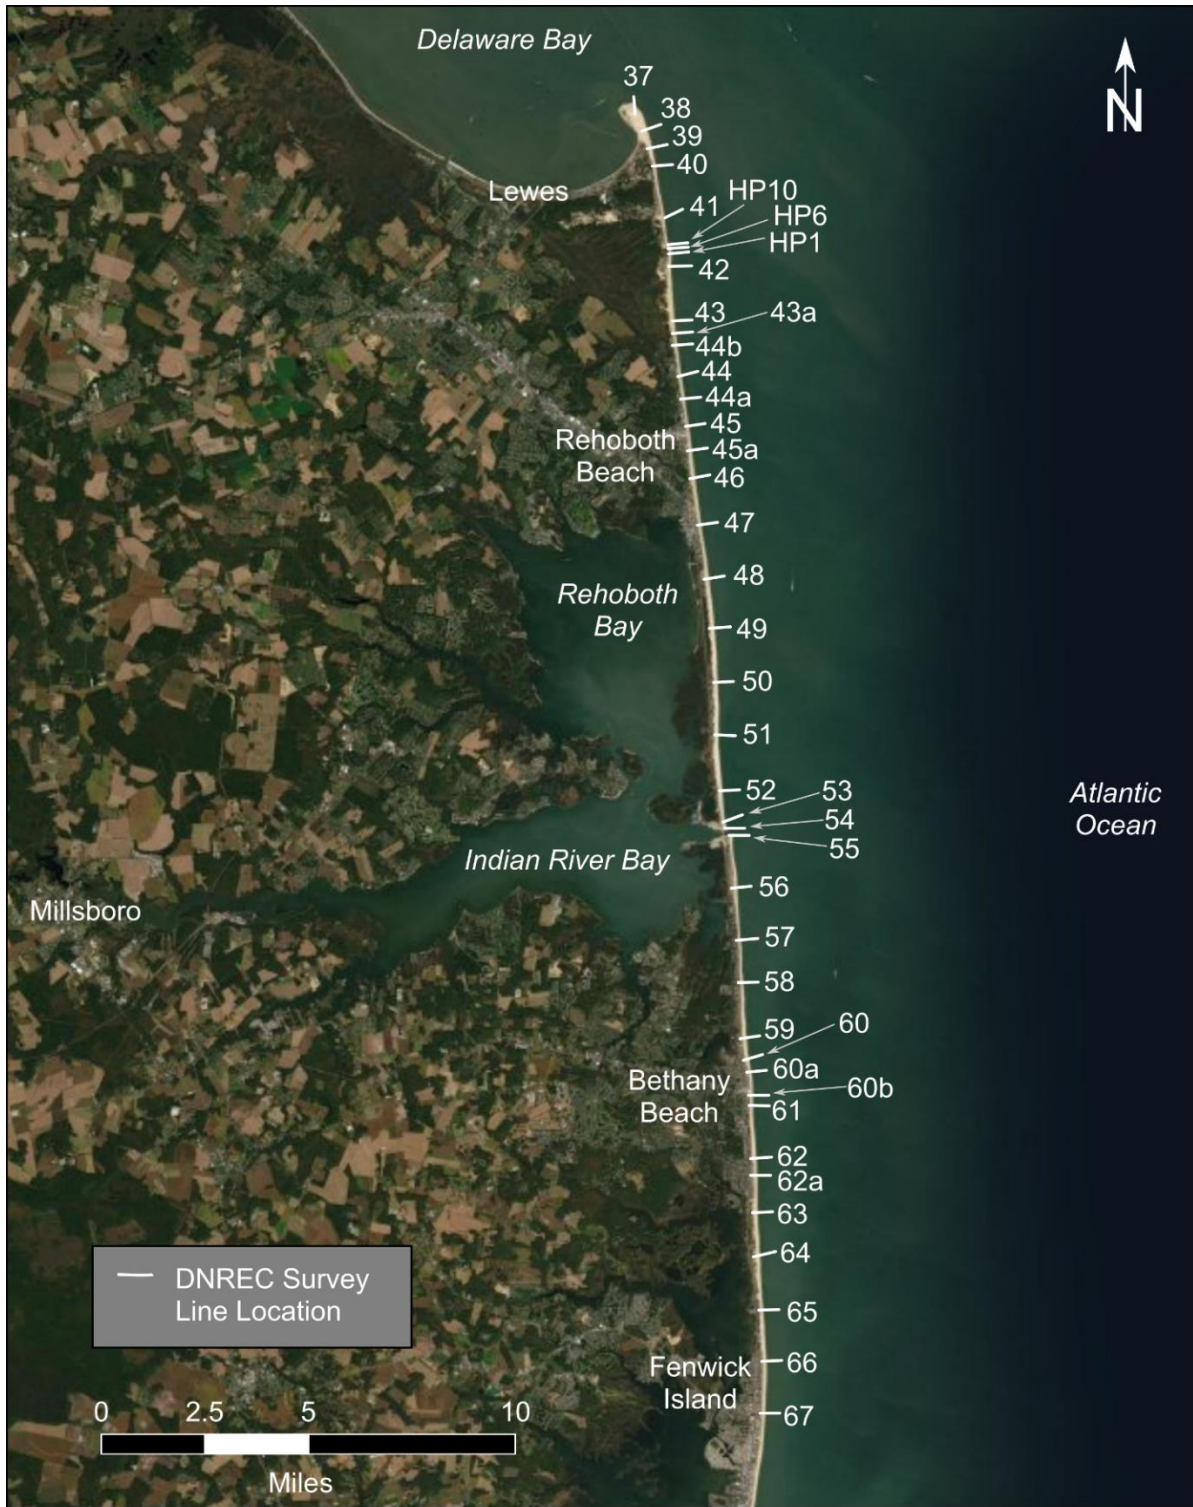
Figure 2: LRP location map

Each fall and spring, the Section’s survey crew measures the beach (berm, dune, and nearshore bathymetry). Bathymetry data are collected out to about a 30-foot depth. The crew measures 41 longitudinal range profiles (LRPs) or transects along the Atlantic Coast. These locations of these transects are shown in Figure 2. Comparisons between winter and summer surveys demonstrate how beaches recover naturally after winter storms. Comparison between summer surveys from year-to-year, demonstrate long term erosion or accretion trends along Delaware Beaches. These trends are used to inform beach management strategies including beach nourishment projects.

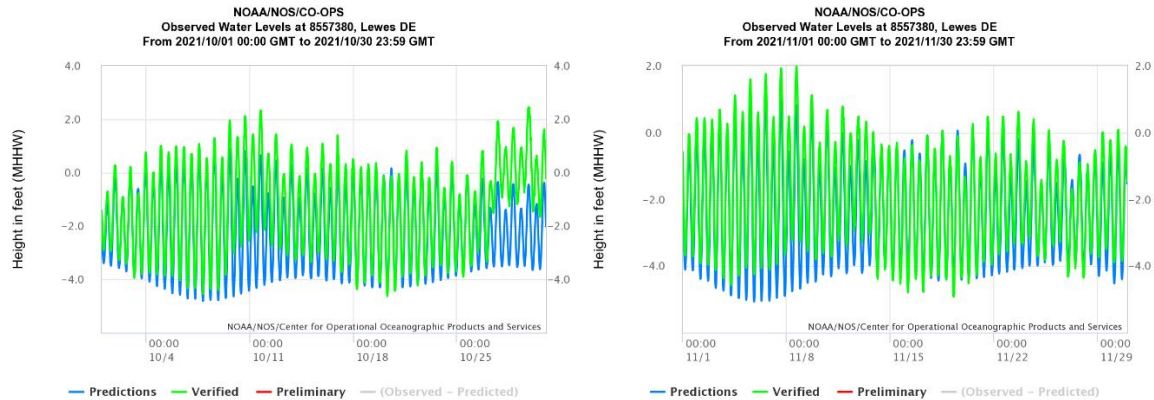
Figure 4: Measured (green) vs. Predicted (blue) water levels at Lewes Beach.

Throughout the months of October and November, there were nor'easter storms or steady east winds, that impacted the Delaware Ocean coastline. These storms and east winds kept tides higher than average. Additionally, there were storm surge events. According to the measured water levels at the Lewes gage (Figure 44), the tides were at least 0.5' higher than predicted throughout most of October and November. Higher water levels tend to induce erosion of beaches and dunes which is correlated to the duration, water level, and wave power associated with each event.

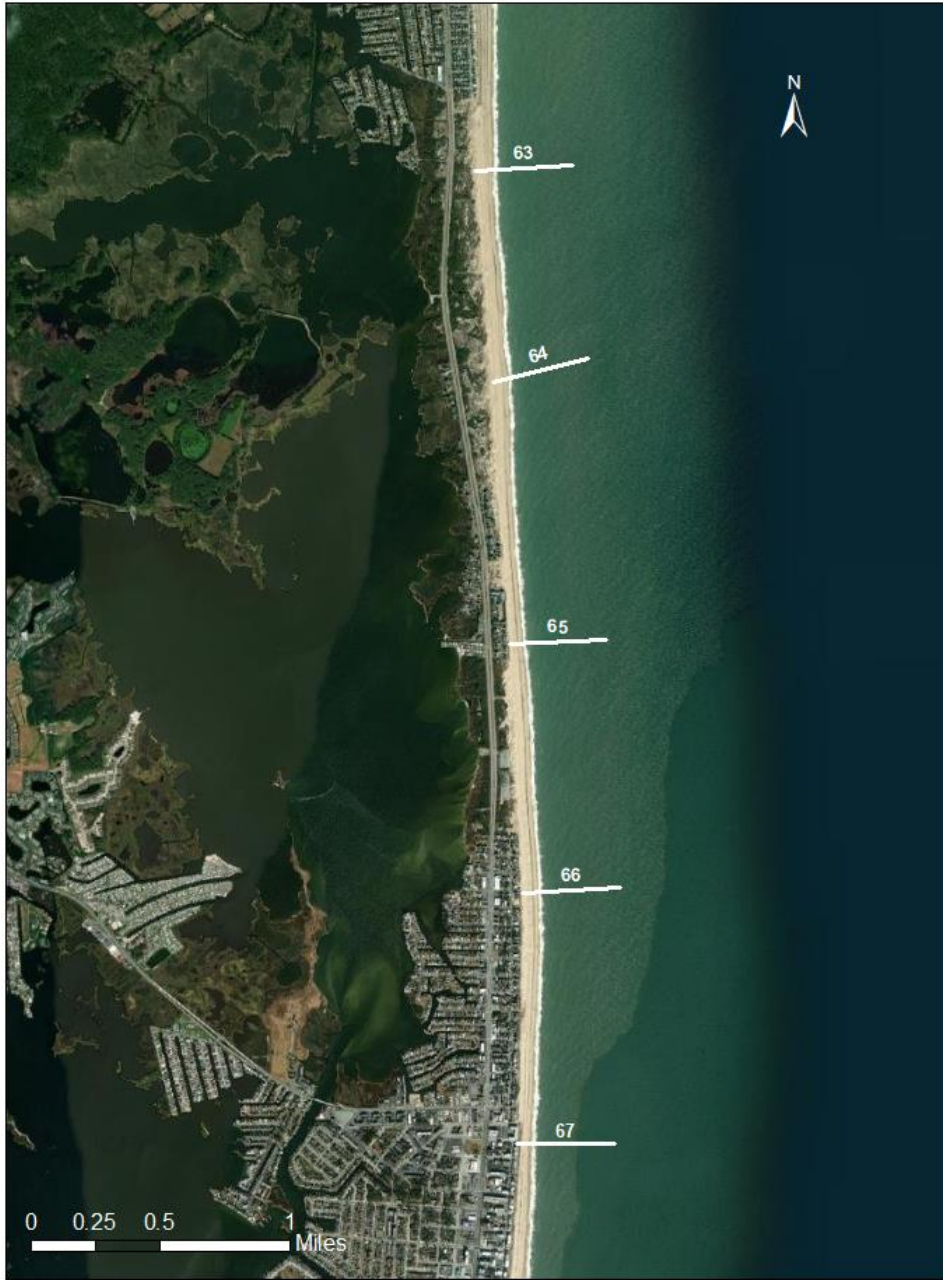
Figure 5: LRP location map for Fenwick Island

Fenwick Island is densely populated from the Delaware and Maryland state line to about 1 mile north of this boundary. North from this location, the coastline is sparsely populated and includes Fenwick Island State Park. There are five survey lines spaced roughly 5,000' feet apart along the section of coastline as shown in Figure 5. Within Fenwick Island, there is a federal nourishment project that aims to protect the developed portion of the shoreline.

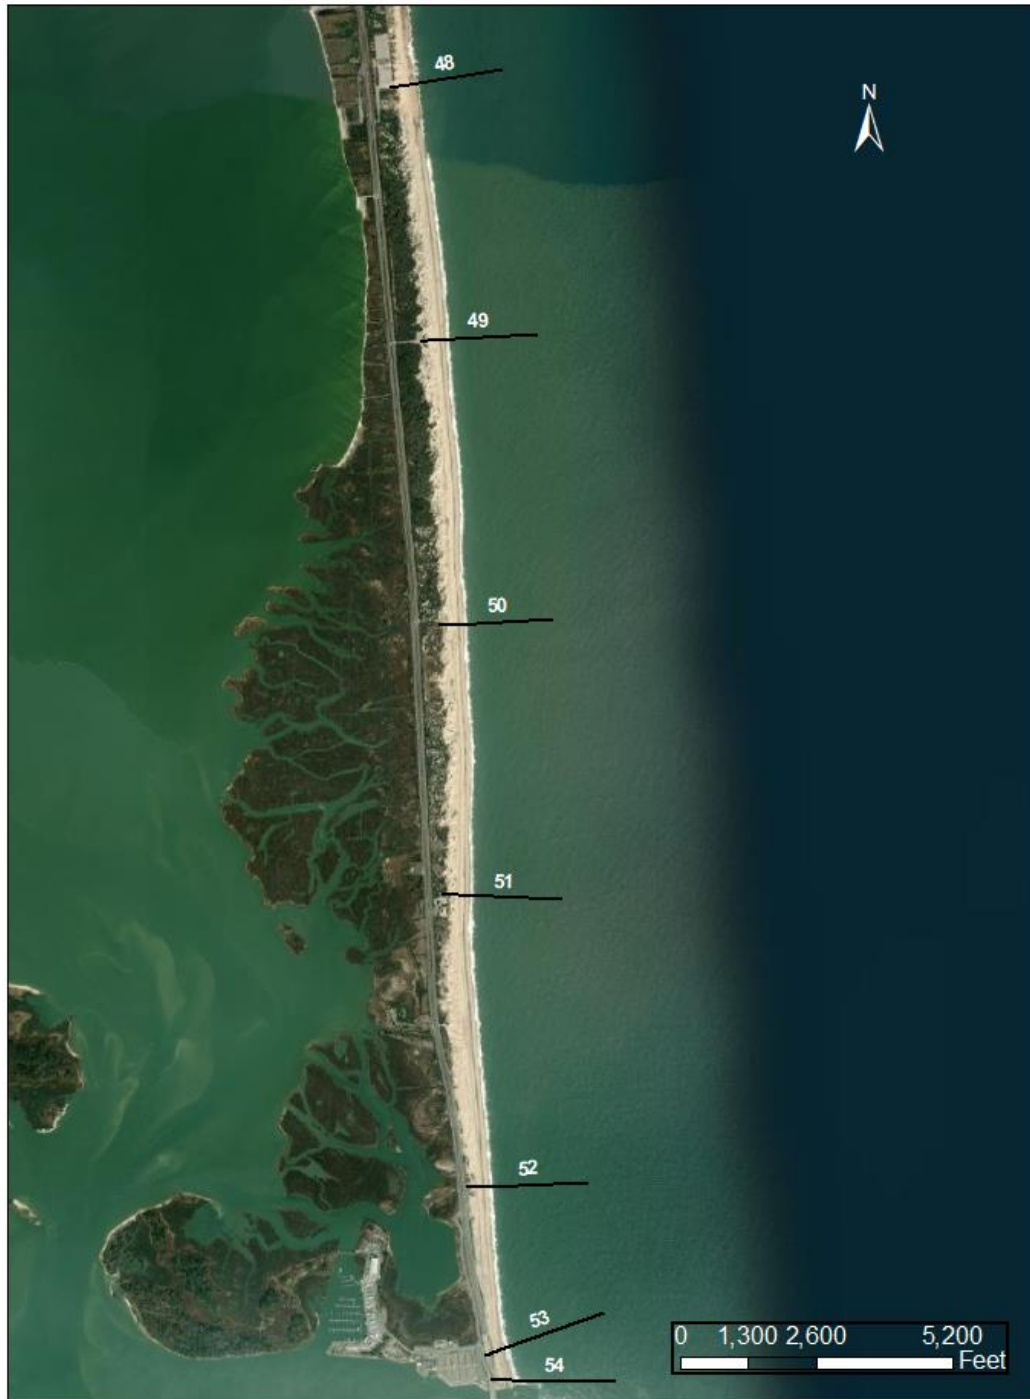
Figure 15: LRP location map in northshores of Delaware Seashore State Parks

Northside of Indian River Inlet contains nearly five miles of state-owned beaches from Tower Road at the north end to the inlet at the south end. Within this five-mile stretch, there are seven survey lines that are evenly spaced, save for the two that are closet to the inlet as shown in Figure 15.

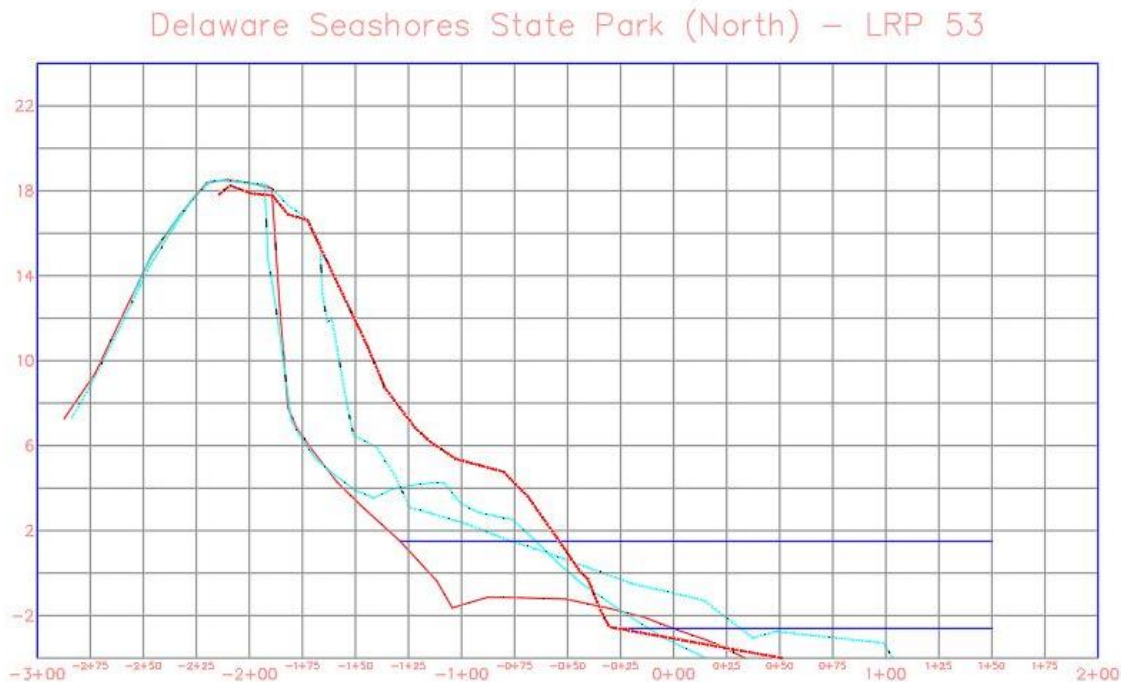
Figure 16: DSSP North: The plots are as follows: Summer 2020 (dashed red); Summer 2021 (solid red); Winter 2021 (dashed cyan); Winter 2022 (dashed dark grey). The blue lines represent the tide levels with the higher line being MHHW and the lower line being MLLW

Since Summer 2020, the beaches north of the Indian River Inlet accreted nearly 25% or 450 cf/lf, on average. Oddly, the beach appears to have eroded in the summer and accreted in the winter (Table 6 and Figure 16), which is counter to the general theory of seasonal shoreline change.

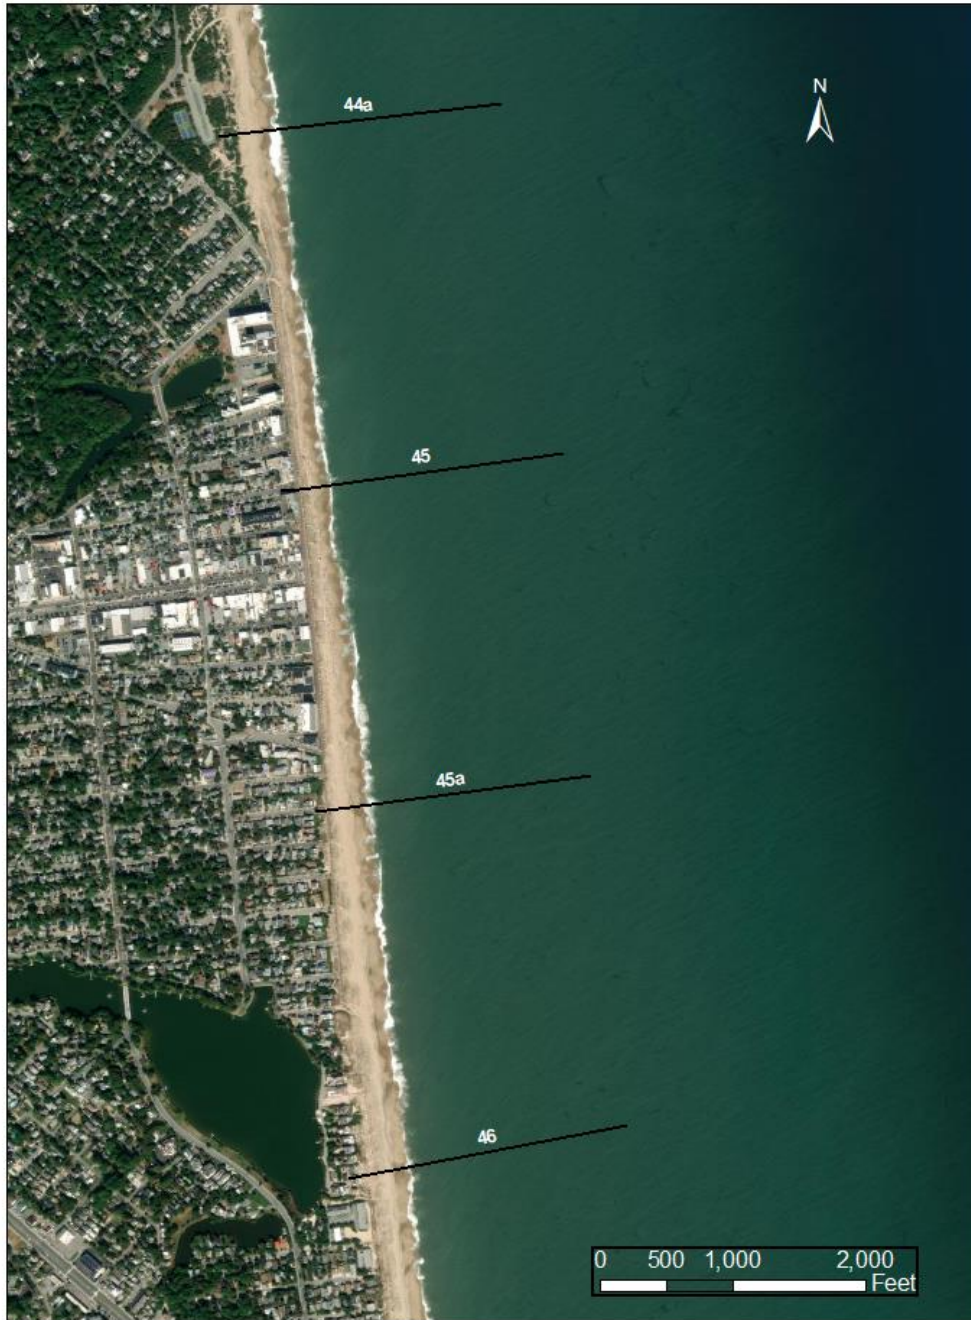
Figure 19: LRP location map in Rehoboth Beach

North of Silver Lake Shores is the town of Rehoboth Beach, which is approximately 8,500' long. Rehoboth is densely populated and includes four profiles as shown in Figure 19. Directly north of Rehoboth Beach is Henlopen Acres.

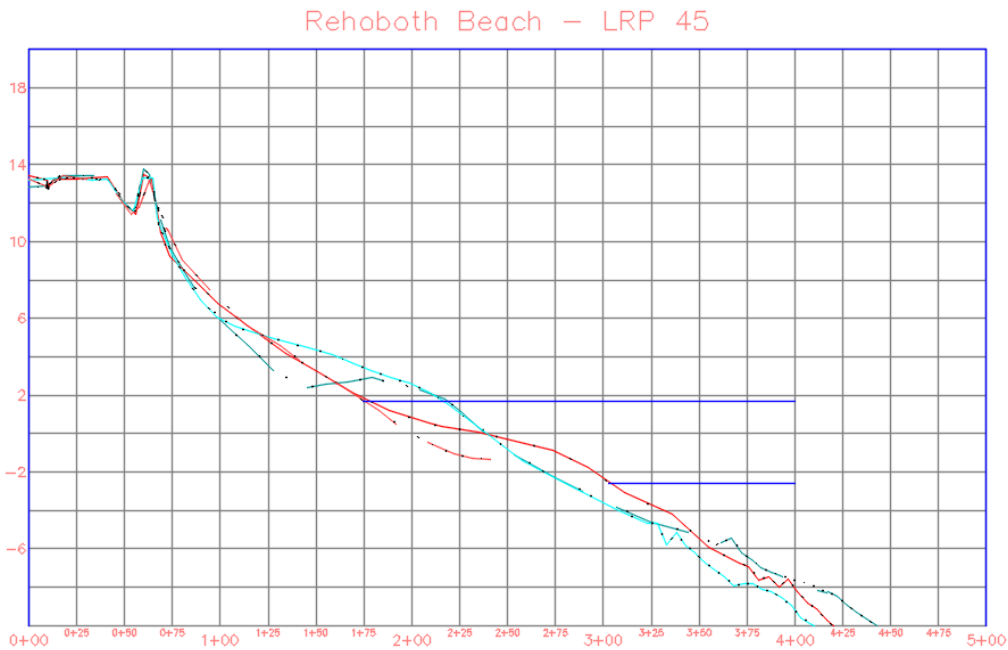
Figure 20: Rehoboth Beach: The plots are as follows: Summer 2020 (dashed red); Summer 2021 (solid red); Winter 2021 (dashed cyan); Winter 2022 (dashed dark grey). The blue lines represent the tide levels with the higher line being MHHW and the lower line being MLLW

Since the Summer of 2020, the beach at Rehoboth has accreted by roughly 100 cf/lf with the seasonal beach change trends matching that of Dewey Beach.

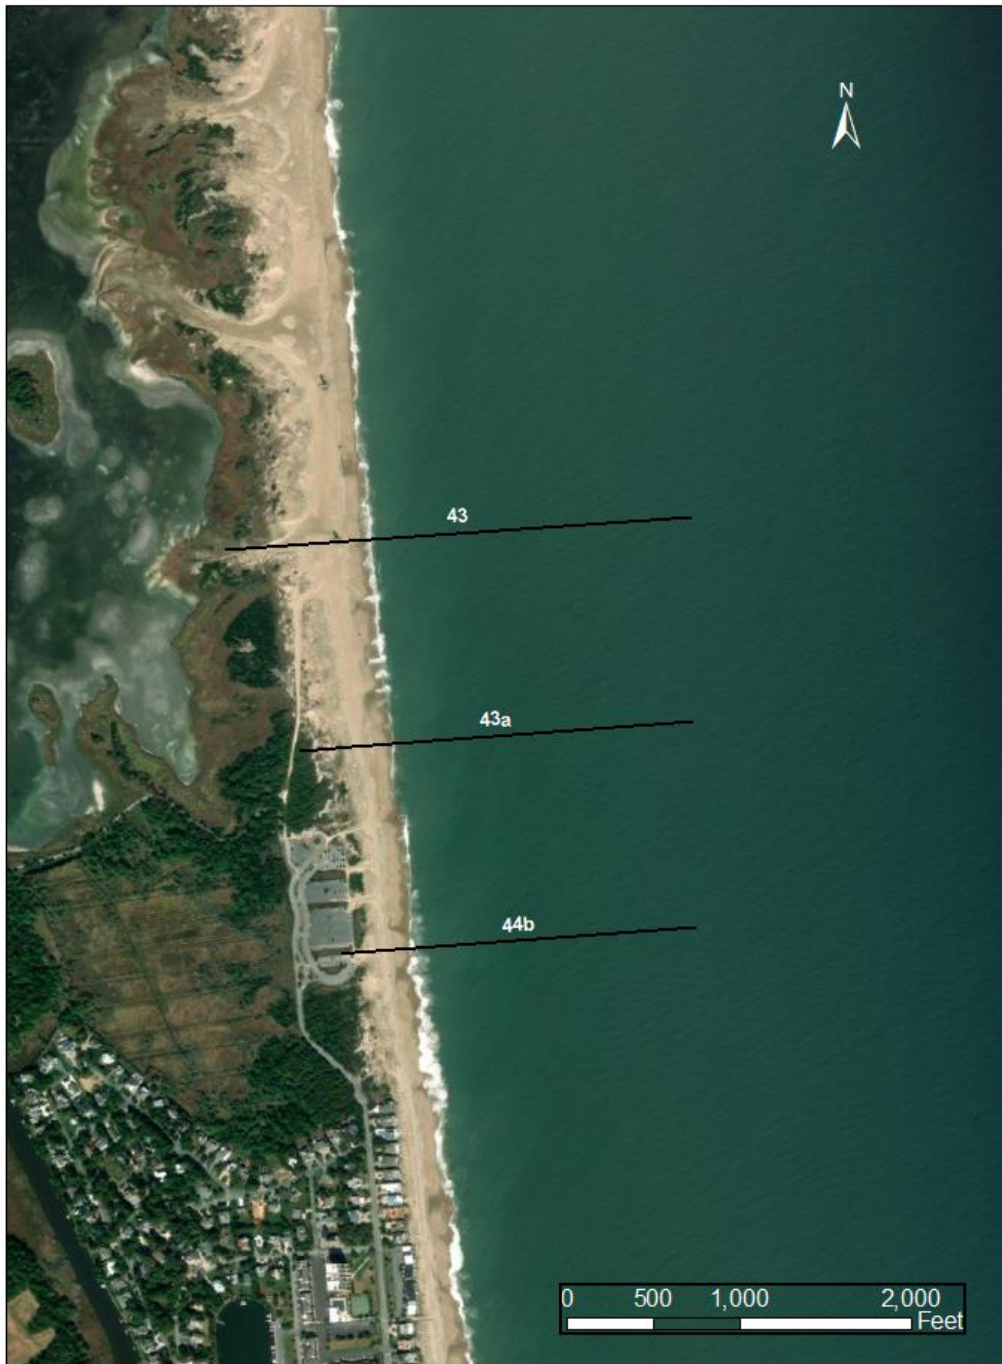
Figure 21: LRP location in Gordon's Pond State Beach

North of Henlopen Acres, which contains one profile line, is North Shores and Gordon Pond State Beach. This section of coast includes three profile lines.

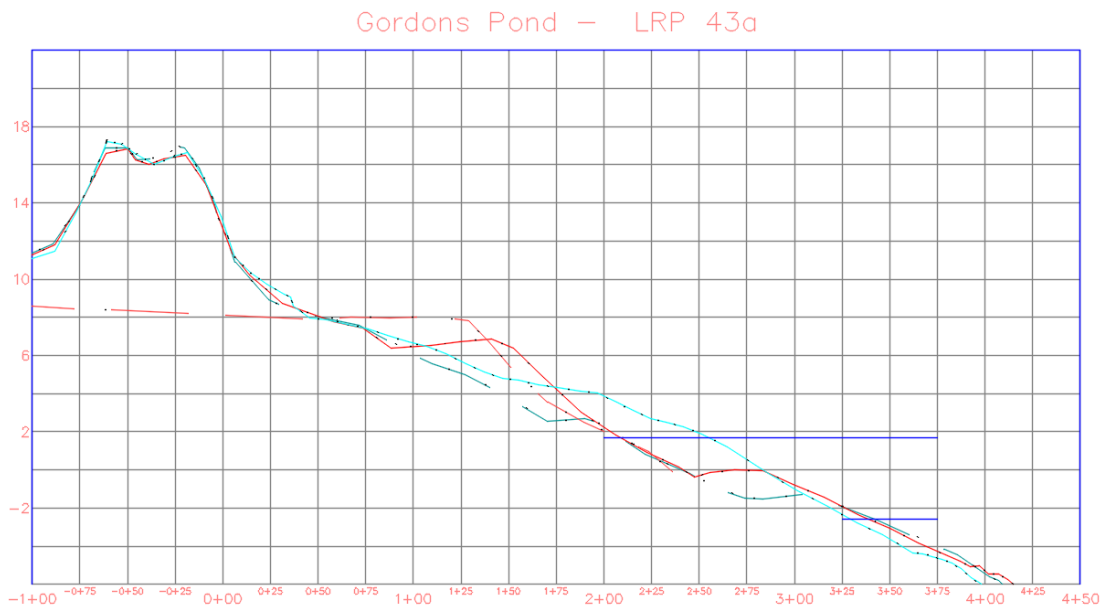
Figure 22: Gordons Pond: The plots are as follows: Summer 2020 (dashed red); Summer 2021 (solid red); Winter 2021 (dashed cyan); Winter 2022 (dashed dark grey). The blue lines represent the tide levels with the higher line being MHHW and the lower line being MLLW

It is noteworthy that the surveys at Gordon's Pond did not extend out beyond MLLW for all seasons. Because of this, the profile volume was computed between the dune crest and the MHHW line. Therefore, the change in the intertidal zone is not accounted for. Nevertheless, the beach nearly

doubled in volume since Summer of 2020 with the seasonal change being the opposite of what is expected.

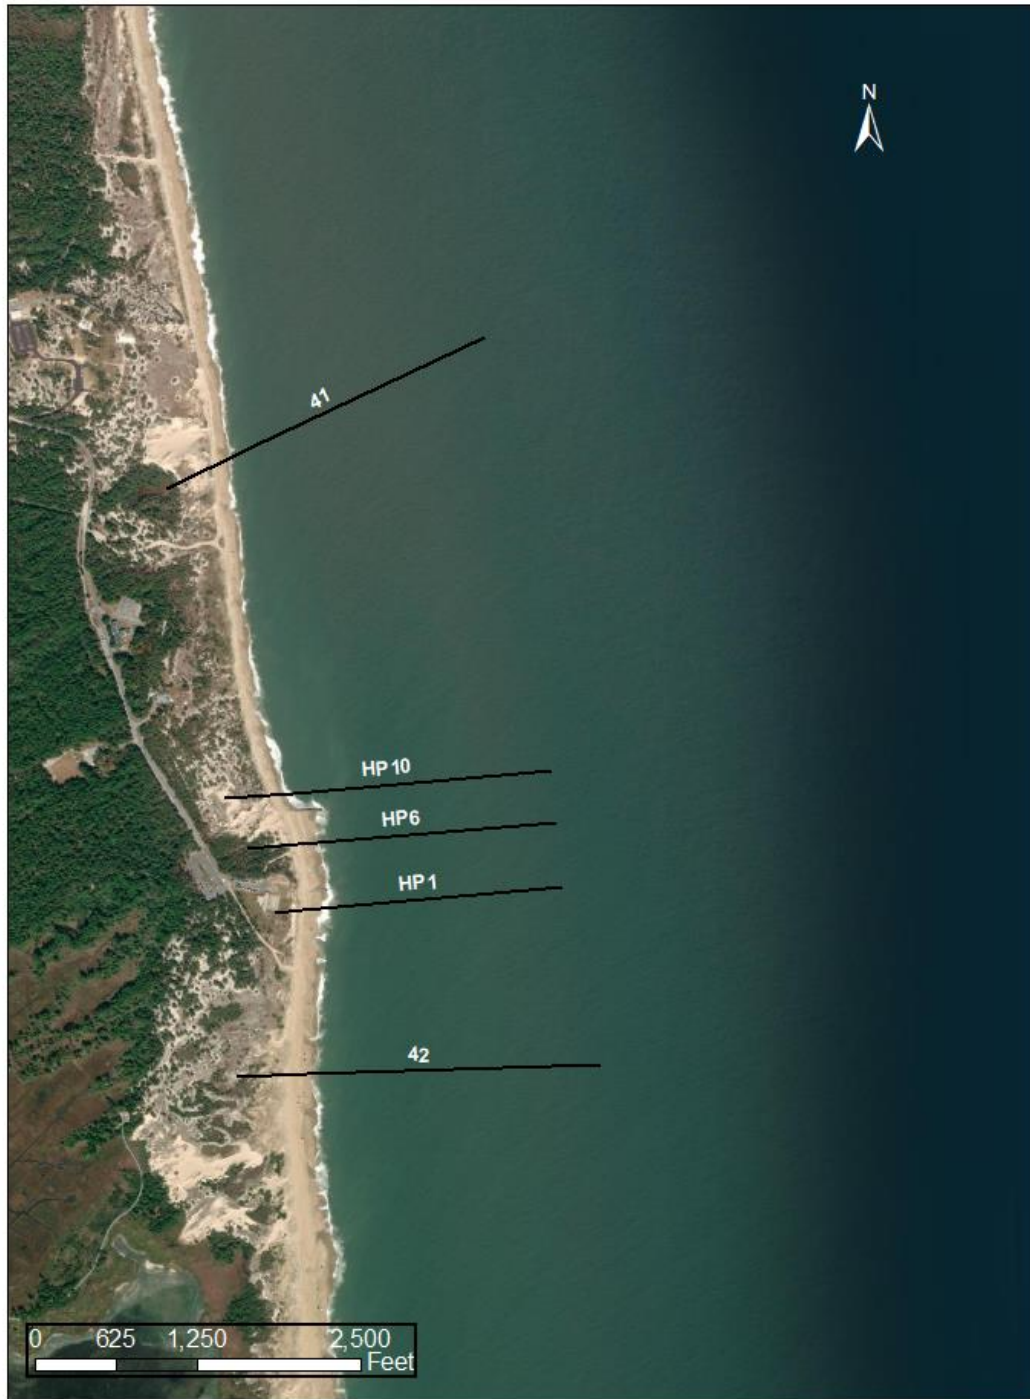
Figure 23: LRP location map in Cape Henlopen State Park at Herring Point

Cape Henlopen State Park is the northernmost section of beach along Delaware’s ocean coast. Herring Point is at the southern end of the park and is characterized by the large naval jetty. There are five LRP lines in Herring Point as shown in Figure 23.

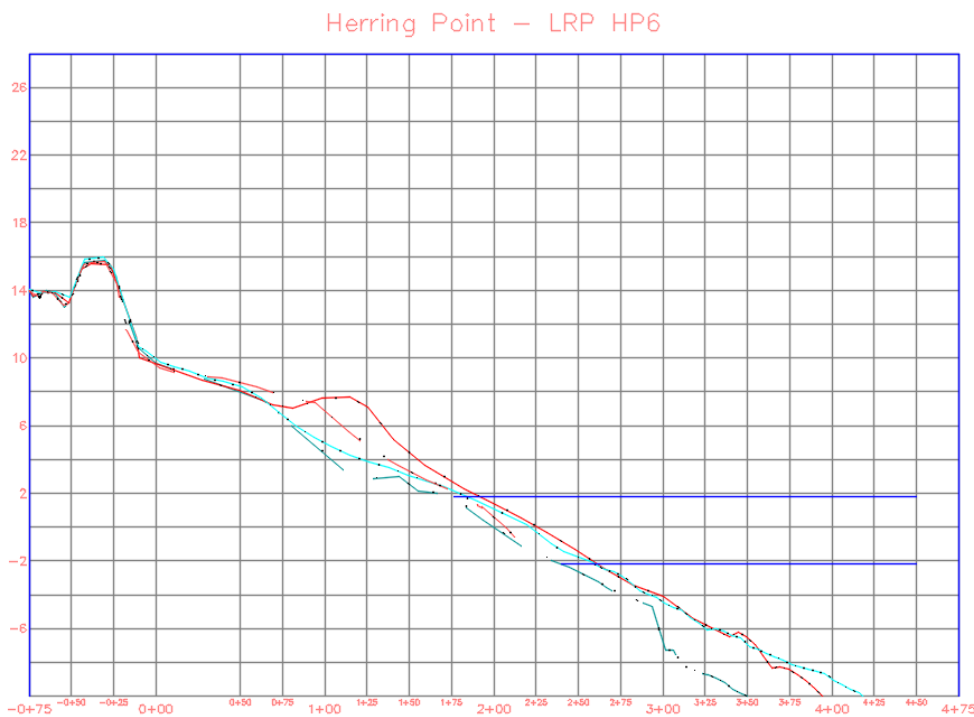
Figure 24: Herring Point: The plots are as follows: Summer 2020 (dashed red); Summer 2021 (solid red); Winter 2021 (dashed cyan); Winter 2022 (dashed dark grey). The blue lines represent the tide levels with the higher line being MHHW and the lower line being MLLW

On average, the beach at Herring Point in Cape Henlopen State Park accreted between Summer 2020 and Winter 2021 when it began eroding until the current season. The profiles align, roughly, above the 7' contour and most of the profile change was of the beach berm out to the intertidal zone. This suggests that Herring Point was not impacted by a strong storm surge in recent years.

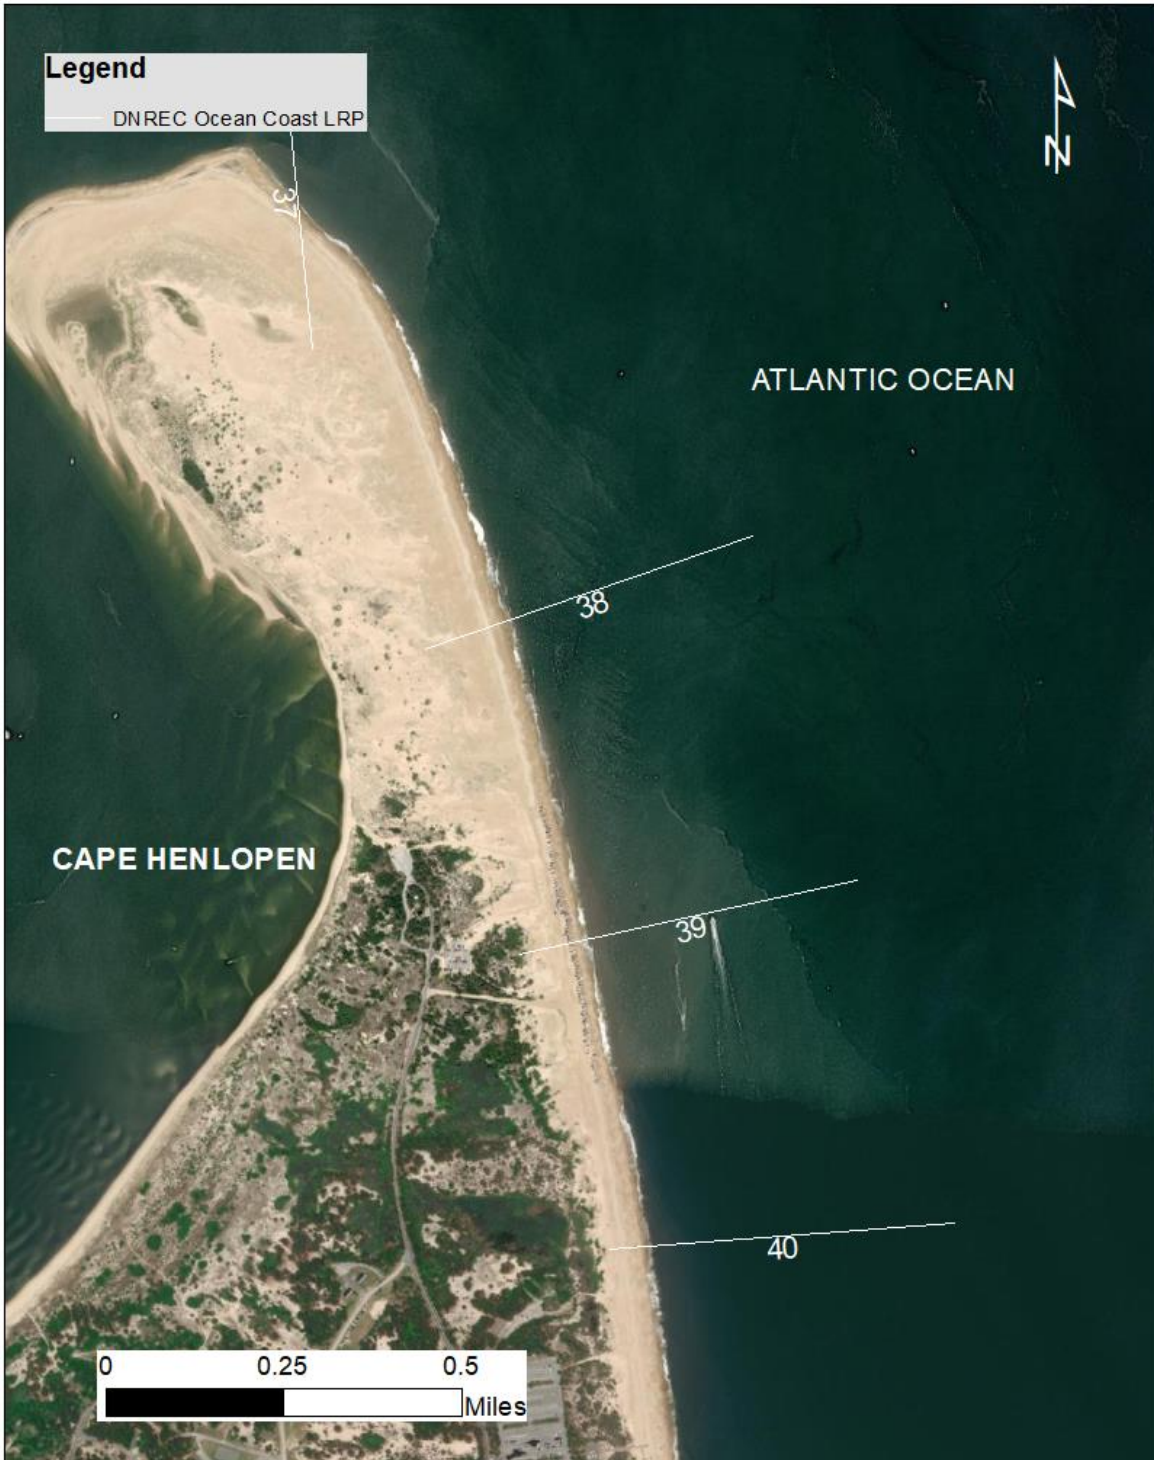
Figure 25: LRP location in the northern portion of Cape Henlopen State Park

The main day-use area is north of Herring Point in Cape Henlopen State Park. This portion of the park contains four survey lines; the two northernmost lines on the spit are sometimes inaccessible due to closures for piping plover nesting.
