Delaware Annual Beach Change Report: **Bay Coast**

Delaware Department of Natural
Resources and Environmental Control

October 2023

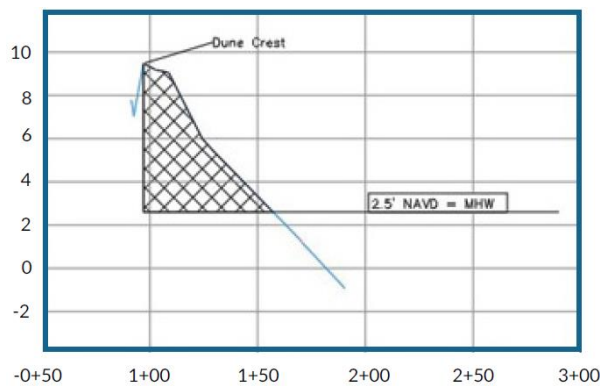
The following sections will describe the changes in beach volumes for each of the Bay Beach communities. Two beach volumes are reported for each LRP line. One is defined as the volume of material between the crest of the dune and the intersection of the MHW contour while the other is out to the intersection of the MLW contour. The volume calculation is sketched below:

Figure 3: Sketch of beach profile calculations.

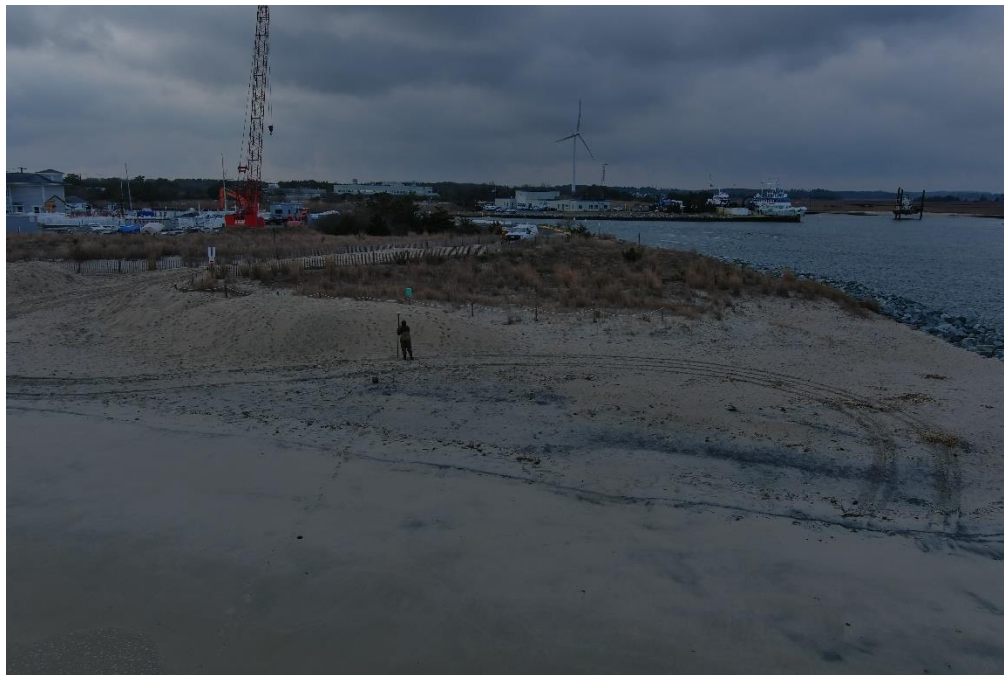
The beach profiles at LRP 30, which is directly adjacent to the Roosevelt Inlet, is shown in Figure 5. There is a large mound of sand on the profile present in Winter of 2023 that was not present in other seasons. This is not a result of natural process, rather, was likely placed there from material attained from maintaining the vehicle access. The mound is shown in the picture shown in Figure 6.

Figure 6: Picture taken at LRP 30 during the Winter 2023 survey. There is a mound of sand just seaward of the dune that is not the result of natural accretion.

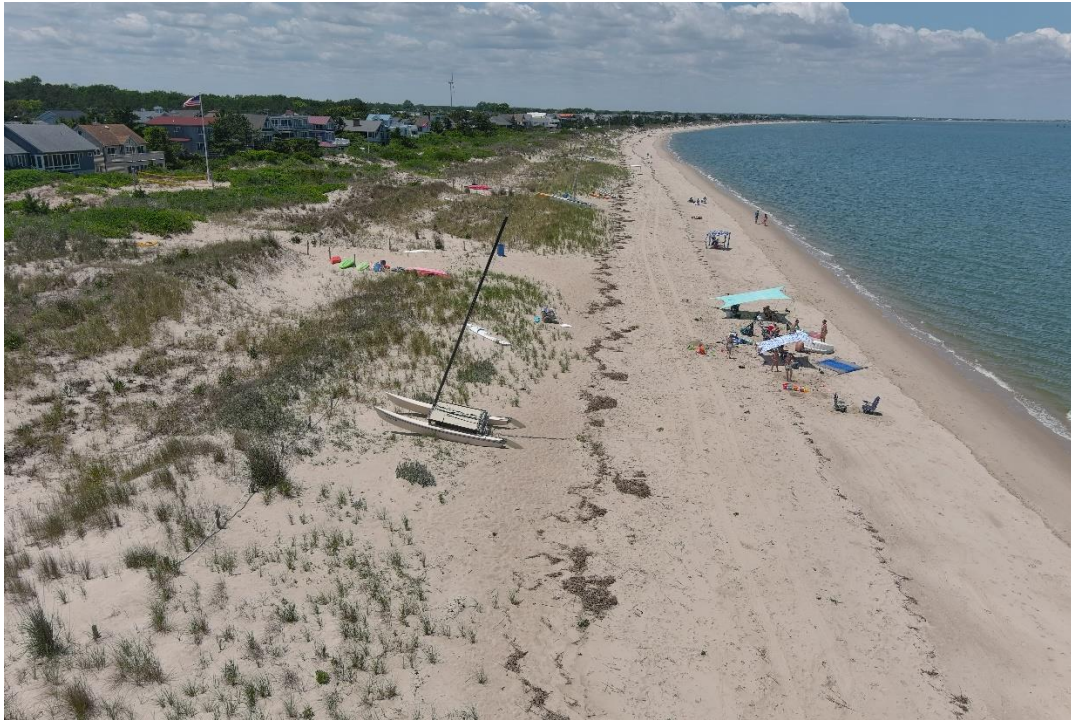
Figure 7: UAV image of Lewes Beach in the middle of the community taken on June 5th, 2023.

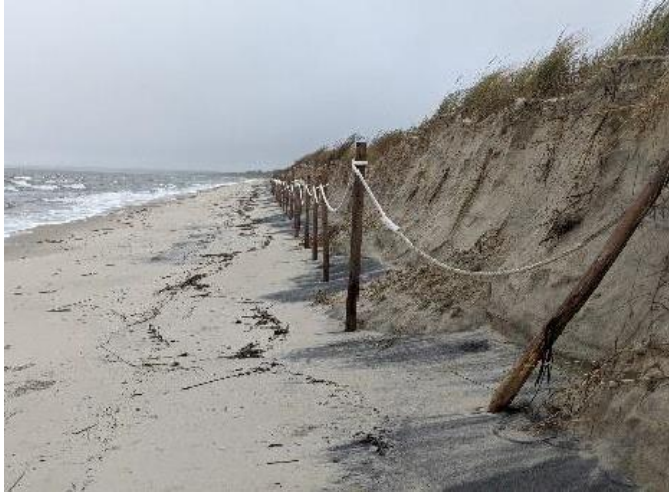
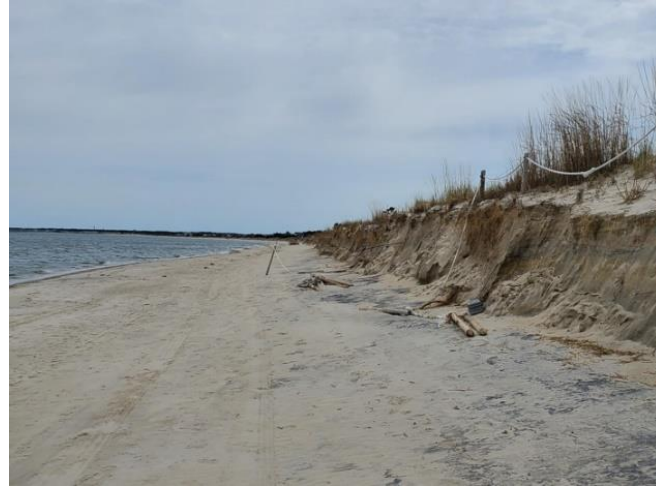
The Section's crew responded to three of the storm surge events that impacted Lewes Beach on 10/09/2021, 04/18/2022 and 10/03/2022. Typically, the western end of the beach, near the Roosevelt Inlet, suffers the most damage from storms and tends to be erosional. This is evident in the beach volumes as the beach has reduced in volume from season to season excluding the mound of material placed along LRP 30. The dune at this location was severely damaged in October of 2021. The dune was further damaged on 4/18/2022 but not 10/03/2023. The fact that no damage was observed on 10/03/2023 is likely because the previous storm eroded the dune to a point that this storm action could not reach it.

Figure 7: Scarped dune at the western end of town near the Inlet. An October 2021 storm damaged the dune as depicted in the photo on the left. The photo on the right was taken on 4/18/2022 which further damaged the dune.

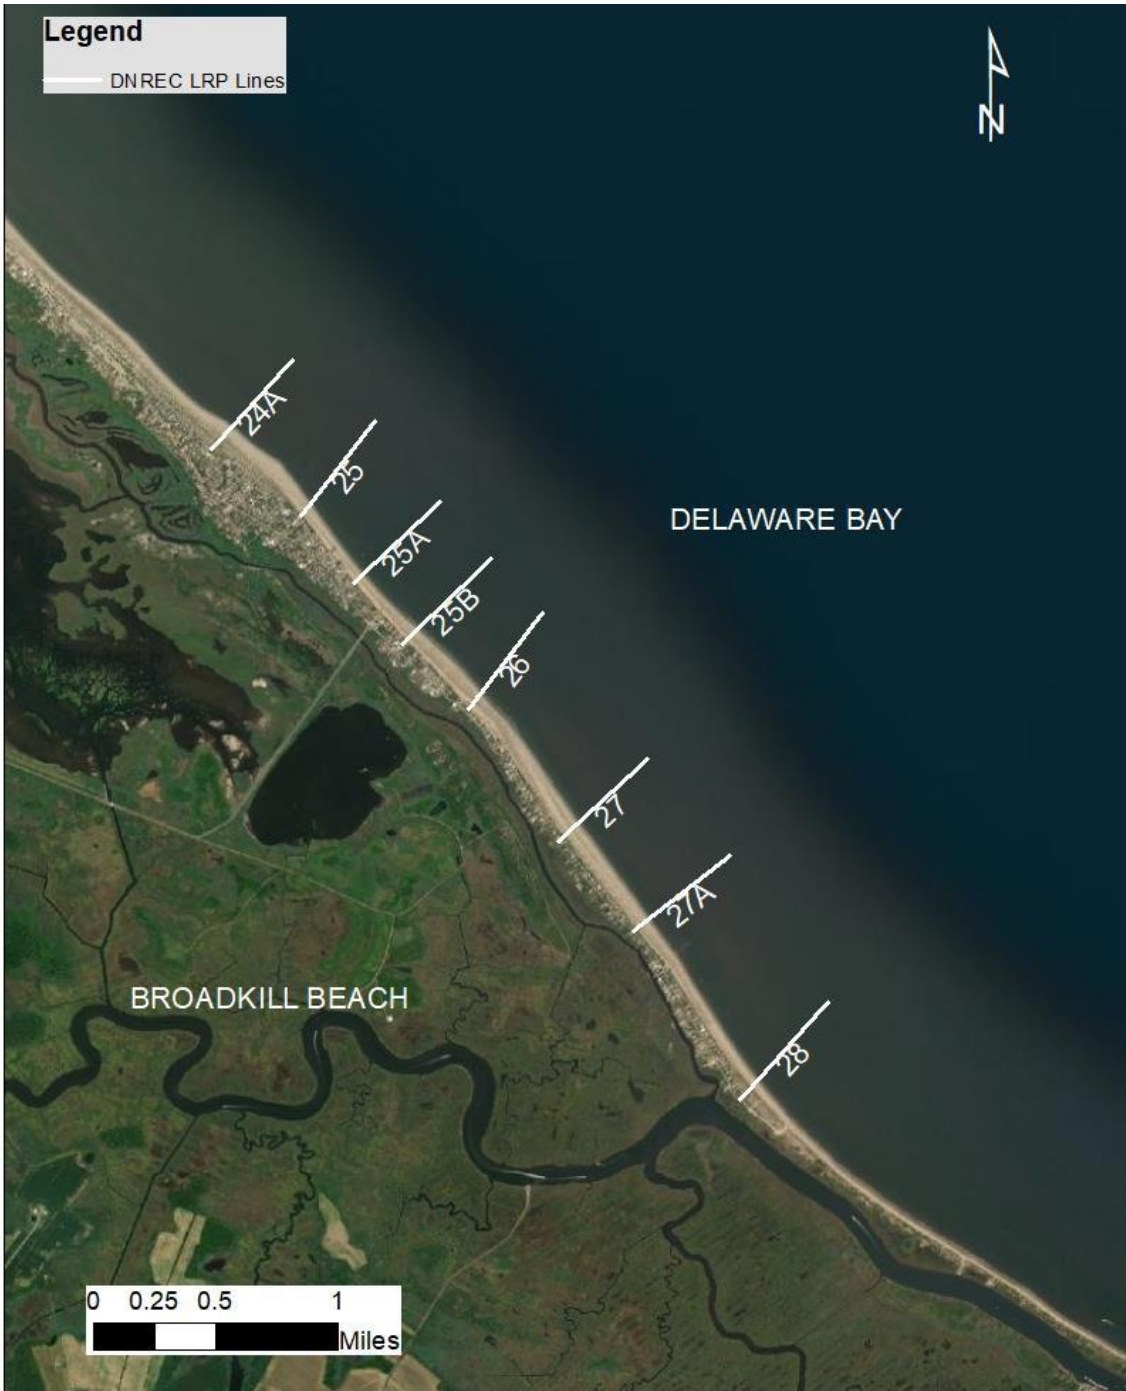
Figure 11: LRP location map in Broadkill Beach

Broadkill Beach is situated between Lewes Beach and Prime Hook Beach. It is roughly 16,000' or three miles in length and includes nine survey lines. Survey lines are spaced roughly 2,000' at the south end of the community and 1,500' in the more developed northern end of the community. In 2016/2017, the USACE placed 1.7 million cubic yards (cy) of sand dredged from the Delaware River onto Broadkill Beach to widen the beach by 150' and to add a dune with a crest of 15-16'.

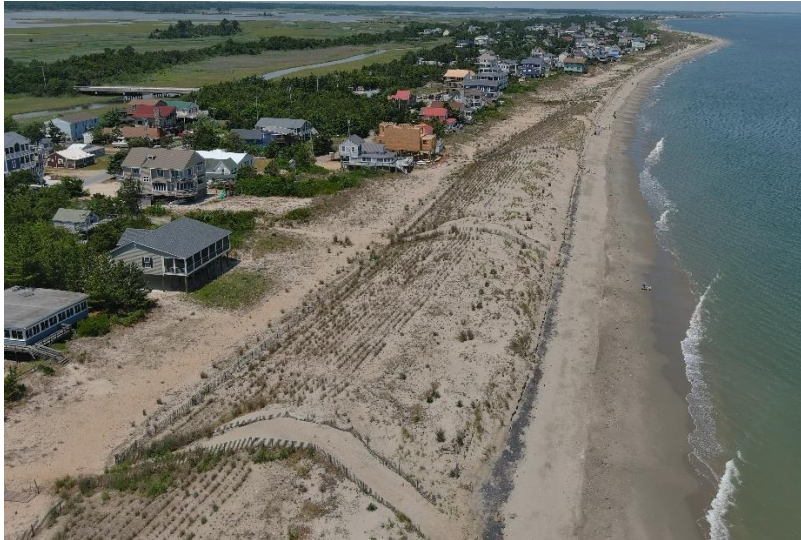
Broadkill Beach Overview:

The Section's crew responded to four storm events over the past 2 years (10/09/2021, 10/03/2022, 04/18/2022 and 05/09/2022). At the Rt. 16 crossing, the scarping of the dune was exacerbated by these events. Along S. Bayshore Drive southward of Bayfront Road, the foredune on the berm was partially eroded but the berm and primary dune remained in good condition. The storm in October of 2022 likely induced based damage to the upper beach and dune in Broadkill Beach. Figure 15 shows the beach during the storm tide. This highwater indicators show that the high tides reached the toe of the scarped dune which likely caused erosion and collapse of this feature.

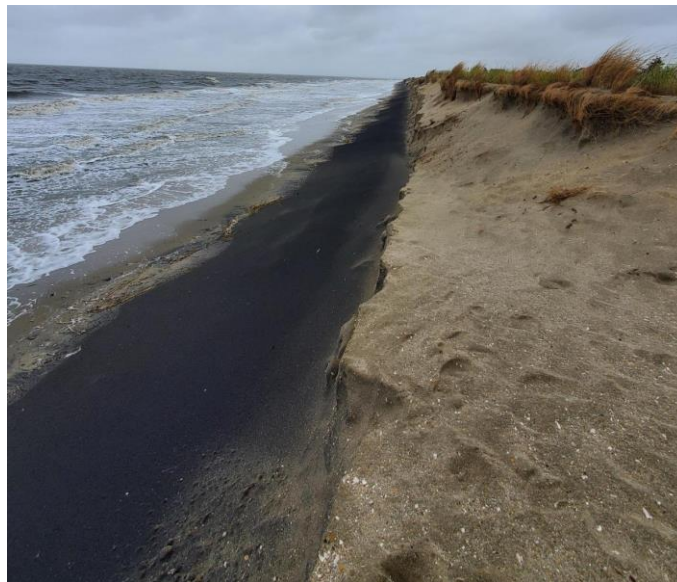
Figure 15: Beach and dune erosion in the middle portion of Broadkill Beach

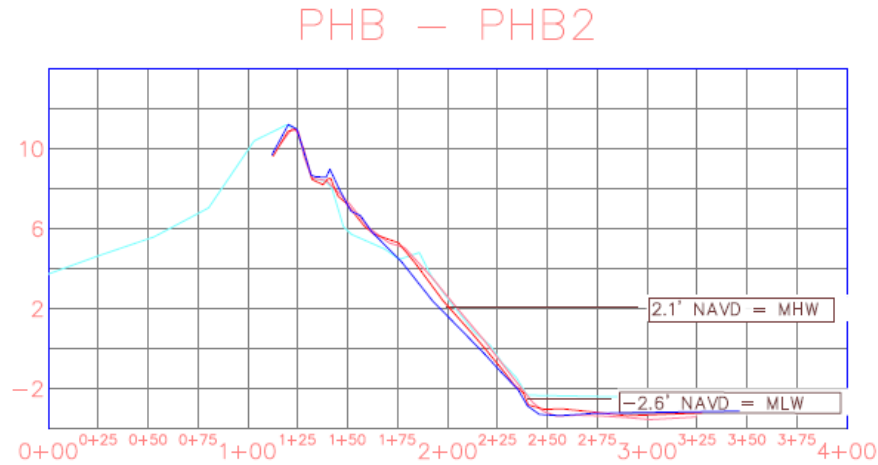
A representative profile from the center of the beach is shown in FIGURE. The profile demonstrates that there is variability in the beach profile, from season to season, from the intertidal zone to the upper beach to the 6’ elevation. In the winter of 2022, the upper part of the beach is eroded with some of the eroded material accumulated in the intertidal zone.

Figure 14: Beach profiles in the center of Prime Hook Beach. Data are from winter 2022 (light blue), summer 2021 (pink), winter 2023 (blue solid), and summer 2022 (red solid).

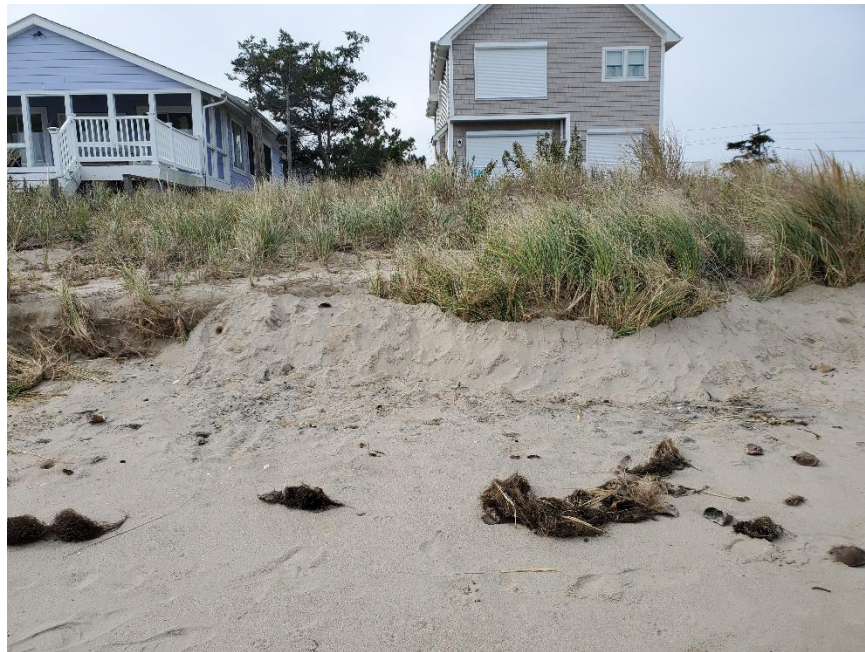
On November 4th, 2021, Prime Hook Beach was inspected for damage due to a storm during the previous days. The storm cause scarping in the lower part of the dune. This scarping can also be seen on the profile plot for winter 2022 in FIGURE.

Figure 15: Upper beach and lower dune scarping in Prime Hook that occurred in the Fall of 2021. This accounts for the erosion observed between Summer of 2021 and Winter of 2022.

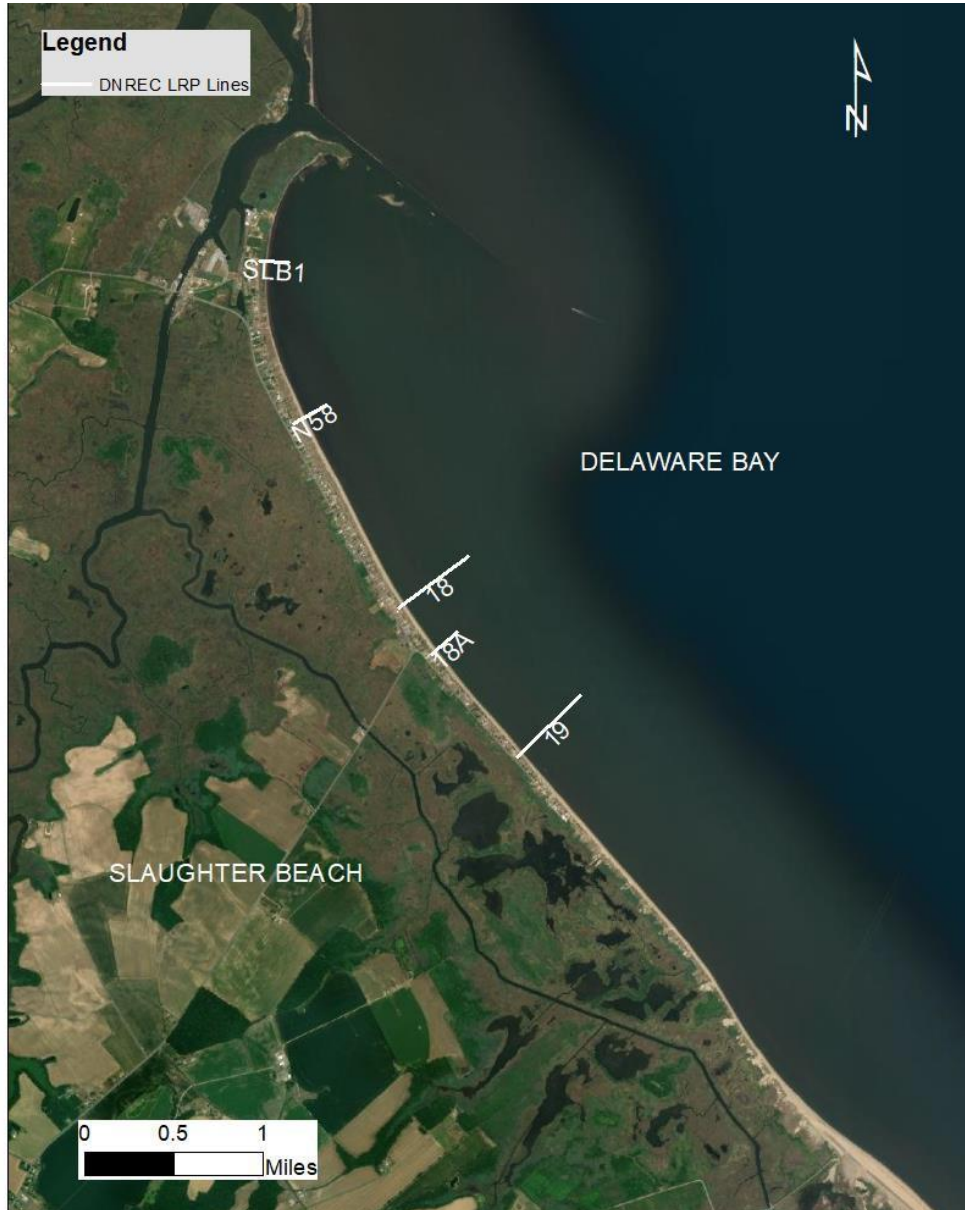
Figure 18: LRP locations in Slaughter Beach

Slaughter Beach is directly north of Prime Hook and contains five survey lines. It is roughly 16,000' or about three miles in length. Not all five lines were surveyed every season, therefore, the four lines that were surveyed are used for the calculations.

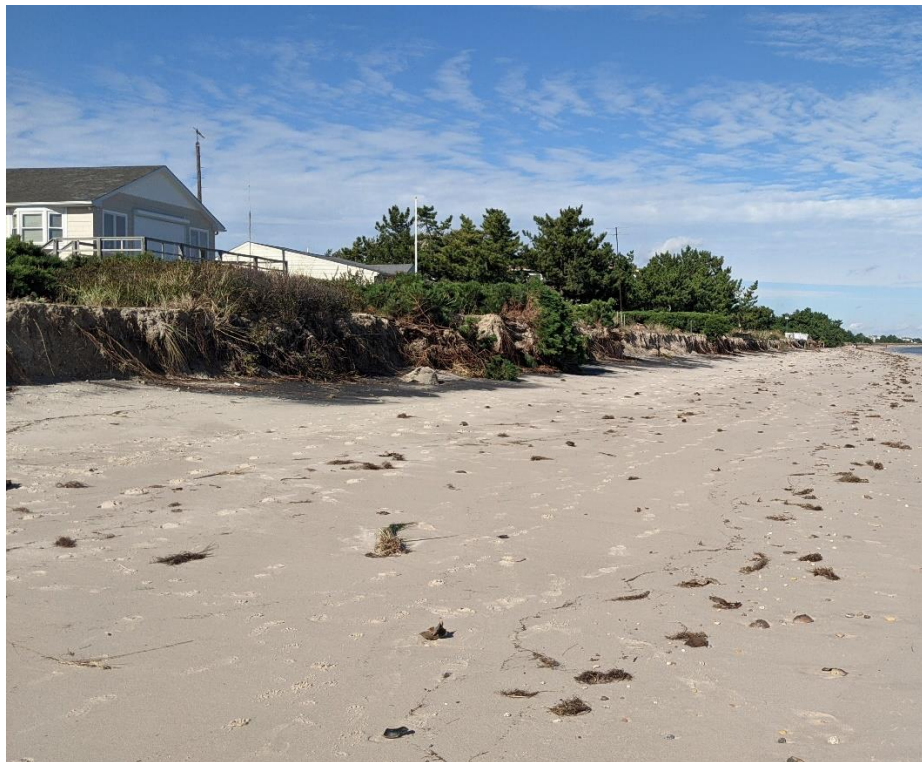
The nor' easter that occurred in early October caused the tide to reach the seaward edge of the dune, which induced a small scarp in the dune and caused erosion of the berm. The scarping of the dune was less stark near the center of the community at LRP 18. Further south, the upland terrain is greater in elevation making the scarp higher and more vulnerable to collapse. Erosion was not reported nor observed further north along the shoreline where the coast is sheltered due to the south/southeast orientation.

Figure 15: Slaughter Beach bluff erosion during the Fall of 2021. In the southernmost 2000' of the community, from Simpson to Sussex Ave where the bluff encroaches closest to homes.

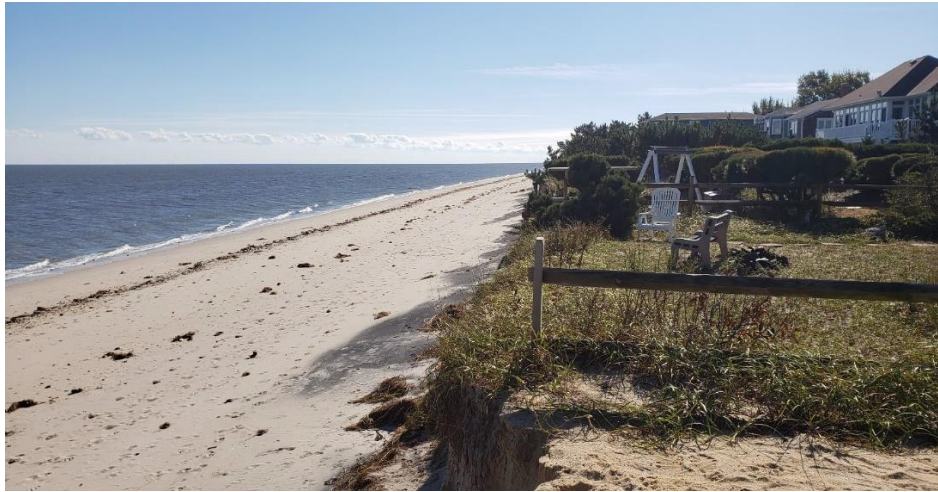
Additional dune and beach were likely eroded during the last October storm.

Figure 21: Severe erosion creating an unstable, vertical scarp in Slaughter Beach

The nor' easter in early November further damaged the beach and dune at Slaughter Beach leading to washed out trees, beach access structures and exposed bulkheads. A homeowner mentioned that this storm along with the previous nor' easter caused the most erosion he has seen in 40 years. In response to these storms, the Section placed fill to bolster the eroding bluff.

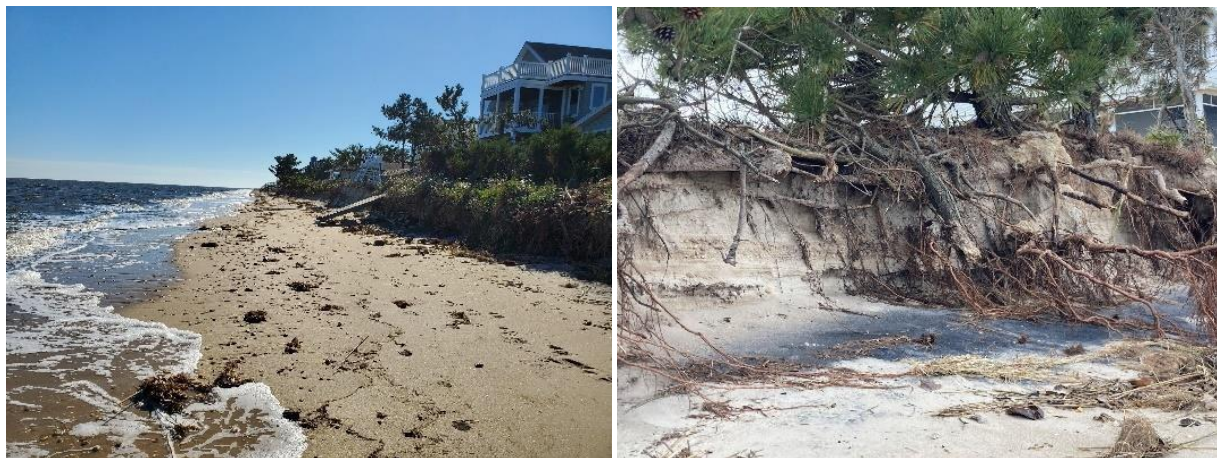
Figure 22: Slaughter at high tide (left) and a Japanese black pine in Slaughter Beach that was undercut during fall storms.

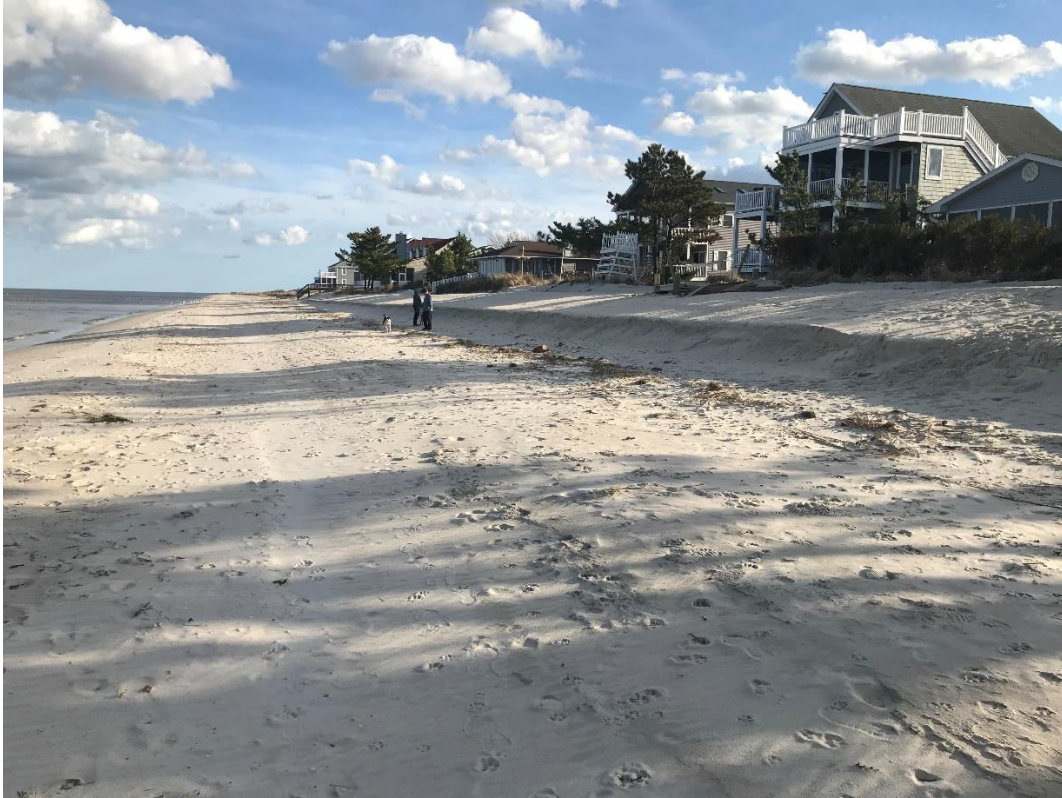
The FIGURE shows the beach after this fill job. The lower part of the fill template was reshaped by the astronomical tides shortly after the project. This was because the fill template was steeper than the natural beach.

Figure 22: Slaughter after completion of the February 2022 nourishment job. The lower part of the steep template was reshaped into a relatively flat berm.

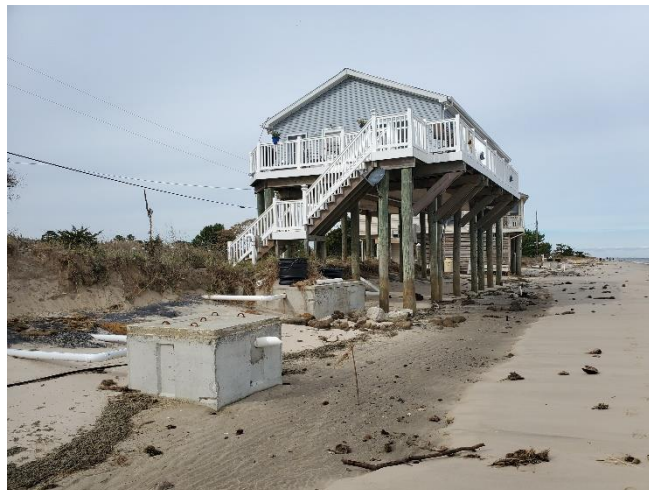
The storms during the Fall of 2021 caused major erosion in Big Stone Beach. It should be noted that the image in FIGURE is from the developed portion of Beach whereas the survey location is in the undeveloped land owned by Delaware Wildlands, Inc.

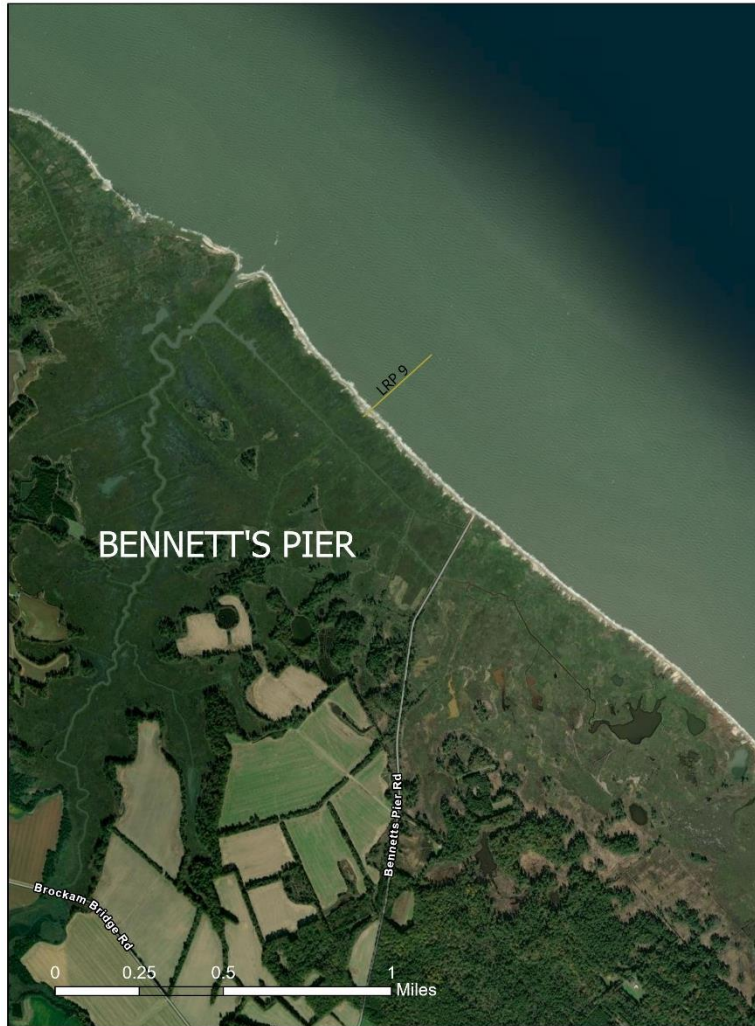
Figure 23: Location of the single LRP line at Bennett's Pier

Bennett's Pier is directly north of Big Stone Beach and contains just one survey line. At present time, this segment of the coast is entirely privately owned, undeveloped and is backed by marshland. DNREC collects data at this location through an agreement with the landowner, Delaware Wildlands Inc.

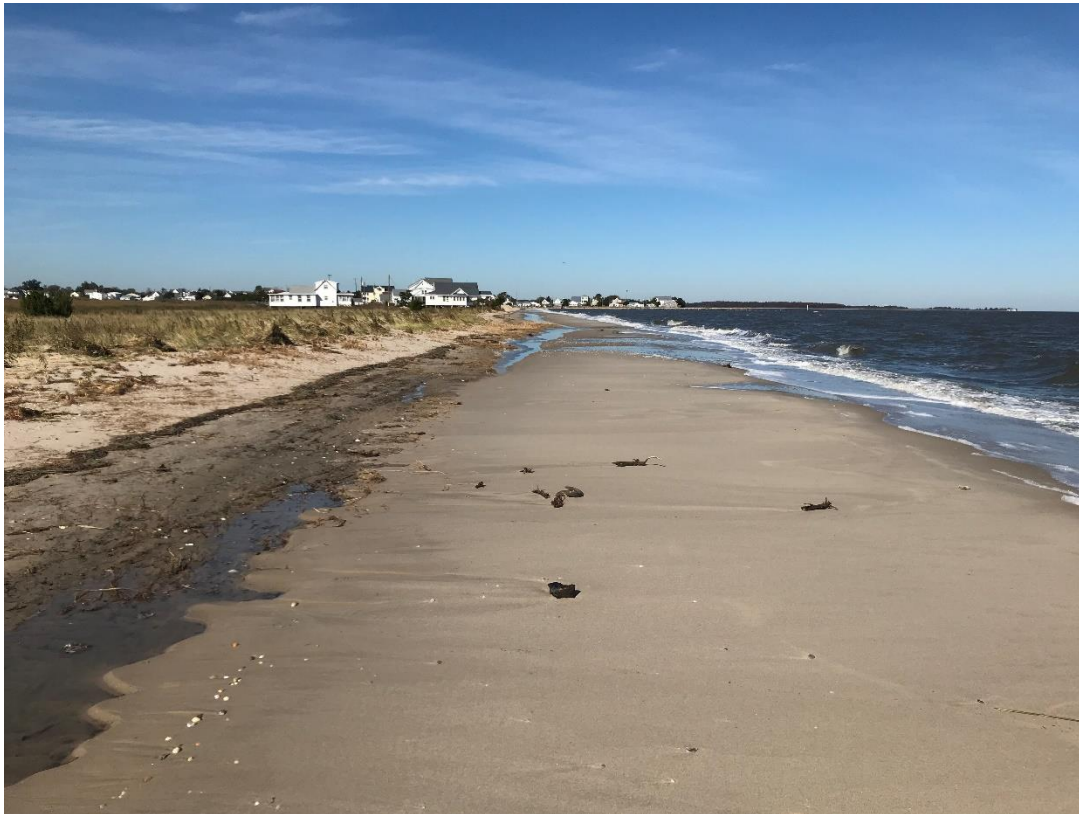
The only storm event for which the Section assessed the conditions of South Bowers Beach was the one occurring in late October of 2021. During that event, the storm tide nearly reached the dunes as depicted in FIGURE.

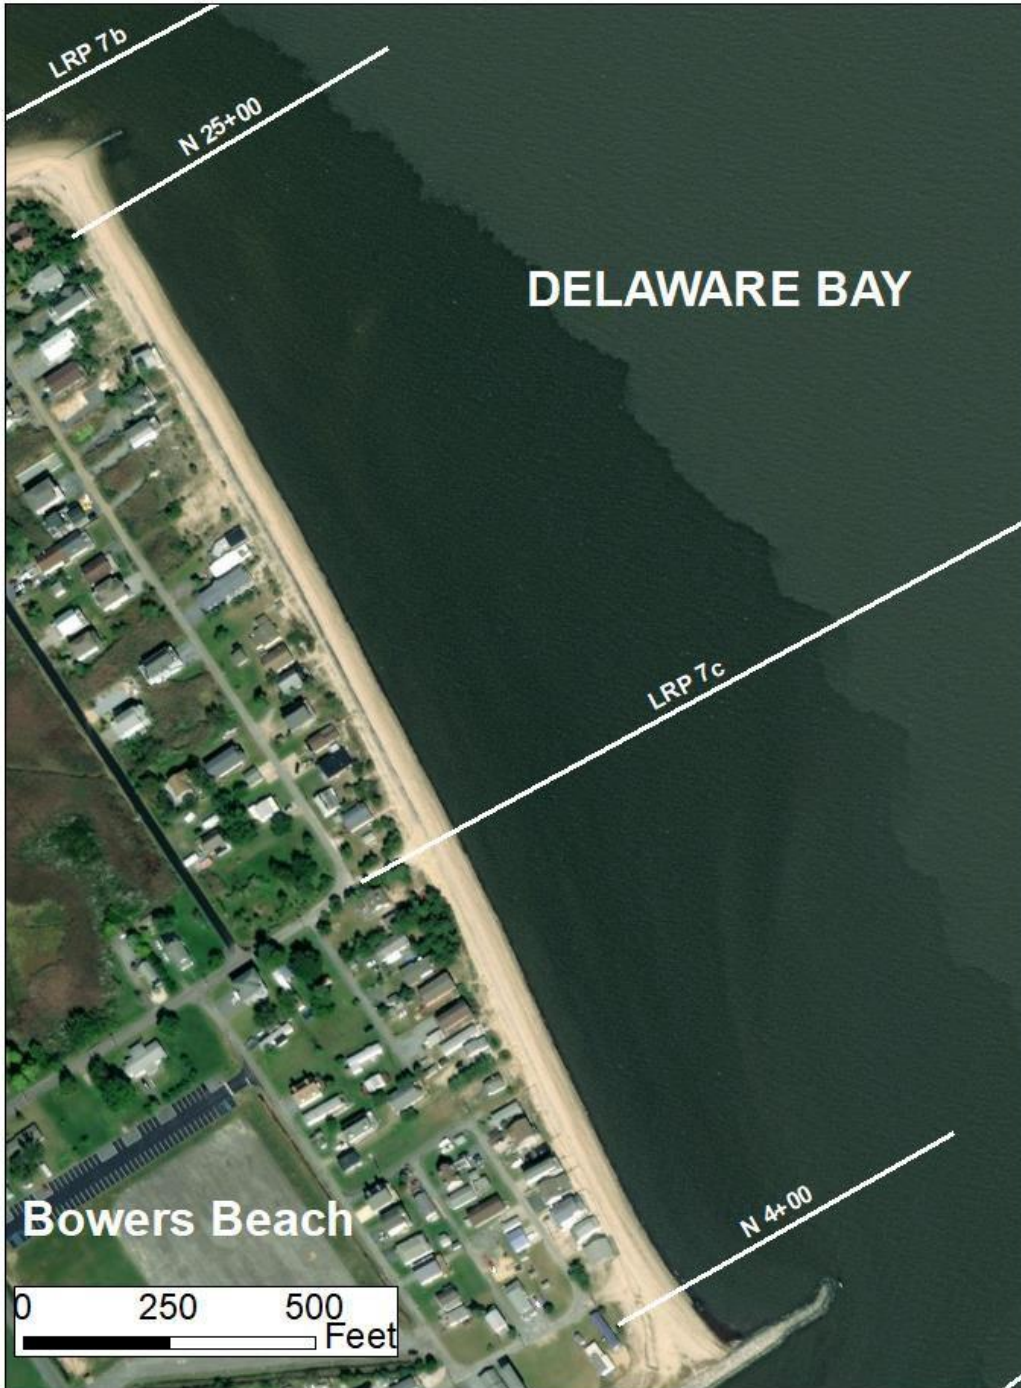
Figure 29: Bowers Beach LRP location map

Bowers is separated from South Bowers by the Murderkill River and is about 2,300' long. The north end of Bowers is bound by the Saint Jones River. Bowers Beach is densely developed. Profile lines are spaced roughly 1,000' in the southern end and densely (250') near the outlet of the St. Jones River. There are three LRP survey lines in the developed portion of the community. There is an additional LRP line north of the northern groin in Bowers where there is no coastal development.

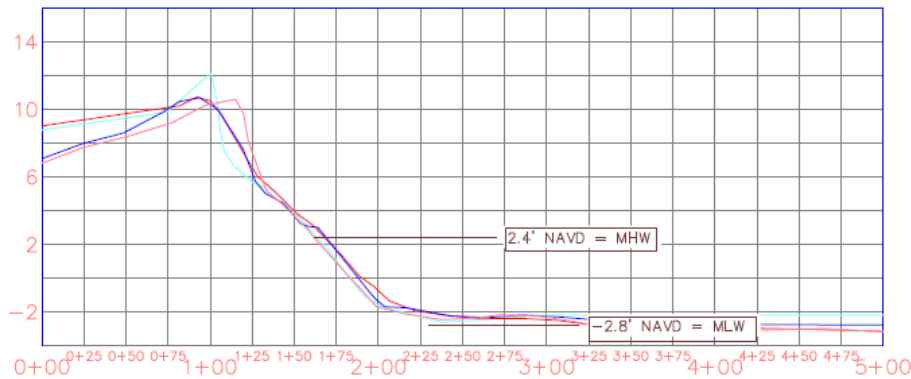
Figure 28. Beach profiles in Bowers Beach. Data are from winter 2022 (light blue), summer 2021 (pink), winter 2023 (blue solid), and summer 2022 (red solid).

The average beach volumes of Bowers are shown in TABLE. The beach profile trends vary along the coast. It is noted that the beach was nourished in the February of 2022. This project essentially repaired damage to the dune that was experience during the Fall of 2021 (See FIGURE). The loss observed between Summer 2021 and Winter 2022 is likely due, in large part, to the storms that occurred in the Fall of 2021. The recovery of the beach prior to the Summer 2022 is likely due to the beach fill project, rather than natural seasonal change. In FIGURE, the scarp incurred during Fall 2021 was captured by the Winter 2022 survey. The subsequent profiles shows that the beach nourishment project repaired the dune, which remains intact. It is noteworthy that LRP 7b is outside of the beach fill project area and is separate by a small concrete bag groin.

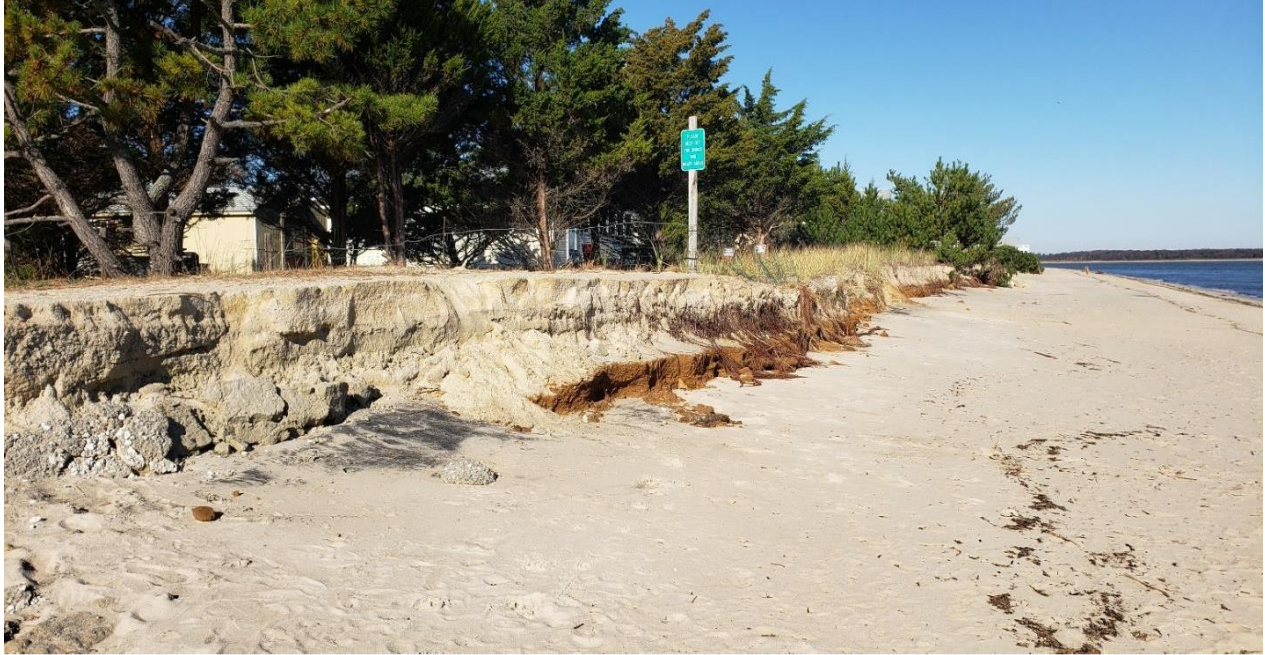
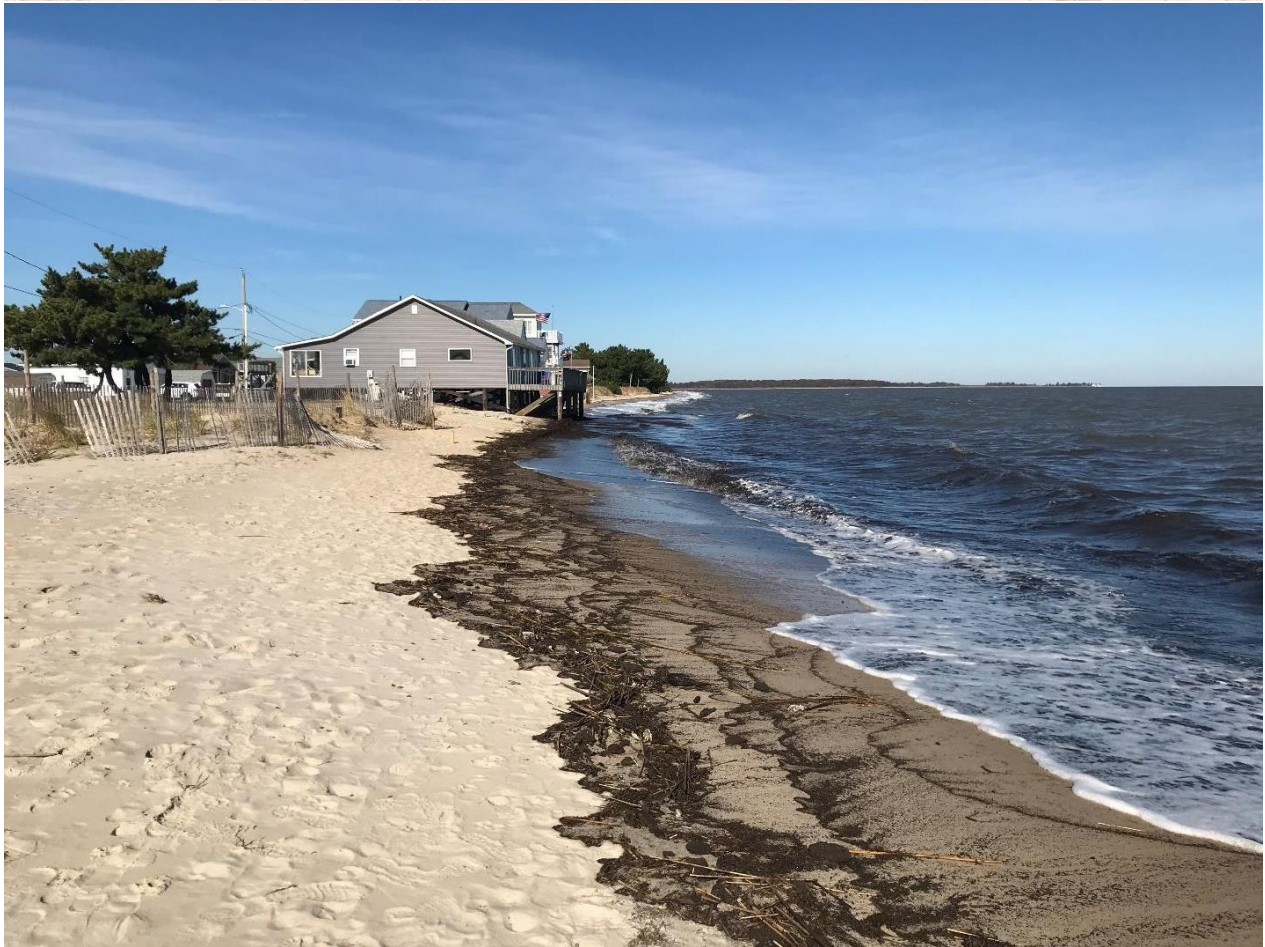
The early October storm caused minor erosion at Bowers Beach allowing water to lap under one home built upon stilts at the south end of the community. The second event in October caused a significant loss of the dune along the entire beach in Bowers.

Figure 31: High tides and erosion resulting from strong east winds

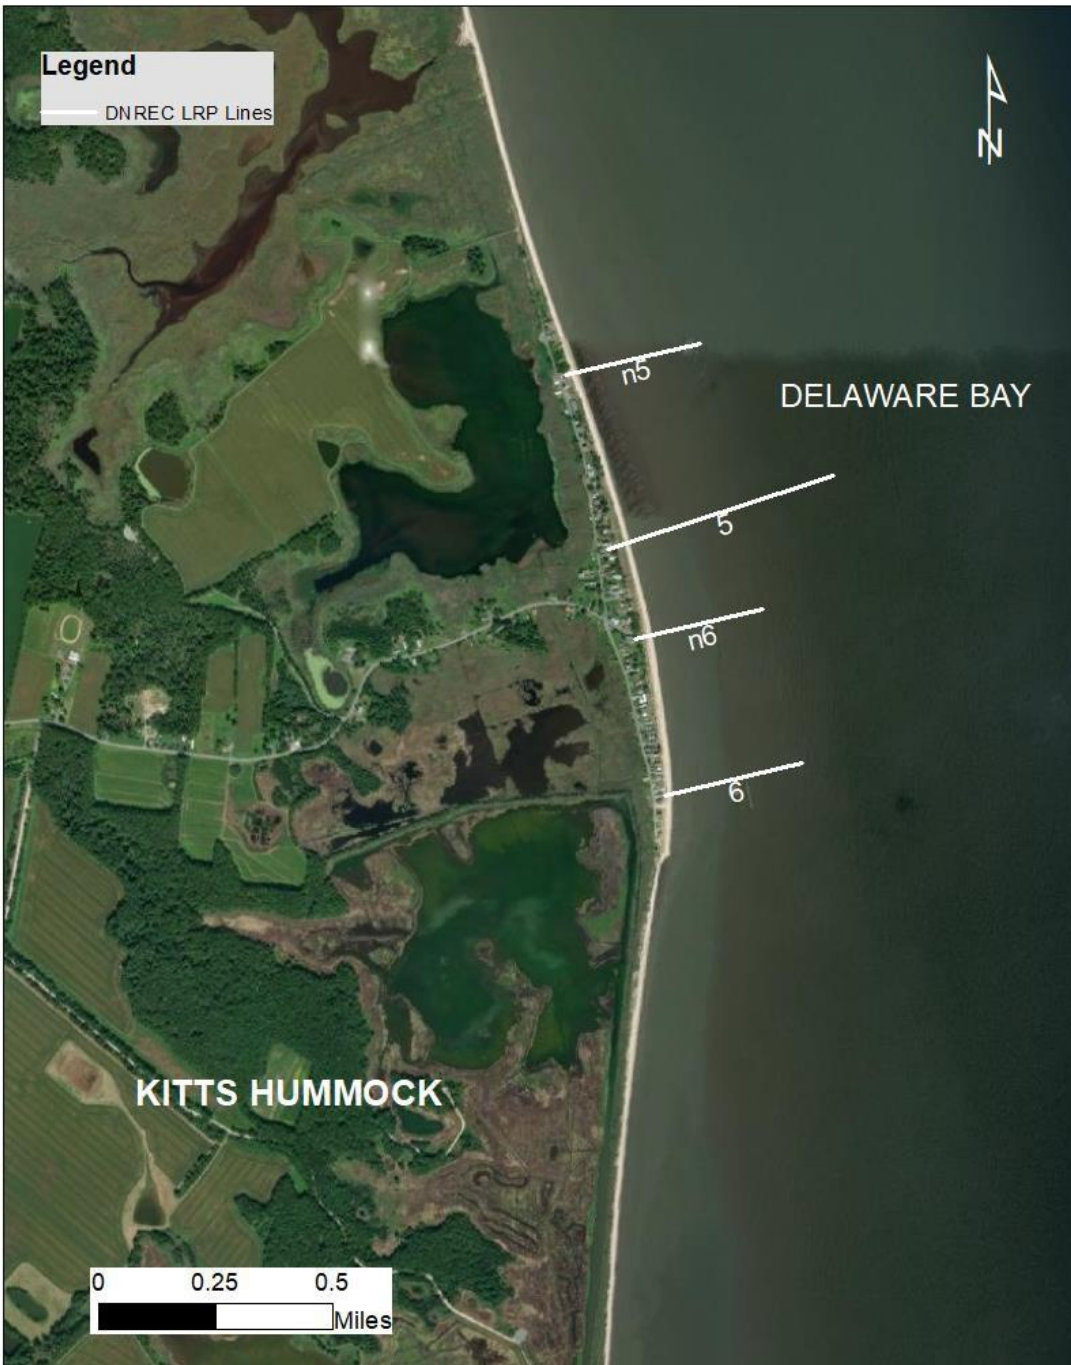
Figure 32. Beach LRP lines at Kitts Hummock.

Kitts Hummock is the next populated community north of the Town of Bowers. It is densely developed along Bay Drive and contains four survey lines in the 4,500' length of shoreline.

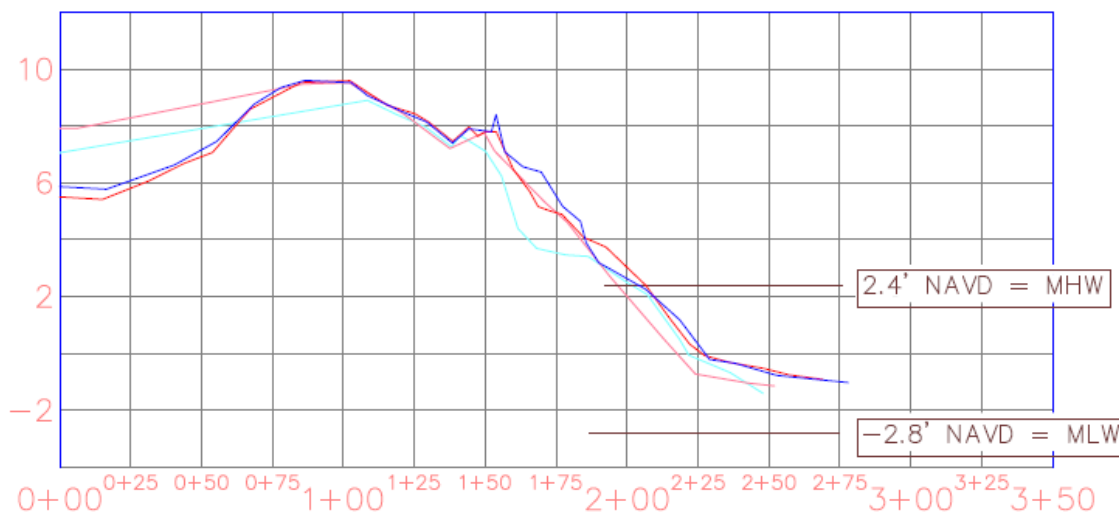
The average beach volumes of Kitts Hummock are shown in TABLE. This beach was also nourished after the Winter 2022 survey date to repair the erosion incurred by the storms during the Fall of 2021. All profiles lost a substantial amount of volume between Summer 2021 and Winter 2022. There was an additional fill project in November of 2022 that was of a smaller scale. Based on the volumes reported in TABLE, these nourishment activities have been successful in terms of repairing and maintained the upper beach and dune.

Figure 28. Beach profiles in Kitts Hummock. Data are from winter 2022 (light blue), summer 2021 (pink), winter 2023 (blue solid), and summer 2022 (red solid).

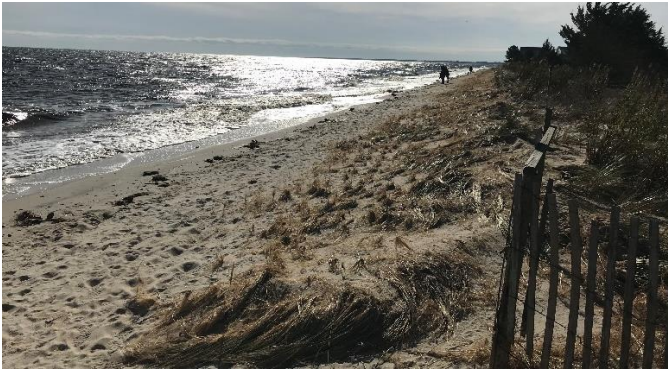
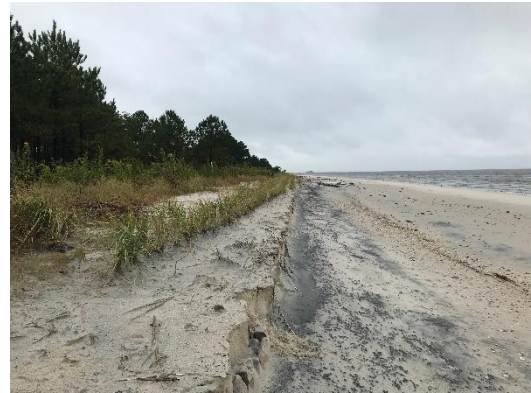
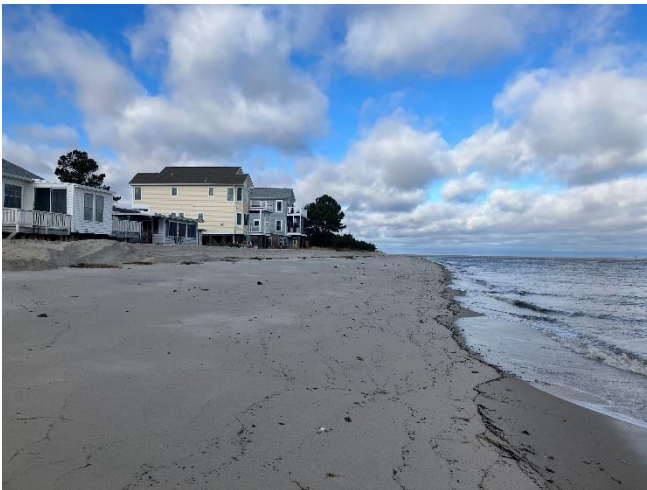
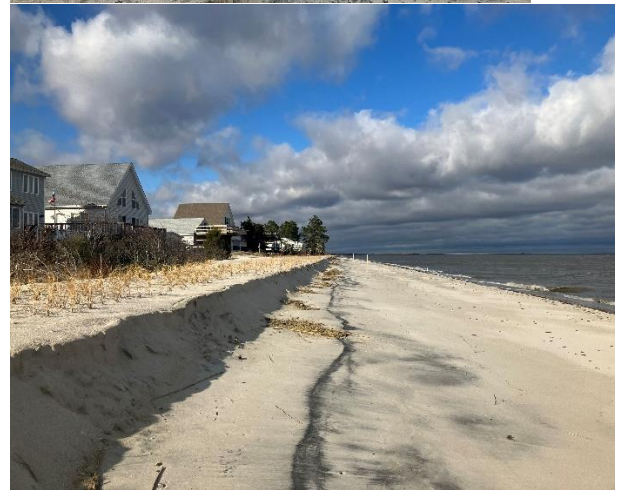
The Section assessed the beach conditions in Kitt Hummock after several storm events in the period covered by this report. The pictures in FIGURE so beach conditions following some of these events. The upper left picture was taken during a storm event occurring on 11/05/2021. The upper right shows the scarping of the upper beach and dune that occurred in early October of 2022. The lower images were

Figure 31: Images of Kitts Hummock beach conditions immediately after storms or, in the case of the lower left hand image, after a beach fill job.

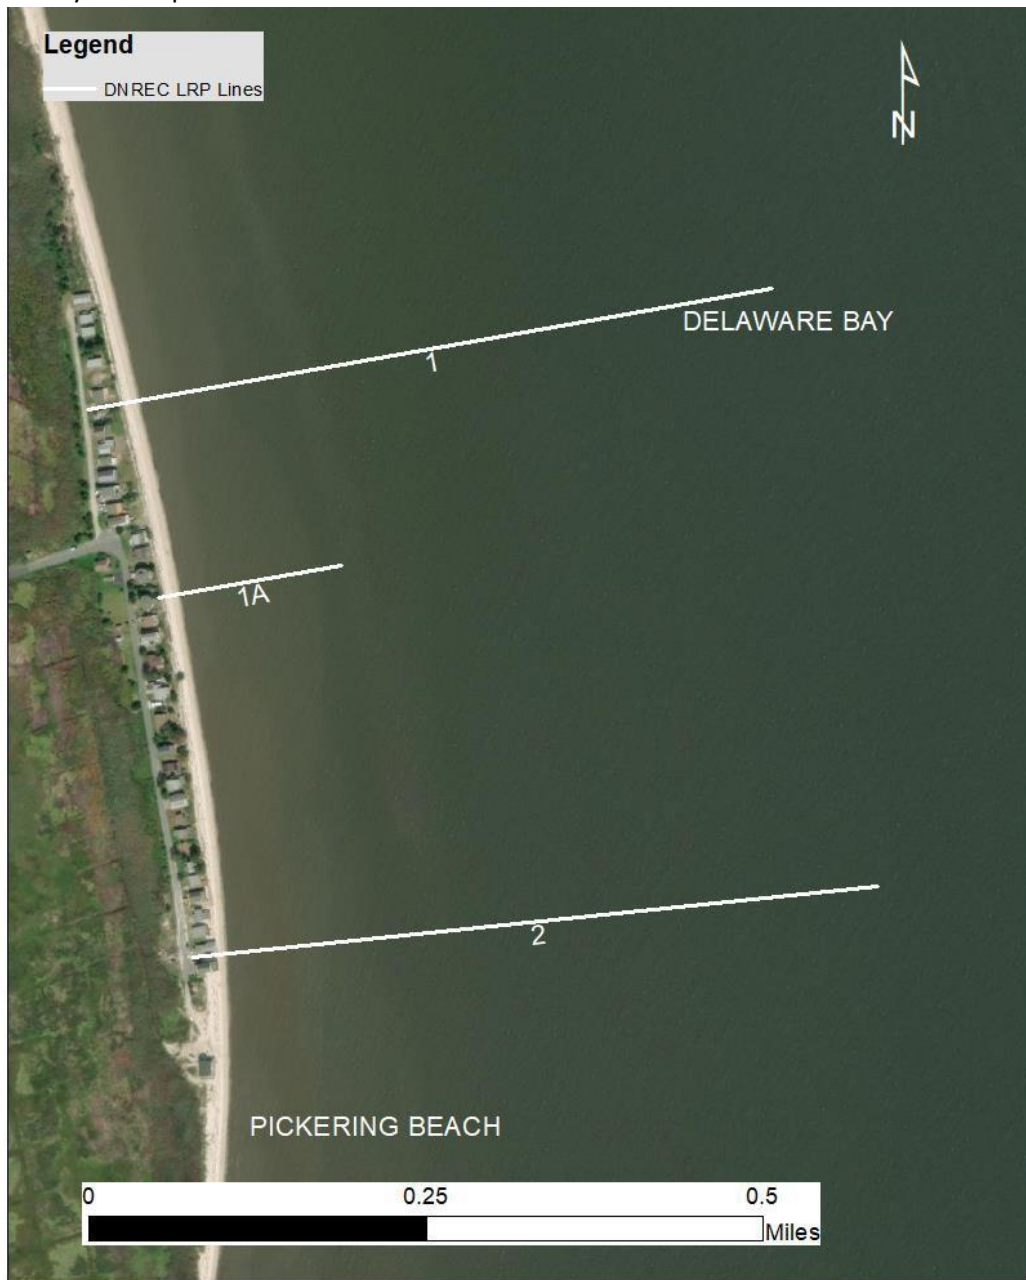
Figure 35 Northernmost LRP located in Pickering Beach

North of Kitts Hummock is Pickering Beach, which consists of three survey lines over 2,300' and is densely developed.
