Delaware Annual Beach Change Report: **Bay Coast**

Delaware Department of Natural
Resources and Environmental Control

October 2023

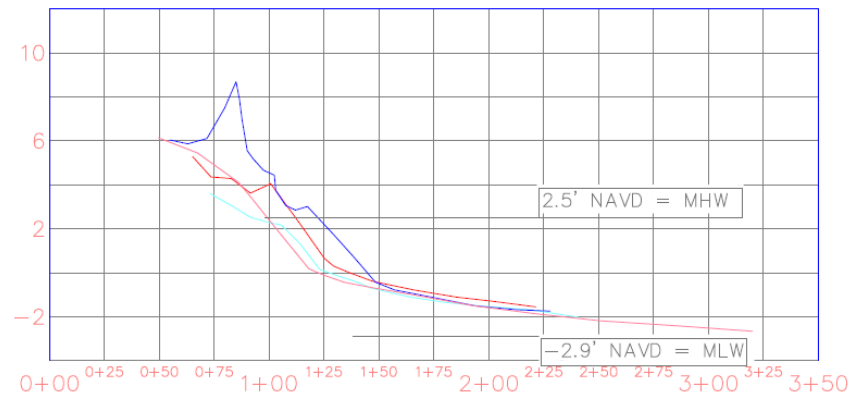
Pickering Beach South

The average beach volumes of Pickering Beach are shown in TABLE. Like Kitts Hummock, Pickering Beach was nourished in April of 2022 again in November 2022. The earlier nourishment repaired major damage to the upper beach and dune in Pickering Beach that occurred in the Fall of 2021 whereas the November project repaired minor losses of the berm. The November project did place a substantial volume of sand at the south end of the community, as represented by LRP 2. This accounts for the large gain in volume from Summer 2022 to Winter 2023.

Figure 28. Beach profiles in Pickering Beach at the south end of the community. Data are from winter 2022 (light blue), summer 2021 (pink), winter 2023 (blue solid), and summer 2022 (red solid).

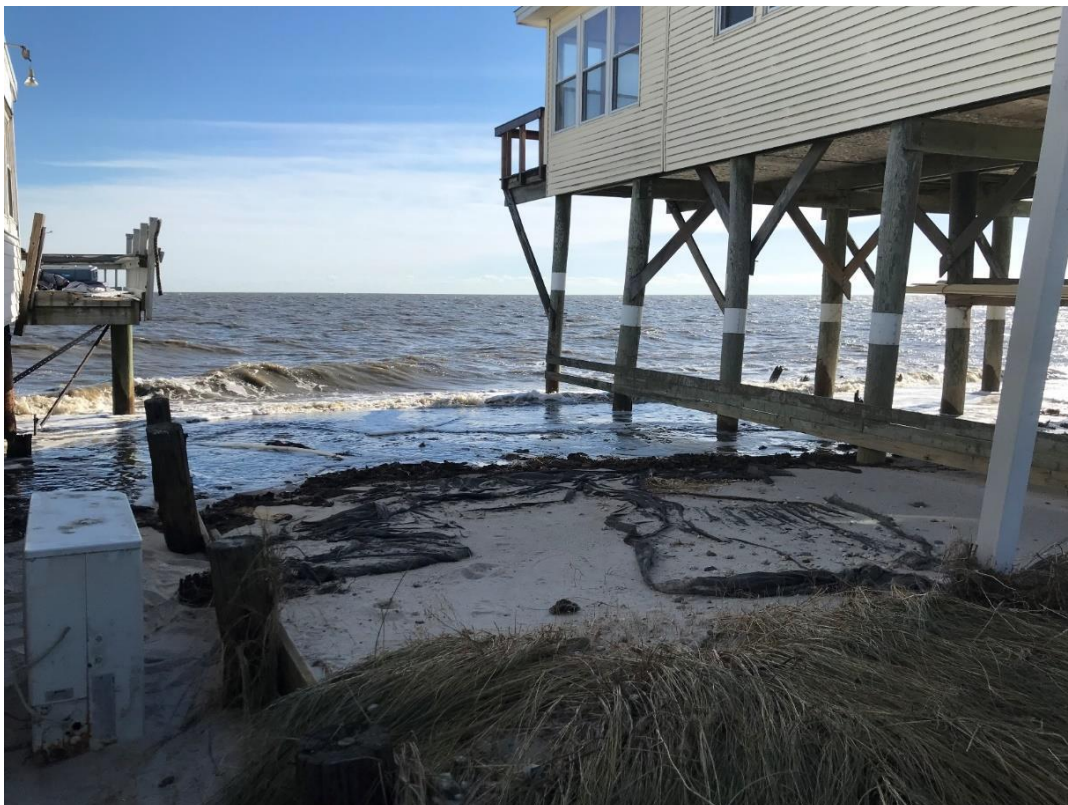
During the first nor'easter in October of 2021, there was minor impacts (erosion/scarping) in Pickering Beach. The storm in later in that October caused the dune to erode entirely. During the November storm, the high tide was underneath the homes at the southern end of Pickering Beach causing scour along posts.

Figure 38 High tide reaching the pilings of homes in Pickering Beach

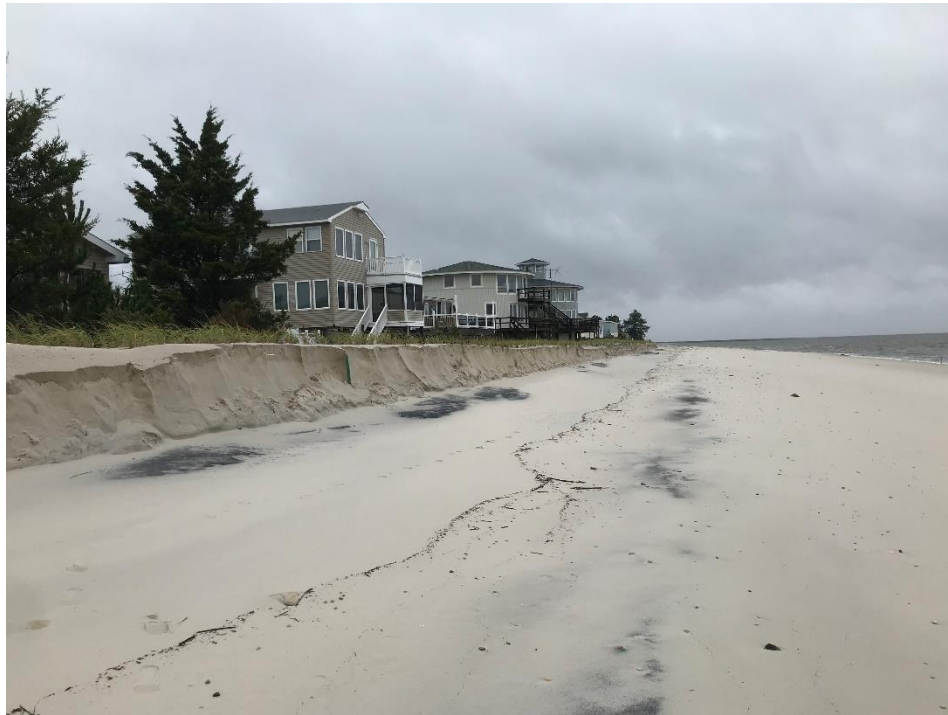
Following these Fall storms, the Section repaired the dune and upper beach at Pickering Beach. In subsequent months, storms caused erosion of that repair. The repaired dune remained intact though it was severely scarped.

Figure 38 Pickering Beach conditions in October of 2022 which depicts the erosion of the beach fill project completed in April of 2022.

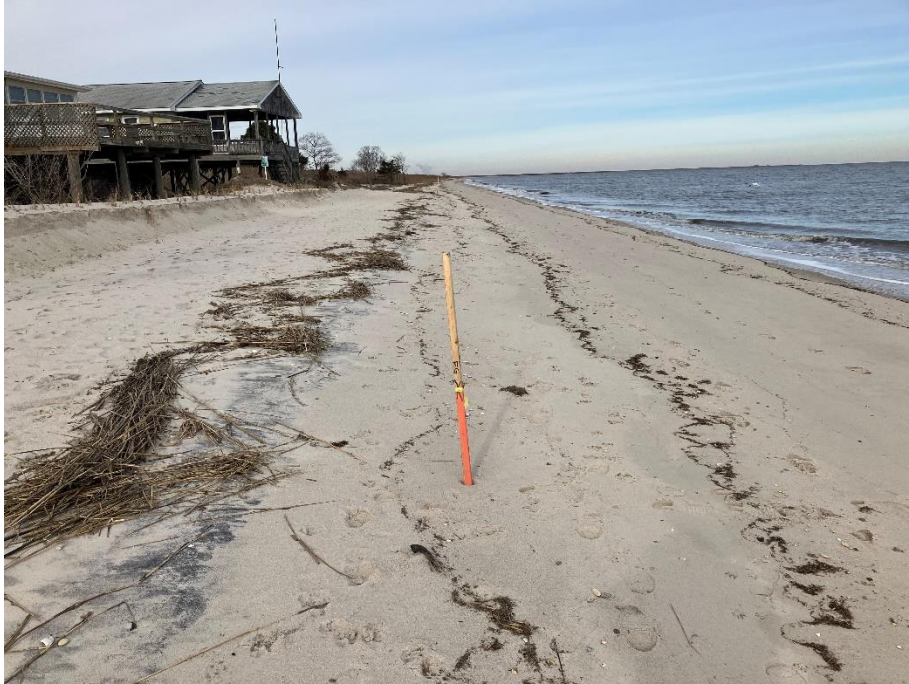
The Section also completed a smaller beach fill job in November of 2022. Immediately following the projects completion, a storm caused substantial erosion. The stake used to guide the construction of the November beach fill job is depicted in FIGURE. The painted portion of the stake is what was to be filled during the nourishment project. The exposed paint demonstrates the erosion in addition to any deficiencies during the construction of the project.

Figure 38 Conditions at Pickering Beach following a December 2022 storm that partially eroded the smaller beach fill job completed in November of 2022.
