Delaware Annual Beach Change Report:

Bay Coast

Delaware Department of Natural
Resources and Environmental Control

2023-2024 Seasons

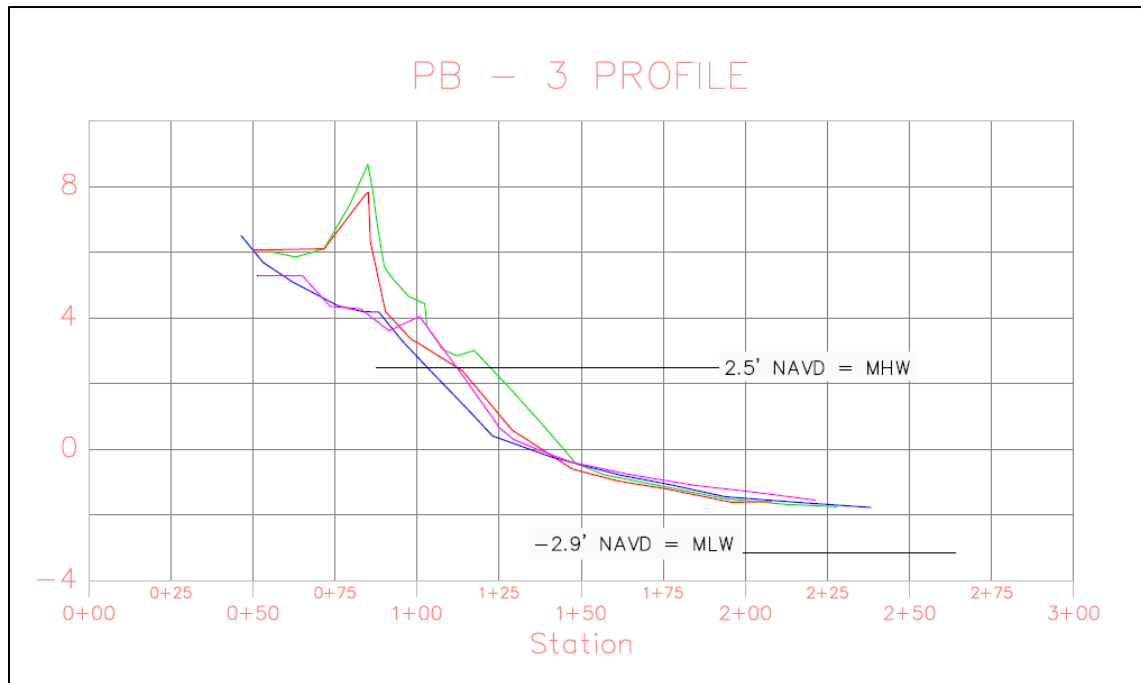
Figure 6B. Beach Profiles at Pickering Beach, Station PB-3.
Pink: Summer 2022, Green: Winter 2023, Red: Summer 2023, Blue: Winter 2024.

Figure 6B demonstrates the large increase in volume at LRP line PB-3 after beach nourishment in Winter 2023. While the dune remains established in the Summer 2023 profile, some erosion is observed. By Winter 2024, however, LRP line PB-3 lost a significant volume of material and returned to a pre-nourished profile. Erosion at PB-2 and PB-3 between Summer 2023 to Winter 2024 was likely due to the impacts of TS Ophelia that occurred during September 2023, as described above.

The average beach volumes determined for Pickering Beach are shown in Table 3. Sand was added in November 2022 to repair erosion at the southern end of the community; therefore, at LRP line PB-3 a large gain in volume was measured from Summer 2022 to Winter 2023. Immediately following the nourishment project, however, a storm caused substantial erosion in November 2022 and the beach did not fully recover in Summer 2023 as expected. The loss of volume between Winter 2023 and Summer 2023 suggests the southern part of Pickering Beach continues to erode each season.

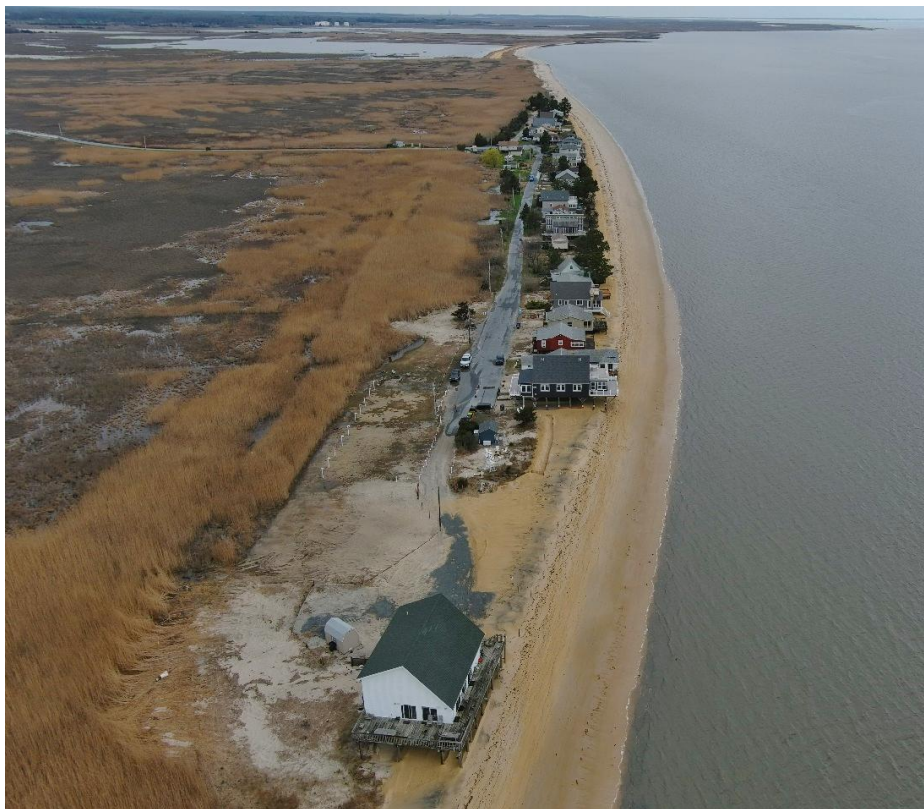
Figure 6C. Aerial view of Pickering Beach (04/04/2024 at 11:23) approaching low tide, looking north.

An aerial view of the Pickering Beach shoreline is shown in Figure 6C. The photo was taken one month following completion of an emergency beach fill job.

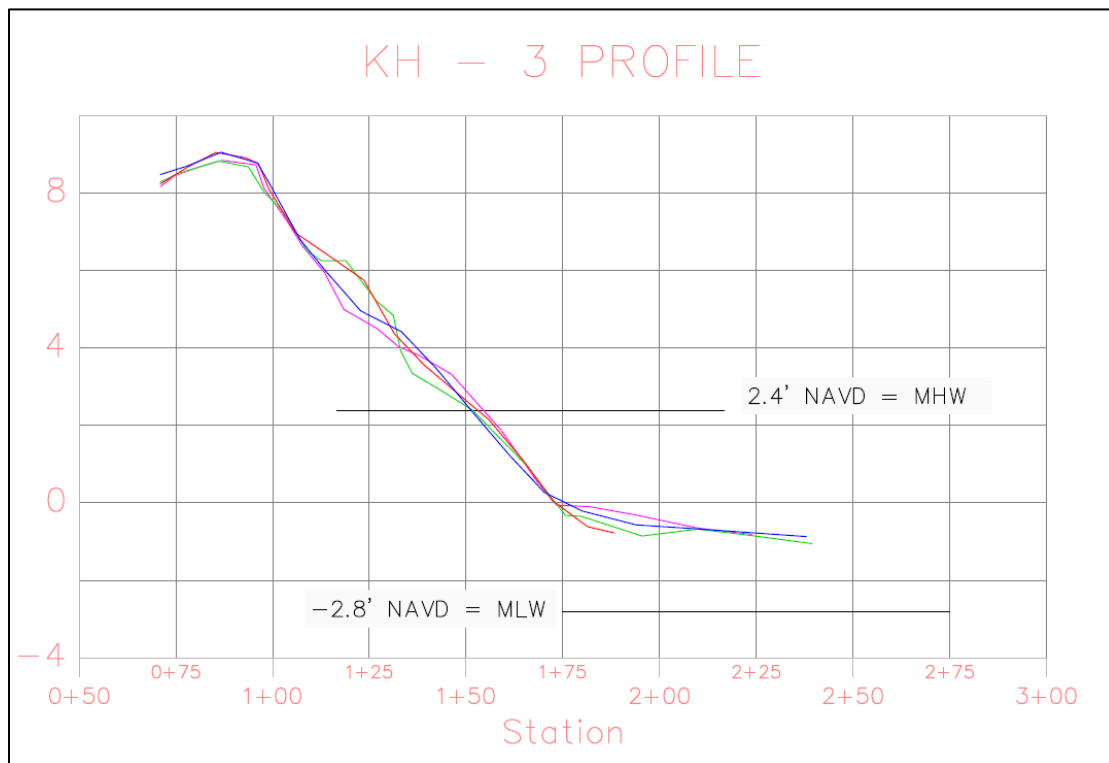
Figure 7B. Beach Profiles at Kitts Hummock, Station KH-3.

Pink: Summer 2022, Green: Winter 2023, Red: Summer 2023, Blue: Winter 2024.

The average beach volumes determined for Kitts Hummock are shown in Table 4. A small-scale beach nourishment project added sand in November 2022; however similar to Pickering Beach, a storm immediately followed and three of four LRP lines lost volume between Summer 2022 and Winter 2023. The volume lost over winter was fully recovered by Summer 2023 in all Kitts Hummock beach profiles. In Figure 7B, the Winter 2023 and Summer 2023 profiles at KH-3 show a small mound of sand near station 1+25; however by Winter 2024, that sand had eroded from the upper dune face and KH-3 returned to a pre-nourished profile. The northernmost LRP line (KH-1) accreted between Summer 2023 and Winter 2024, while all profiles to the south (KH-2, KH-3, KH-4) eroded. Erosion is likely due to the impacts of TS Ophelia during Fall 2023, as described above.

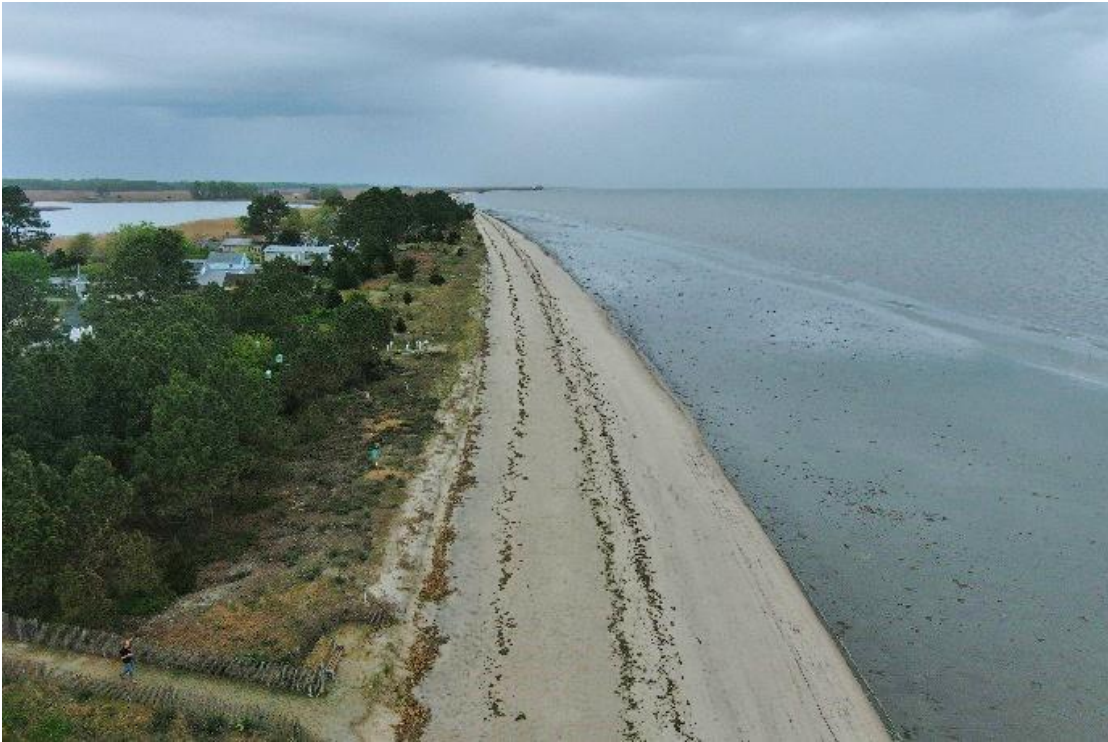
Figure 7C. Aerial view of Central Kitts Hummock Beach (4/17/2024, 12:52) during low tide, looking north

Figure 7C shows an aerial view of the center section of Kitts Hummock during low tide. The Kitts Hummock Beach Road crossover can be seen in the foreground, which is nearest to LRP line KH-3.

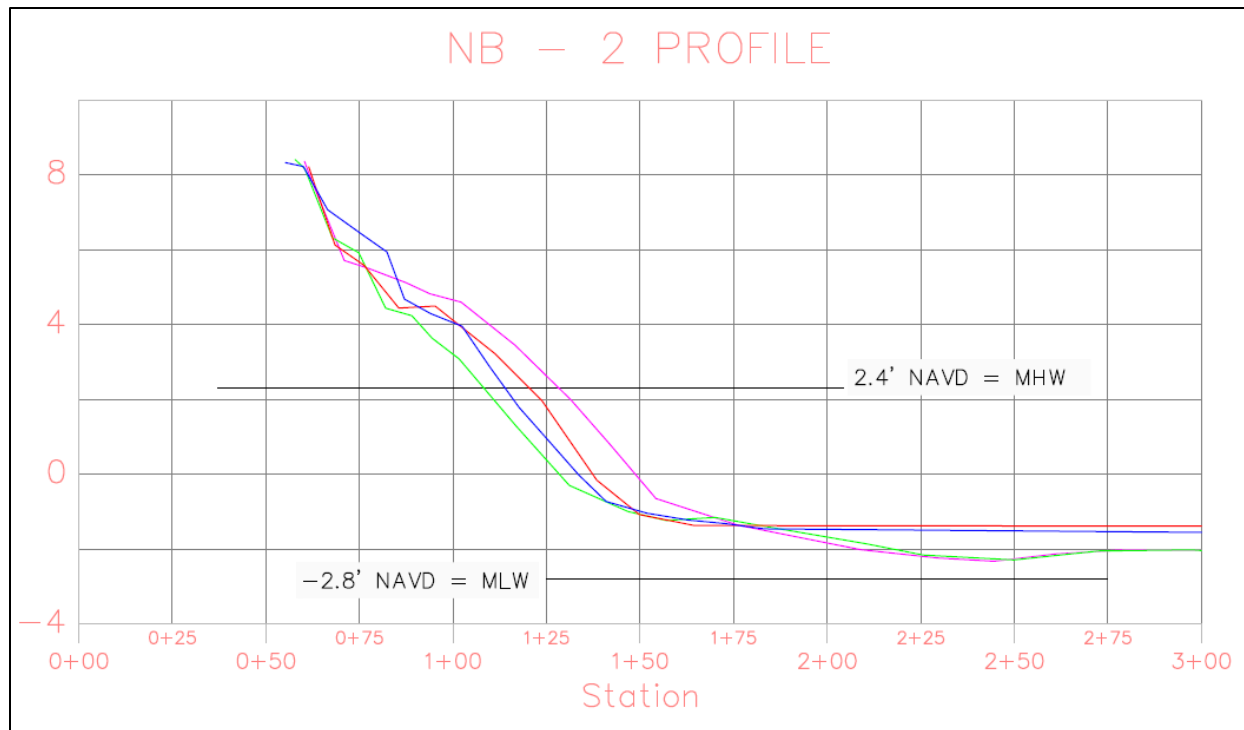
Figure 8B. Beach Profiles at North Bowers Beach, Station NB-2.

Pink: Summer 2022, Green: Winter 2023, Red: Summer 2023, Blue: Winter 2024.

The average beach volumes determined for North Bowers Beach are shown in Table 5. Beach profiles are variable along the coast. The northernmost profile (NB-1) demonstrates the expected seasonal change with losses occurring during fall and early winter seasons and recovery during summer months. Alternatively, significant erosion was observed at NB-2 between Summer 2022 and Winter 2023. While some of this volume was recovered during Summer 2023, a substantial loss was measured between the 2022 and 2023 summer seasons. The profiles in Figure 8B demonstrate the erosion at NB-2, which is likely influenced by the northern jetty. Erosion was also measured at NB-3 from Winter 2023 through Winter 2024.

Significant accretion was observed near the southern jetty (NB-4) between Summer 2022 and Winter 2023, followed by volume losses during Summer 2022 and Winter 2023. Given the location, it is likely the southern jetty trapped sand that may have later washed out during subsequent seasons, and especially during storm events.

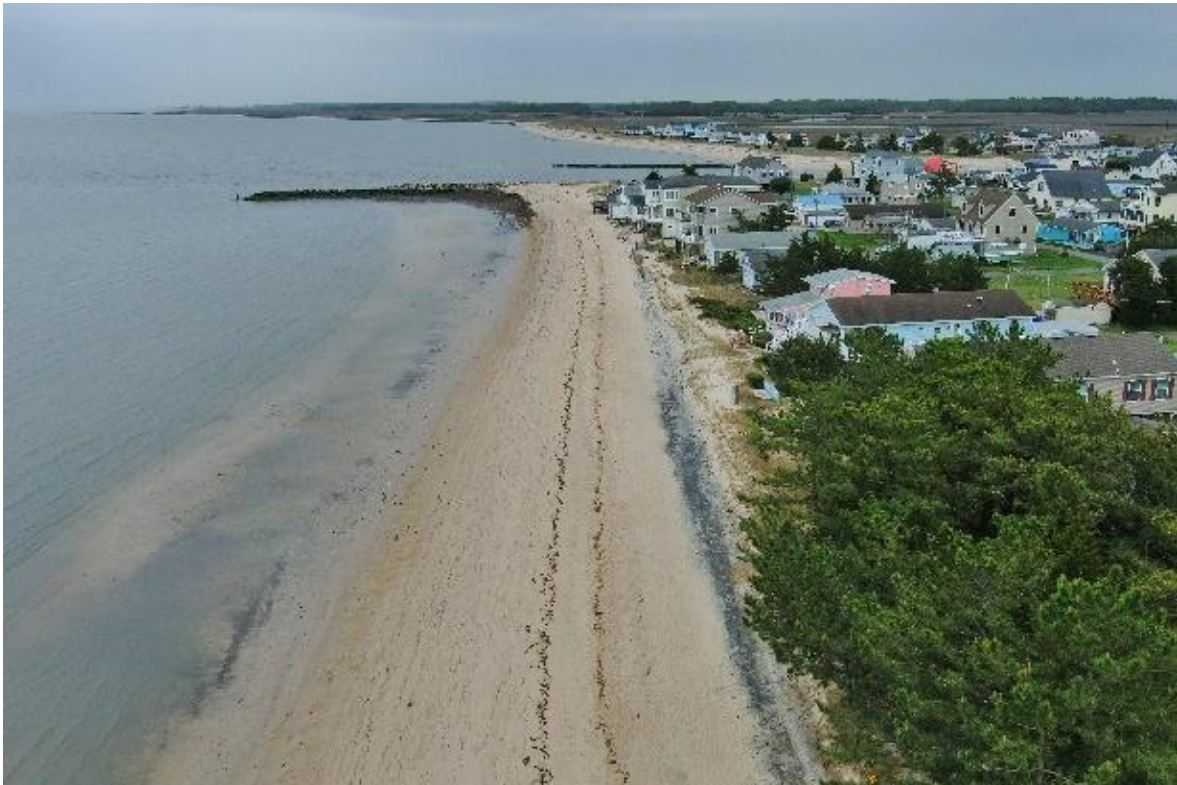
Figure 8C. Aerial view of North Bowers Beach (4/17/2024, 12:06) approaching low tide, looking south

Figure 8C shows an aerial view of North Bowers Beach. The southern jetty and Murderkill Inlet can be seen in the background, which is nearest to LRP line NB-4.

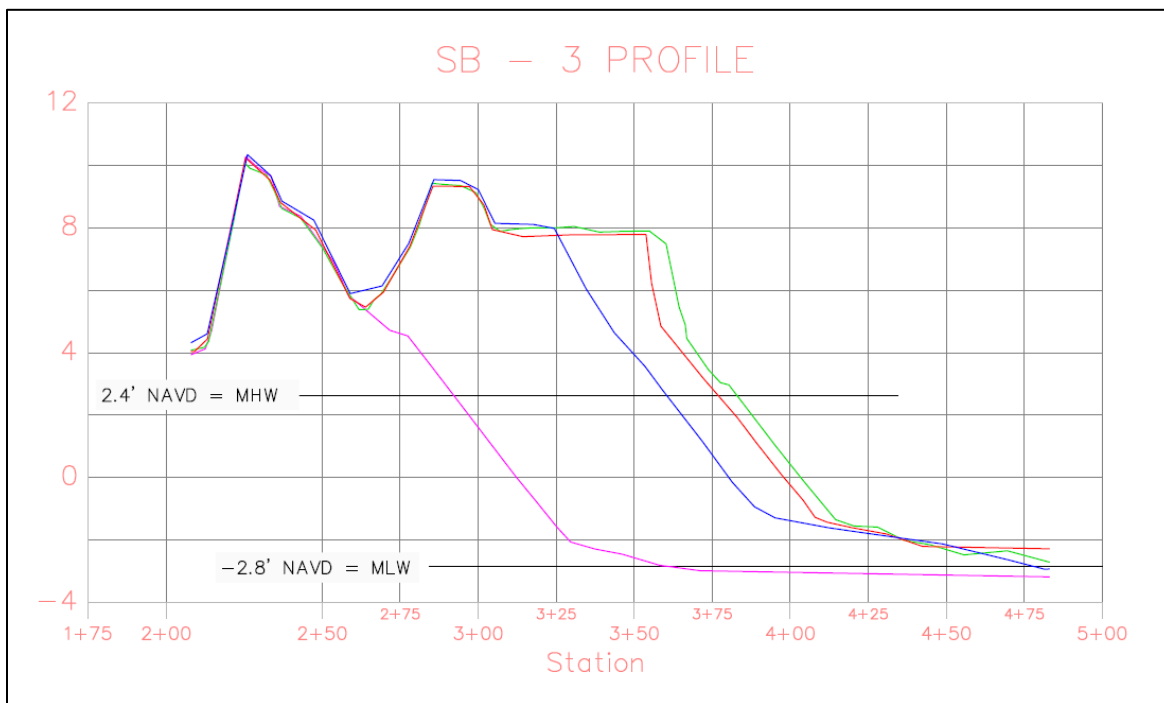
Figure 9B. Beach Profiles at South Bowers Beach, Station SB-3.

Pink: Summer 2022, Green: Winter 2023, Red: Summer 2023, Blue: Winter 2024.

The average beach volumes determined for South Bowers Beach are shown in Table 6. A dredging and beach nourishment project in August 2022 delivered over 52,000 cubic yards of material from the Murderkill River to a quarter-mile section of South Bowers Beach. This nourishment project is reflected by the significant volume gain measured in the SB-3 profiles between Summer 2022 and Winter 2023. Figure 9B also demonstrates beach nourishment at SB-3; however subsequent surveys showed volumes decrease continuously from Winter 2023 through Winter 2024. Erosion at this site measured 22.5 feet between the winter seasons. The significant change between Summer 2023 and Winter 2024 profiles is likely due to the impacts of TS Ophelia that occurred in September 2023, as described above.

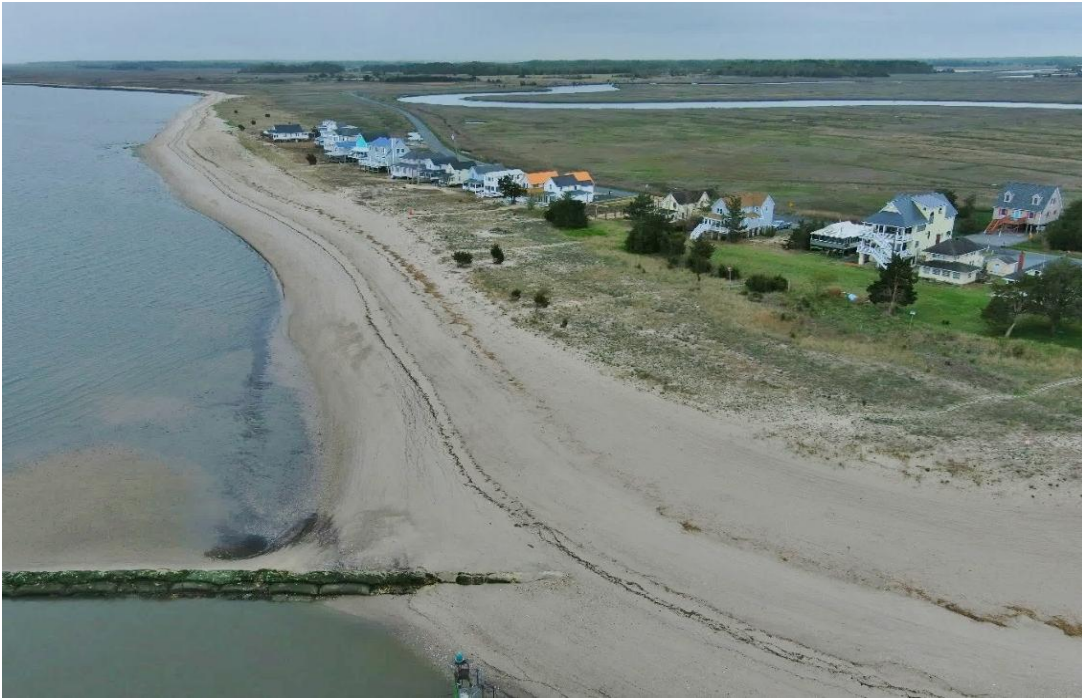
Figure 9C. Aerial view of South Bowers Beach (4/17/2024, 12:15) approaching low tide, looking south

Figure 9C shows an aerial view of South Bowers Beach. The Murderkill jetty, nearest LRP line SB-1, can be seen in the foreground.

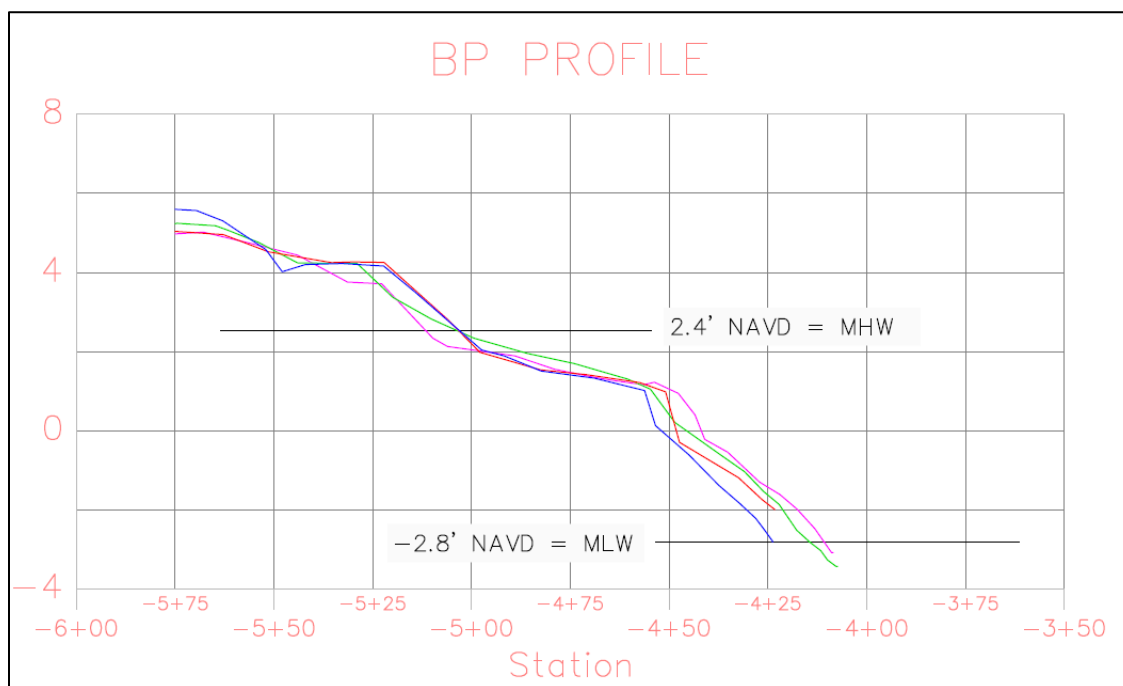
Figure 10B. Beach Profiles at Bennett's Pier Beach.

Pink: Summer 2022, Green: Winter 2023, Red: Summer 2023, Blue: Winter 2024.

The average beach volumes determined for Bennett's Pier are shown in Table 7. This beach showed accretion in Winter 2023, followed by erosion in subsequent Summer 2023 and Winter 2024 seasons. The profiles in Figure 10B show continuous erosion within the intertidal zone each season. In addition, dune scarping appears greater above MHW in Summer 2023 and Winter 2024 profiles.

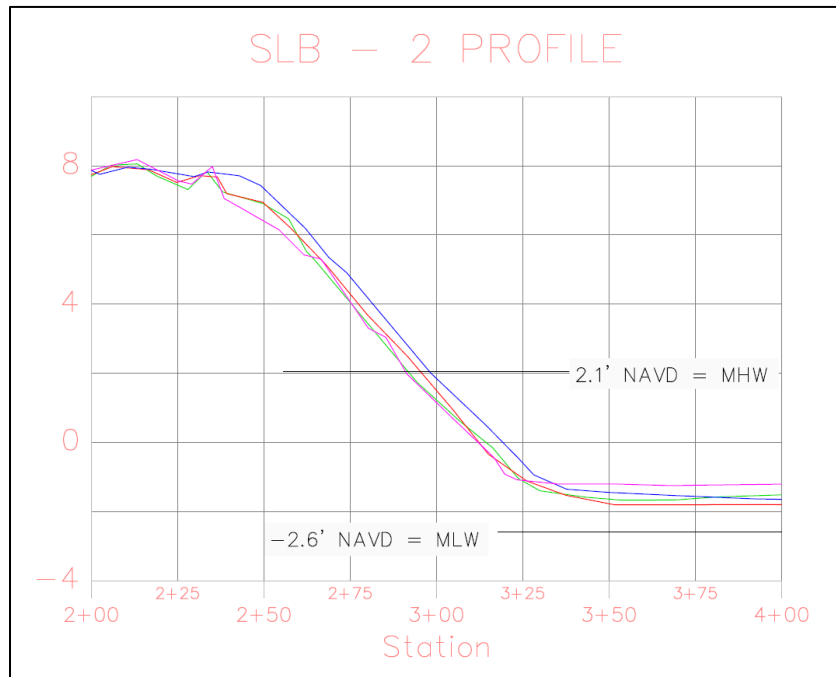
Figure 12B. Beach Profiles at Slaughter Beach, Station SLB-2.

Pink: Summer 2022, Green: Winter 2023, Red: Summer 2023, Blue: Winter 2024.

Farther north in the Slaughter Beach community, SLB-1 and SLB-2 accreted between Summer 2023 and Winter 2024. The profiles in Figure 12B demonstrate continuous accretion at SLB-2 with an overall gain of 7 feet between Summer 2022 and Winter 2024. While the alongshore sediment transport may have contributed to an increase in volume, this area is also influenced by the Mispillion jetty to the north, which traps sand and partially shelters the coastline.

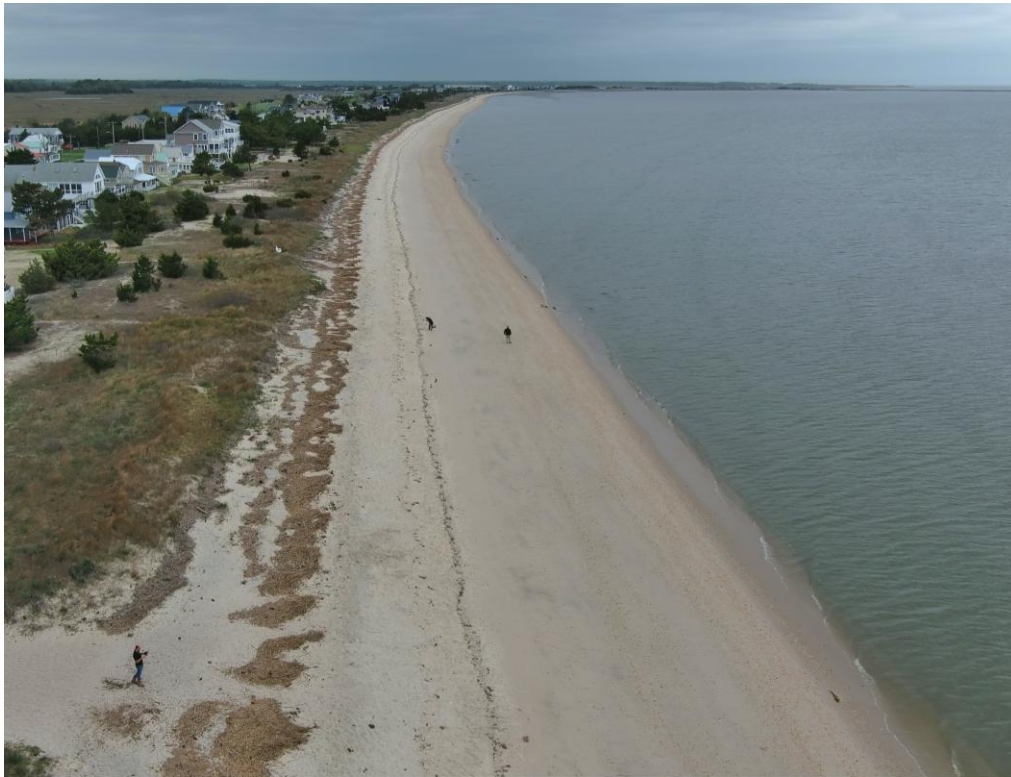
Figure 12C. Slaughter Beach (4/17/2024, 12:10) approaching low tide, looking north

Figure 12C shows an aerial view of Slaughter Beach. The Slaughter Beach Road crossover can be seen in the foreground.

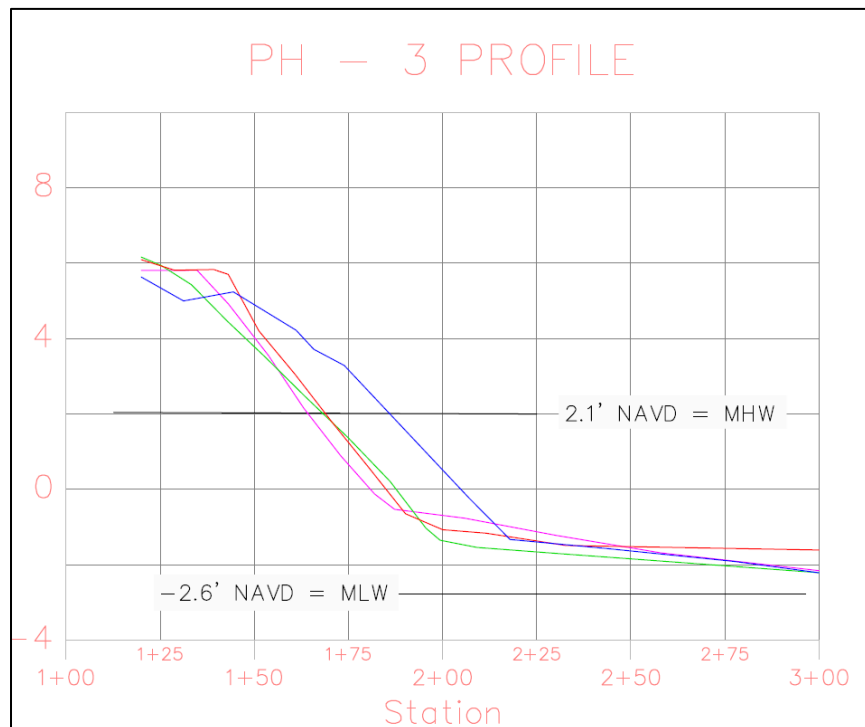
Figure 13B. Beach Profiles at Prime Hook Beach, Station PH-3.

Pink: Summer 2022, Green: Winter 2023, Red: Summer 2023, Blue: Winter 2024.

The average beach volumes determined for Prime Hook Beach are shown in Table 10. The northernmost LRP survey line (PH-1) has been accreting overtime with a gain in volume measured from Summer 2022 through Winter 2024. The central (PH-2) and southernmost (PH-3) LRP lines demonstrate the expected seasonal change with volume loss measured between Summer 2022 and Winter 2023, and volume gain between Winter 2023 and Summer 2023. In addition, survey data indicate these areas accreted between Summer 2023 and Winter 2024; however, the reason is unknown. In Figure 13B, the Winter 2024 profile clearly demonstrates accretion within the intertidal zone at PH-3.

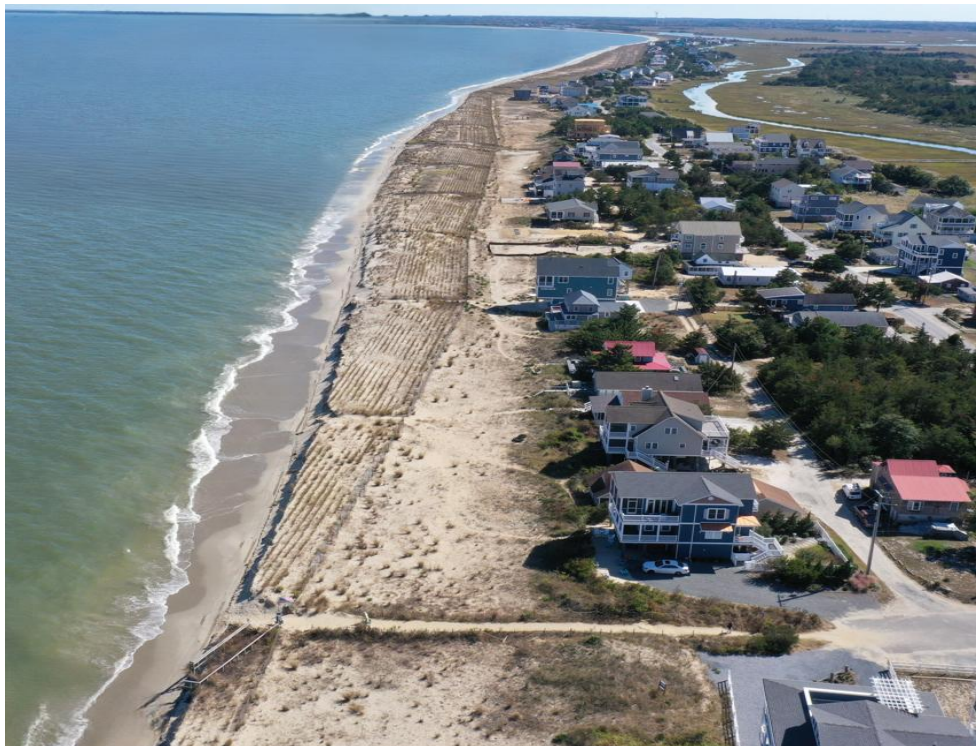
Figure 14C. Broadkill Beach (10/9/2024, 8:56) approaching high tide, looking south

Figure 14C shows an aerial view of Broadkill Beach. The Route 16 crossover and severe scarping are visible in the foreground.

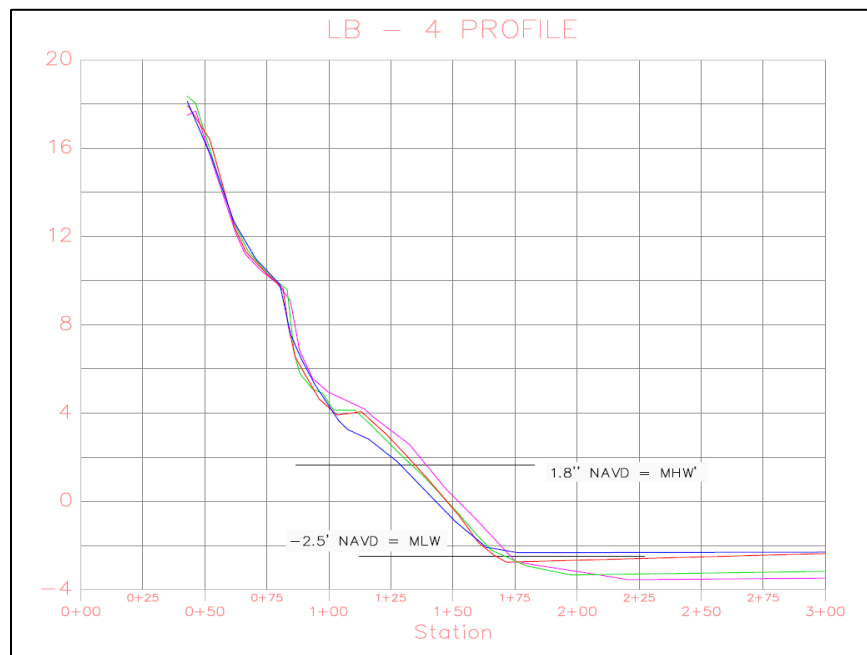
Figure 15B. Beach Profiles at Lewes Beach, Station LB-4.

Pink: Summer 2022, Green: Winter 2023, Red: Summer 2023, Blue: Winter 2024.

The average beach volumes determined for Lewes Beach are shown in Table 12. The USACE completed a dredging and beach nourishment project in December 2023 that delivered 104,000 cubic yards of material from an offshore borrow source to the shoreline proximal to the Roosevelt Inlet (LB-1 and LB-2). Survey data is not available for Winter 2024, however, and this volume gain is not reflected in Table 11. Typically, the western end of Lewes Beach suffers the most damage from storms and tends to be erosional. This is evident by the significant loss of volume between the 2022 and 2023 summer seasons.

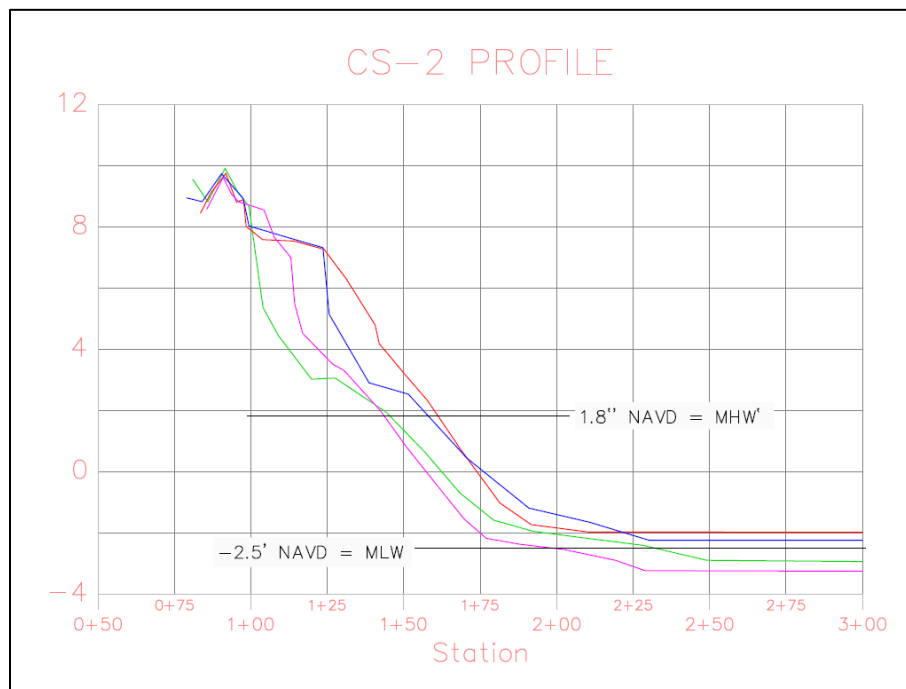
Figure 16B. Beach Profiles at Cape Shores, Station CS-2.

Pink: Summer 2022, Green: Winter 2023, Red: Summer 2023, Blue: Winter 2024.

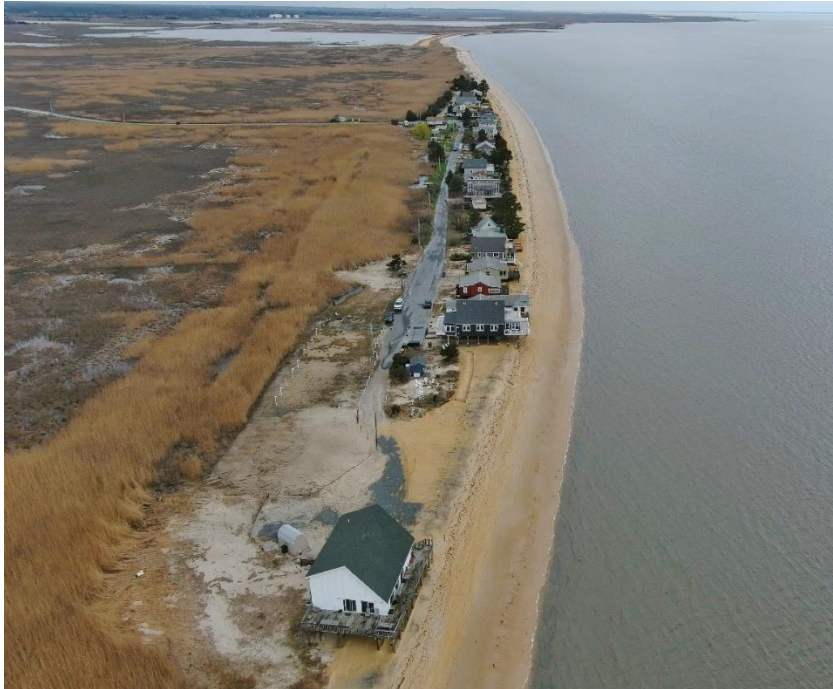
Approaching low tide looking north. Photo taken a couple weeks after an emergency beach fill project.
