Delaware Annual Beach Change Report: **Ocean Coast**

**Delaware Department of Natural
Resources and Environmental Control**

2023-2024 Seasons

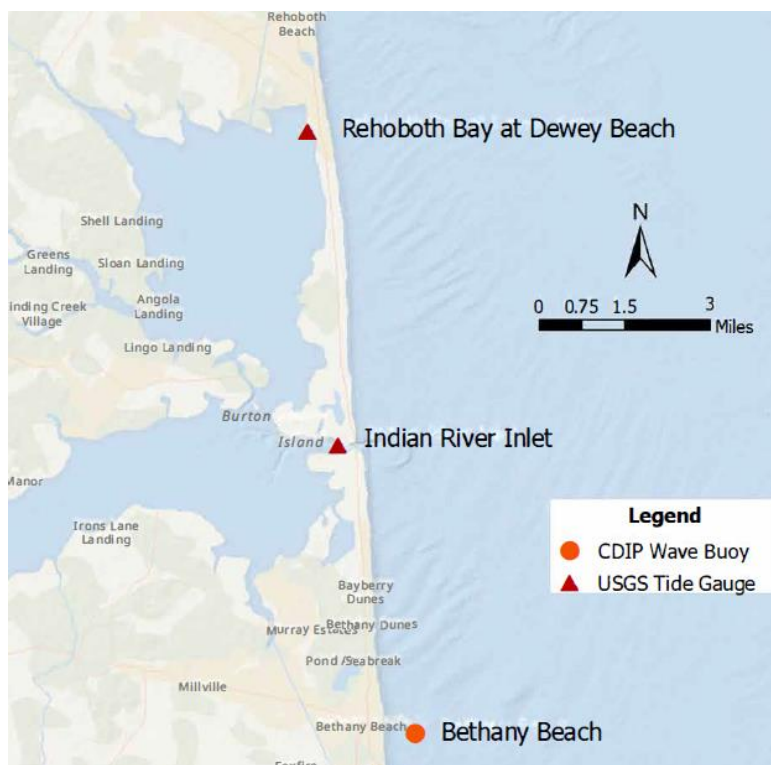
Figure 2: Water level and wave monitoring stations

Coastal erosion along the Delaware shoreline is most damaging during storms when high waves and strong currents combine to suspend and move sand off beaches. Storm surge, especially during high tide, has a greater potential to cause flooding and damage to nearshore structures. Therefore, real-time wave measurements can be used to understand storm intensity and Coastal Flood Events. The U.S. Army Corps of Engineers sponsors the Coastal Data Information Program (CDIP), operated by the Scripps Institution of Oceanography, which developed and maintains a network of buoys, or data collection systems, to monitor waves and beaches along the coastlines of the United States [10]. There is one CDIP buoy (Station-263) along the Delaware coastline that is located 0.5 miles east of Bethany Beach (Figure 2).

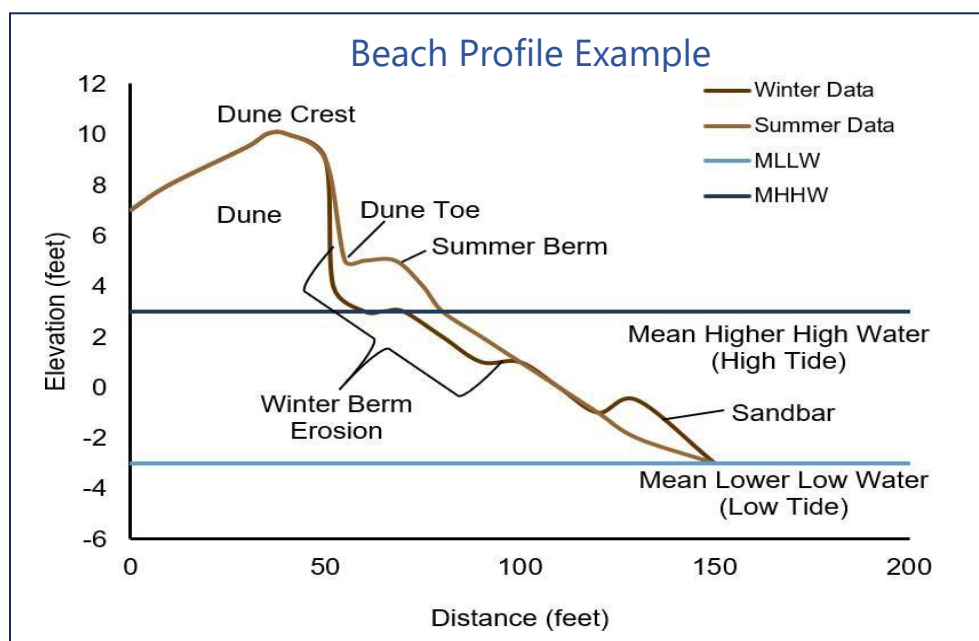
Figure 3: Schematic of a typical beach profile during summer vs winter seasons

Storm-driven erosion and overwash [11] control seasonal-to-annual-scale beach change along Delaware's ocean coast. While storm events are episodic, increases in frequency and intensity promote the likelihood of coastal erosion [12]. Nor'easters typically cause the most annual erosion on Delaware beaches. Hurricanes and tropical storms are less frequent and more transient, but would cause major shoreline change and coastal erosion. Typically, during fall and winter months energetic waves and storm surge cause volume loss, resulting in beach profiles with upper beach face erosion and dune scarping. During spring and summer months, calmer waves and less frequent/intense storms commonly result in beach accretion. Figure 3 demonstrates a schematic of the typical beach profiles during summer versus winter months. It is possible that some beaches may not fully recover the volume lost between seasons [13]. Insufficient seasonal recovery is common on beaches along the Atlantic coast and in the world, leading to a long-term erosion. [14].

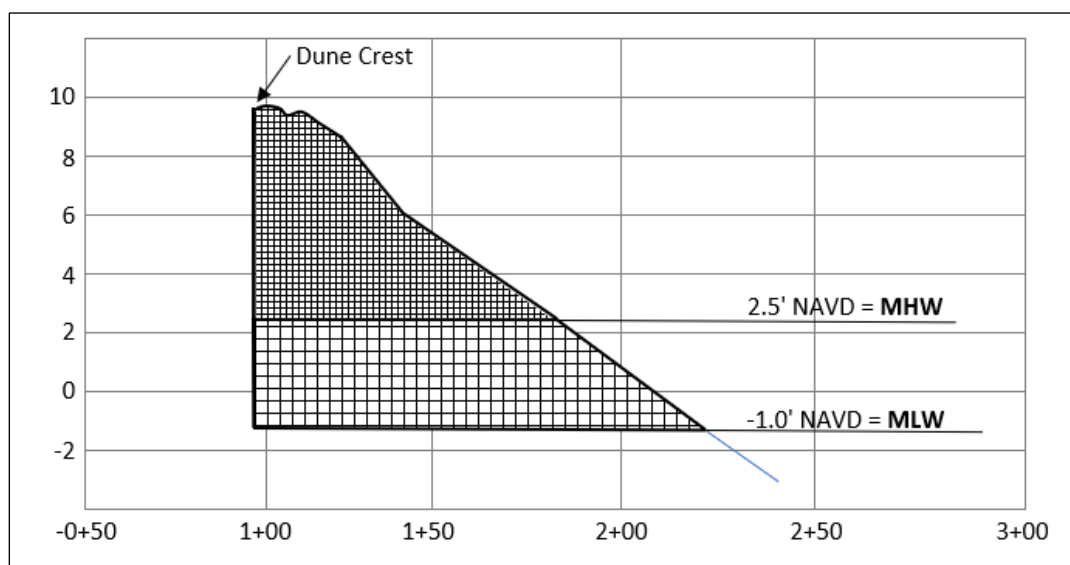
Figure 4: Beach profile sketch showing volume calculations and MHW/MLW contours

Beach change is determined by calculating the measured volume difference between seasons for each transect or LRP line. Beach volume is measured along a 1-dimension transect and reported in cubic feet per linear foot of beach length (cf/lf). Two beach volumes are reported for each LRP line based on the mean high water (MHW) and mean low water (MLW) contours as demonstrated in Figure 4. The MHW volume represents the material between the crest of the dune and the intersection of the MHW contour. The MLW volume includes the material between the MHW and MLW contours, in addition to the MHW volume.

The upper extent of the beach, above the MHW contour, is only reached during storm tides and/or when powerful wave action is occurring. Therefore, the MHW volume is an indicator of beach resiliency to flooding, overwash, and hazardous wave action. The MLW volume and the comparison of the MHW and MLW volumes are better indicators of seasonal beach change. During the stormy season when the upper beach erodes, sand washes down to the intertidal zone or just offshore. Some of the eroded material that ends up in the intertidal zone may be captured in the MLW data. By comparing the MHW and MLW volumes, seasonal erosion and accretion trends can be identified.

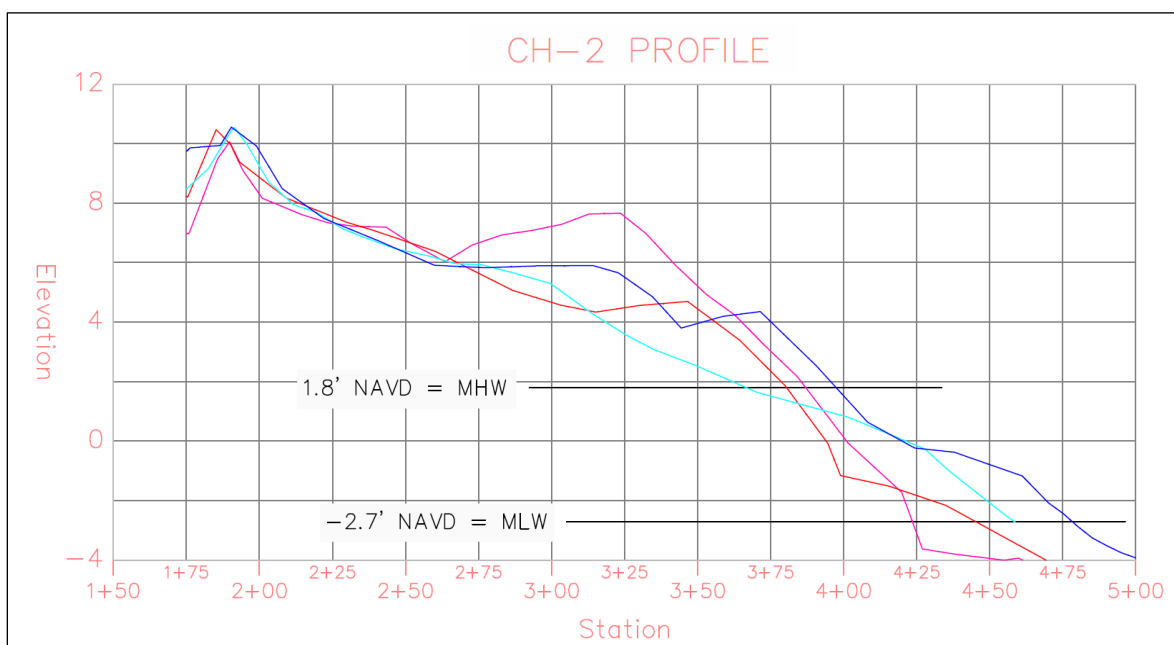
Figure 5B. Beach Profiles at Cape Henlopen, LRP CH-2.

Pink: Summer 2022, Cyan: Winter 2023, Red: Summer 2023, Blue: Winter 2024

The average beach volumes determined for Cape Henlopen are shown in Table 5. Significant erosion was observed along Cape Henlopen Beach between the Summer 2022 and 2023 seasons. While volume loss was expected during the Fall/Winter 2023 stormy season, little to no recovery occurred during summer due to Tropical Storm Ophelia. The Delaware coastline was impacted by TS Ophelia in September 2023, and prior to the 'Summer 2023' survey; therefore, impacts to the coastline are captured in the data.

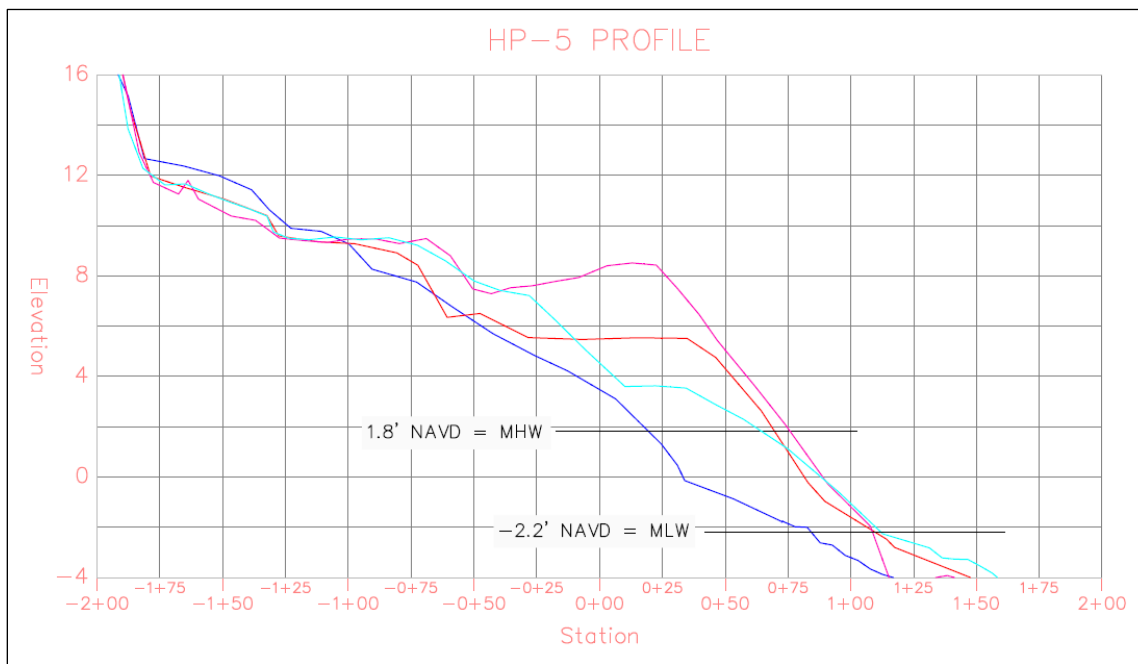
Figure 6B. Beach Profiles at Herring Point, LRP HP-5.

Pink: Summer 2022, Cyan: Winter 2023, Red: Summer 2023, Blue: Winter 2024.

South of the south jetty (HP-4, HP-5) eroded during Winter 2023 and continued to erode during Summer 2023. While LRP line HP-4 is influenced by the south jetty and gained volume during Winter 2024, HP-5 eroded considerably. Figure 6B shows the significant loss of volume from Winter 2023 through Winter 2024 at HP-5. The Summer 2022 and 2023 profiles demonstrate a similar seasonal pattern, but the effects of TS Ophelia impacted the volume loss and shift in profile observed. Figure 6C shows an aerial view of Herring Point looking north at the two large jetties.

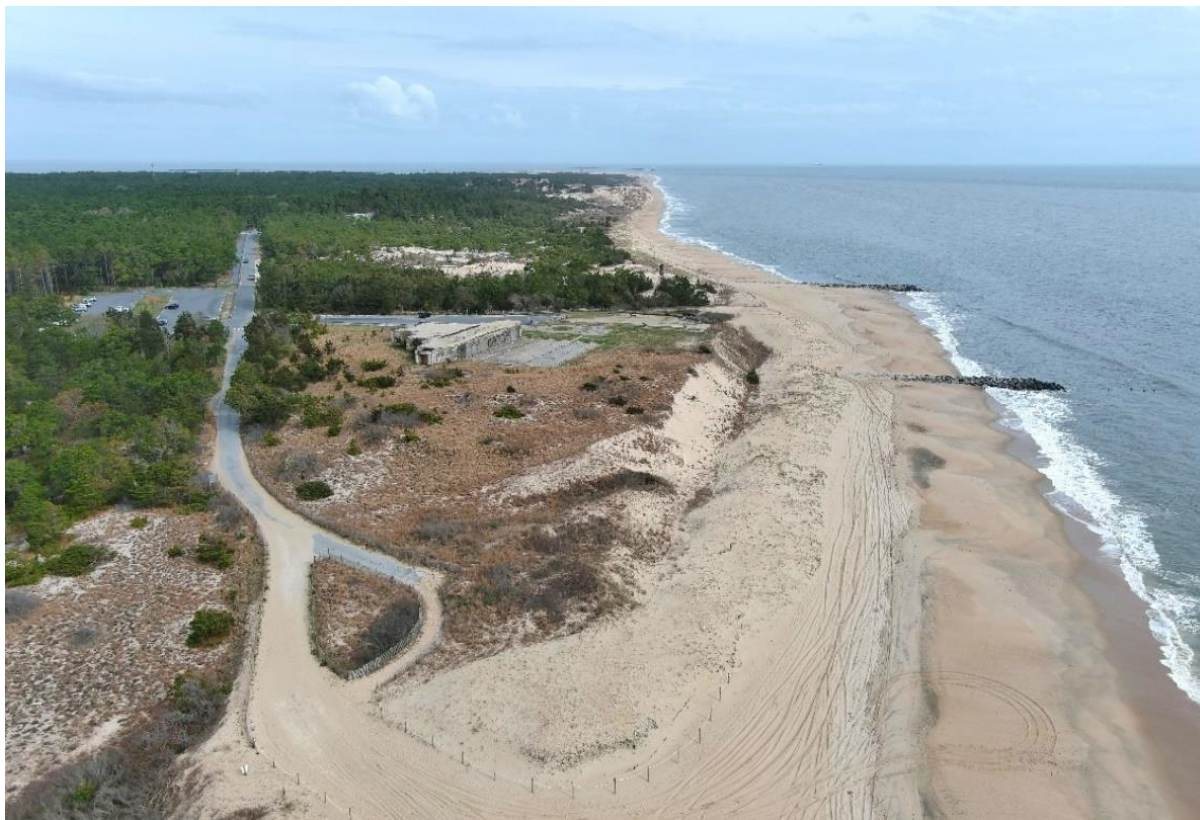
Figure 6C. Herring Point (4/11/2024, 9:40) approaching high tide, looking north.

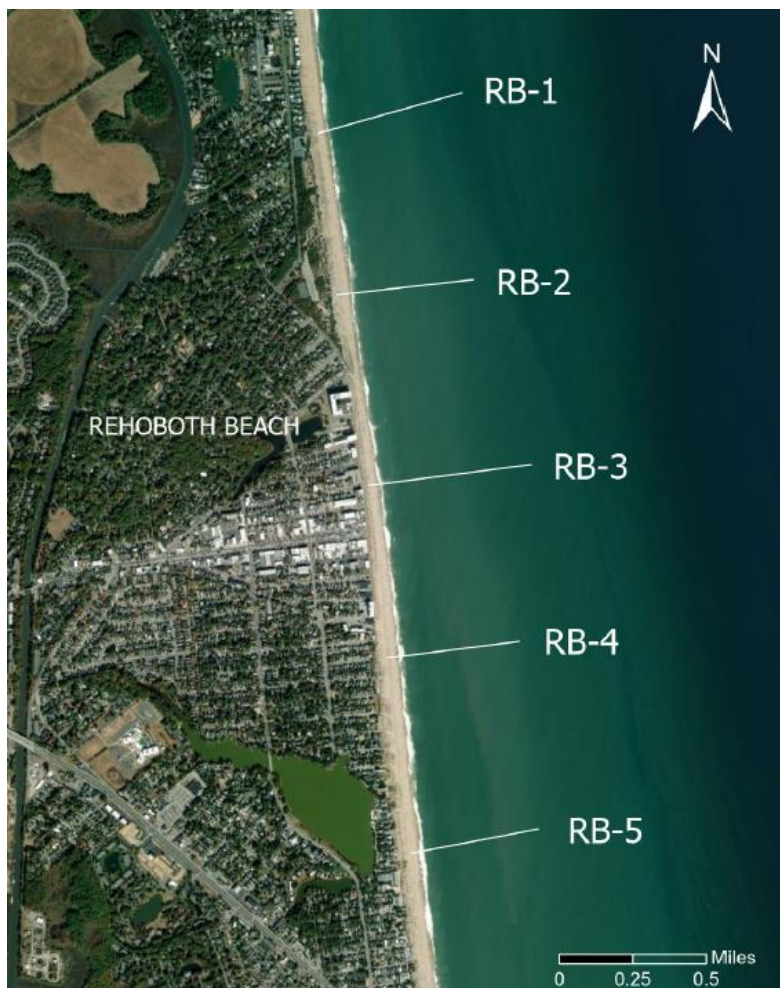
Figure 8A. LRP lines at Rehoboth Beach

Henlopen Acres is a small, incorporated town that lies between North Shores to the north and Rehoboth Beach (RB) to the south. The shoreline is about 1,000 feet in length and contains LRP line RB-1 (Figure 8A). Rehoboth Beach is a densely developed incorporated town that accounts for over 9,200 feet of coastline that includes the state-owned northern end (RB-2), known as Deauville and the unincorporated southern region (RB-5), known as Silver Lake. There are nine constructed jetties and four additional LRP lines within this stretch of shoreline (Figure 8A).

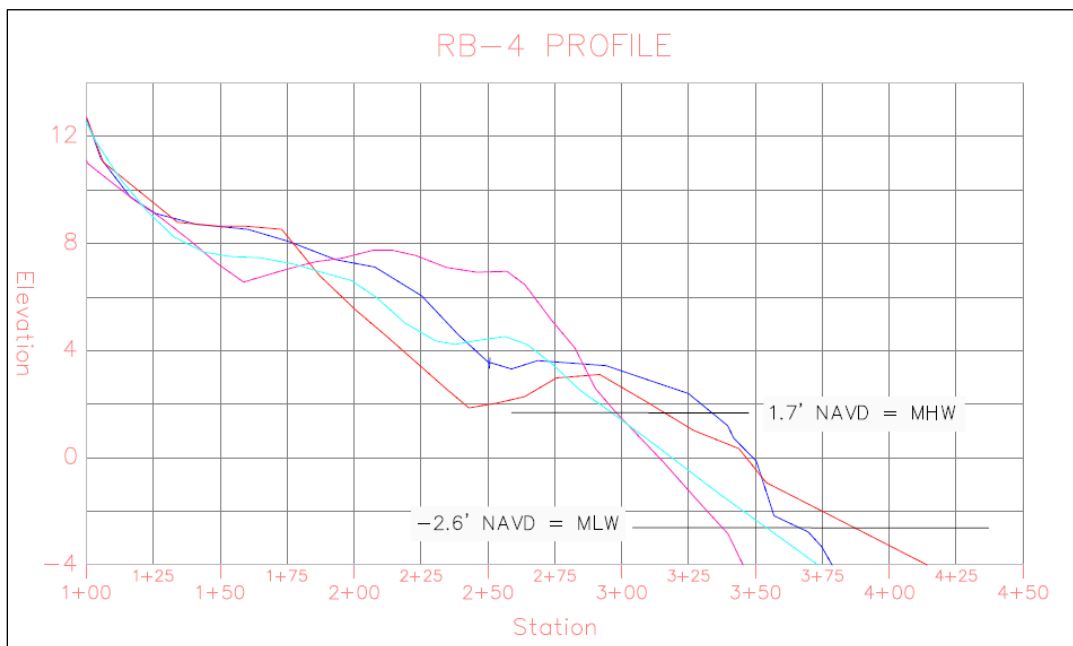
Figure 8B. Beach Profiles at Rehoboth Beach, LRP RB-4
Pink: Summer 2022, Cyan: Winter 2023, Red: Summer 2023, Blue: Winter 2024.

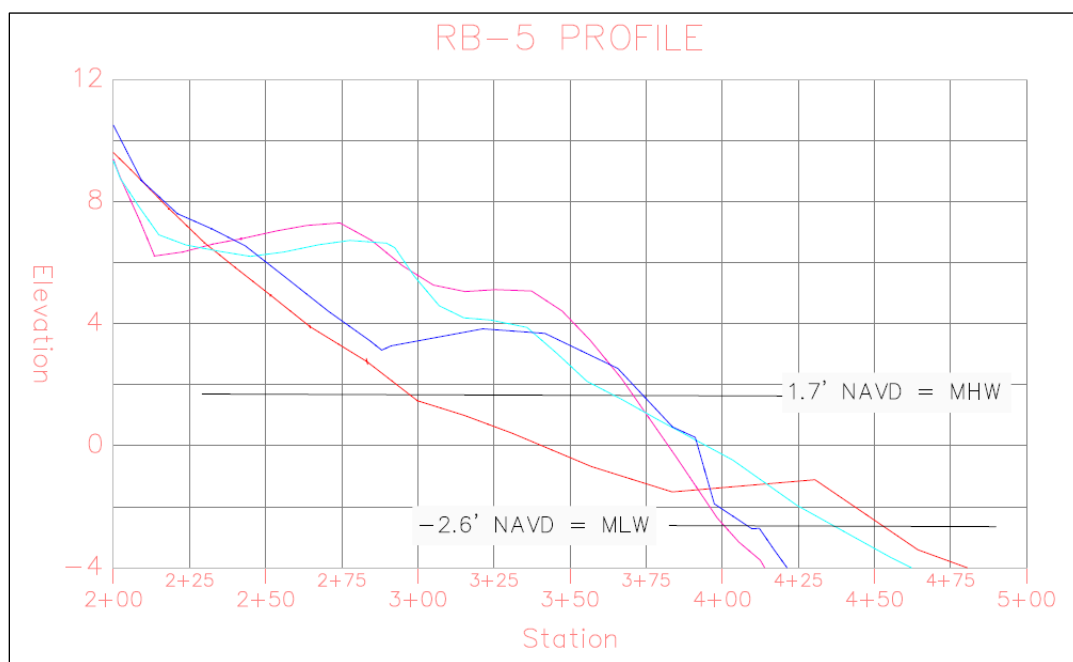
Figure 8C. Beach Profiles at Rehoboth Beach, LRP RB-5.
Pink: Summer 2022, Cyan: Winter 2023, Red: Summer 2023, Blue: Winter 2024.

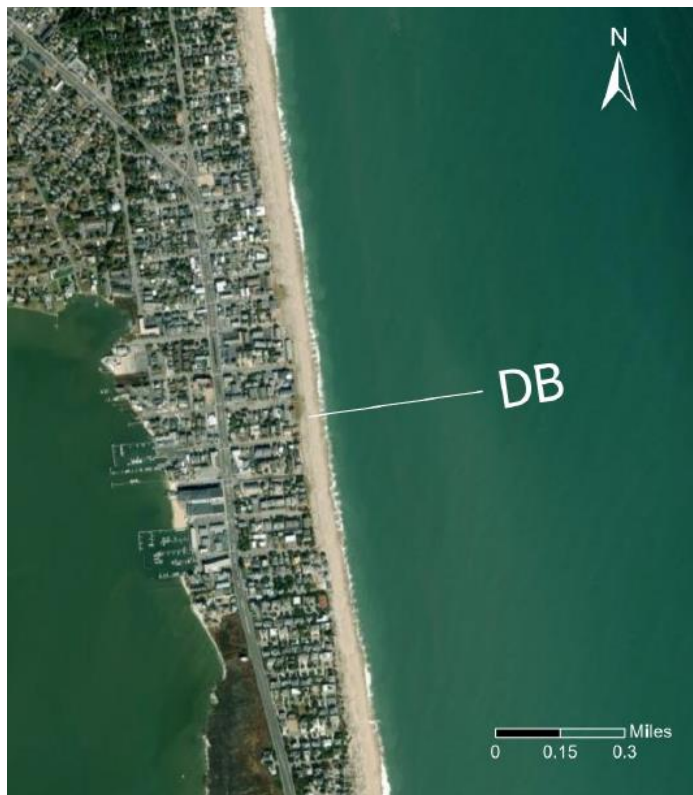
Figure 9A. LRP line at Dewey Beach

Dewey Beach (DB) is located south of the Silver Lake region, which separates Rehoboth and Dewey Beaches. This stretch of coastline is about 7,500 feet in length and contains one LRP line (Figure 9A).

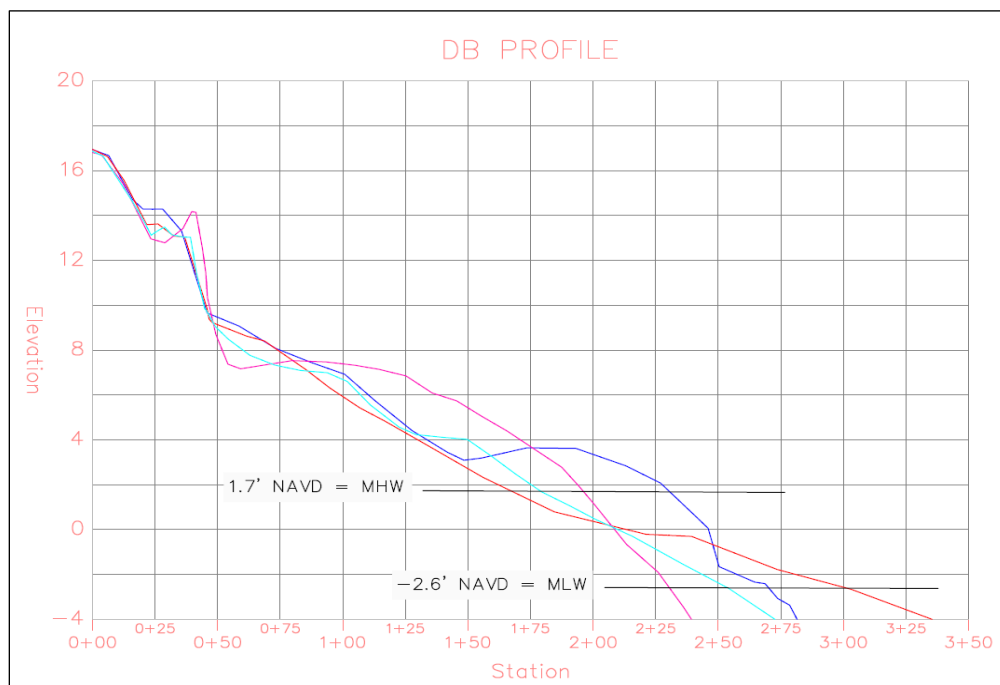
Figure 9B. Beach Profiles at Dewey Beach.

Pink: Summer 2022, Cyan: Winter 2023, Red: Summer 2023, Blue: Winter 2024

The average beach volumes determined for Dewey Beach are shown in Table 9. Similar to Rehoboth, Dewey Beach is part of the federally authorized Delaware Coastal Storm Risk Management Projects described above and was last nourished in May 2023. Net accretion was measured in Summer 2023 as nourishment offset the volume lost due to TS Ophelia. Figure 9B suggests renourished material from the upper dune washed down to the intertidal zone, where accretion is observed. The increased volume measured in Winter 2024 likely represents some fraction of material that had eroded the prior season. An aerial view of Dewey Beach is shown in Figure 9C.

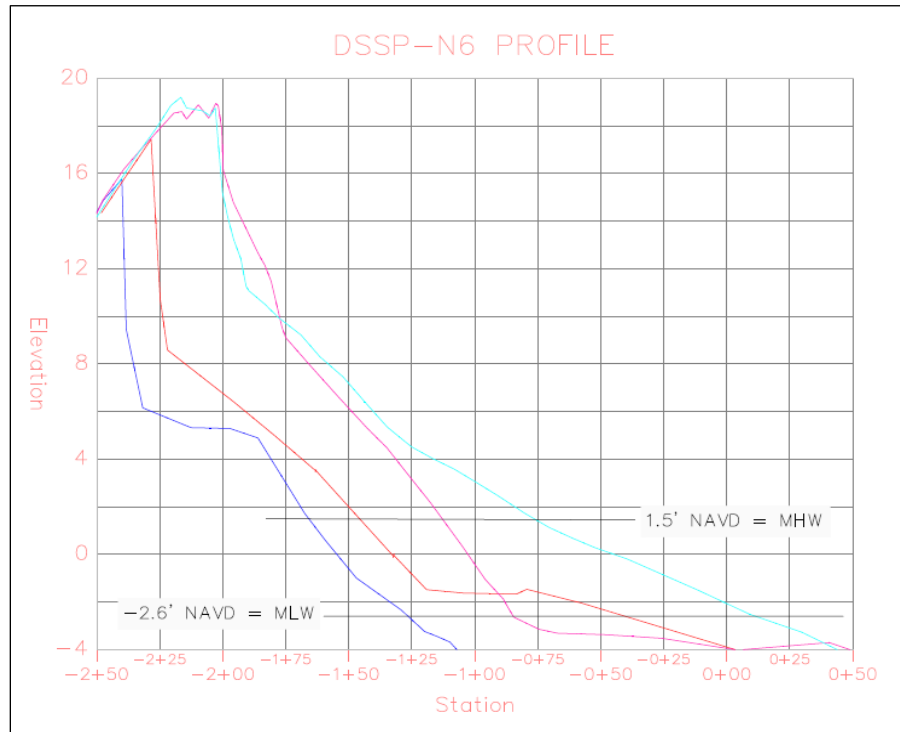
Figure 10D. Beach Profiles at Delaware Seashore State Park – North, LRP DSSP-N6
Pink: Summer 2022, Cyan: Winter 2023, Red: Summer 2023, Blue: Winter 2024.

The seasonal profiles near Indian River Inlet are typically erosional due the presence of the jetties as discussed above. While sand bypassing was the primary method for maintaining the northside beach, the facility became inoperable in 2019 and DNREC has since relied on truck-hauled sand from inland sources for repairs. Due to the erosive October 2022 storms, this shoreline was nourished in Fall 2022, and thus LRP lines DSSP-N6 and DSSP-N7 both gain volume in the Winter 2023 profile. However, Figure 10D suggests some of the nourished material had eroded from the upper dune and washed down to the intertidal zone, where you see most of the accreted volume. Drastic coastal erosion due to TS Ophelia is evident in the Summer 2023 profile as well as the continued volume loss through Winter 2024 (Figure 10D).

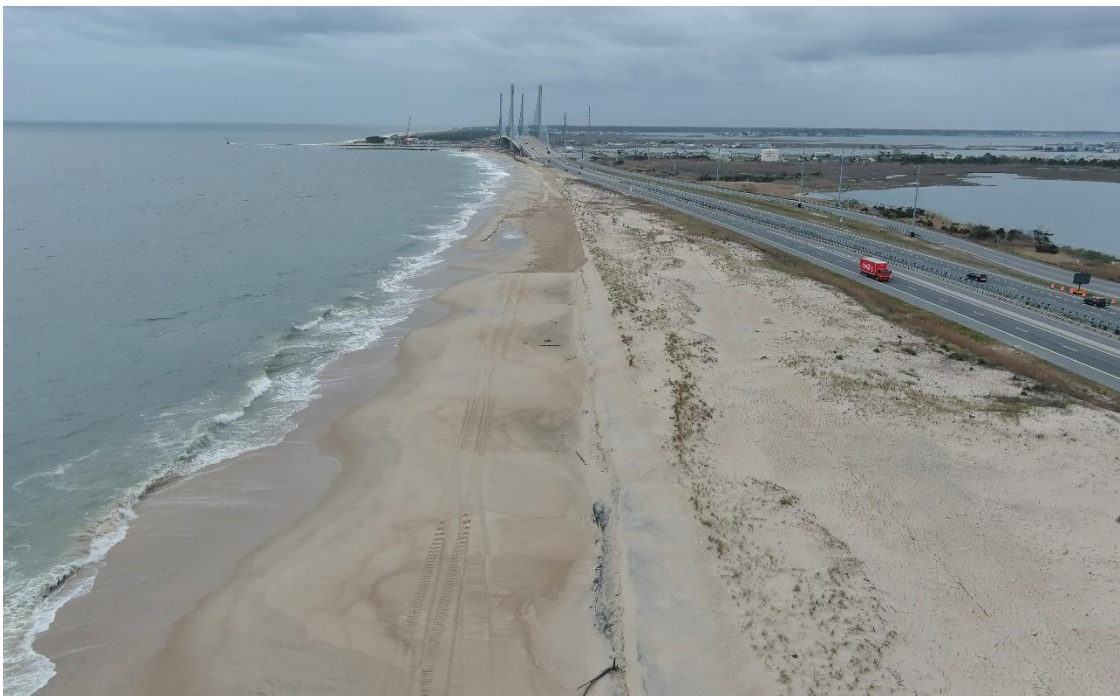
Figure 10E. DE Seashore State Park - North (4/11/2024, 11:07) at high tide, looking south

Figure 10E shows an aerial view of the Delaware Seashore State Park - North coastline looking south toward Indian River Inlet at high tide.

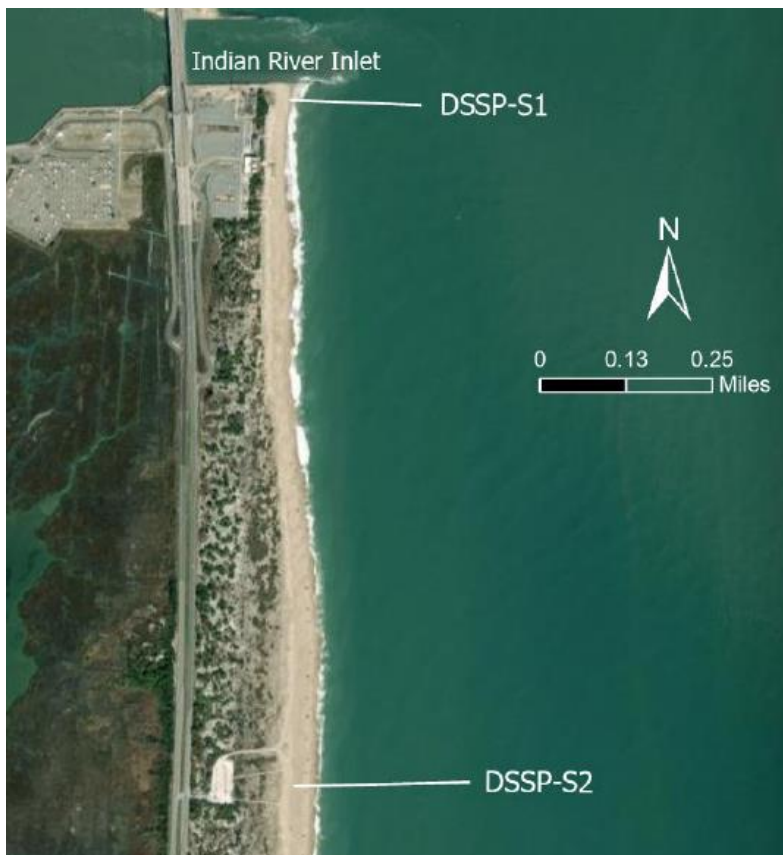
Figure 11A. LRP lines at Delaware Seashore State Park - South

Delaware Seashore State Park – South of Indian River Inlet (DSSP-S) is approximately one-mile long with two LRP lines located at the south inlet day-use area and 3'R Beach (Figure 11A).

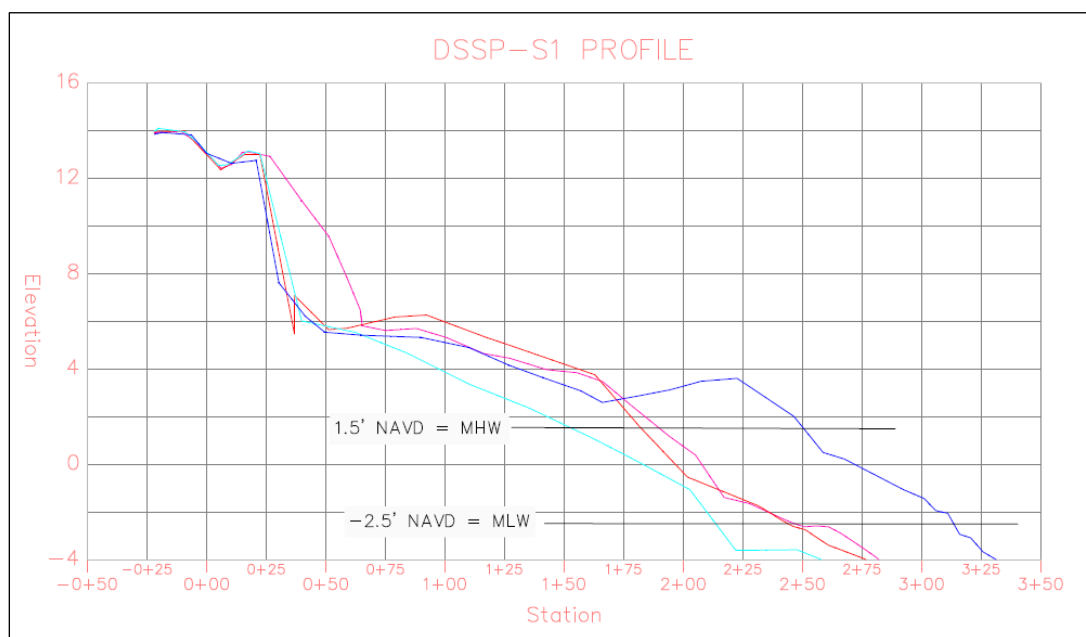
Figure 11B. Beach Profiles at Delaware Seashore State Park - South, LRP DSSP-S1.
Pink: Summer 2022, Cyan: Winter 2023, Red: Summer 2023, Blue: Winter 2024.

The average beach volumes determined for Delaware Seashore State Park - South are shown in Table 11. It should be noted that survey data from south of Indian River Inlet was collected on 9/20/2023, prior to Tropical Storm Ophelia; therefore, impacts from the storm are not captured in the Summer 2023 profiles. Directly adjacent to the south jetty is LRP line DSSP-S1, which eroded considerably in Winter 2023 but recovered the volume lost in Summer 2023. Further accretion was measured in Winter 2024, and Figure 11B demonstrates the significant volume increase in the foredune compared to Summer 2023. Accreted sand had likely eroded the previous season due to TS Ophelia and subsequently became trapped by the south jetty. Overall, this area appears accretional since the Summer 2023 profiles contain more volume than Summer 2022, and similarly the Winter 2024 profiles contain more volume than Winter 2023.

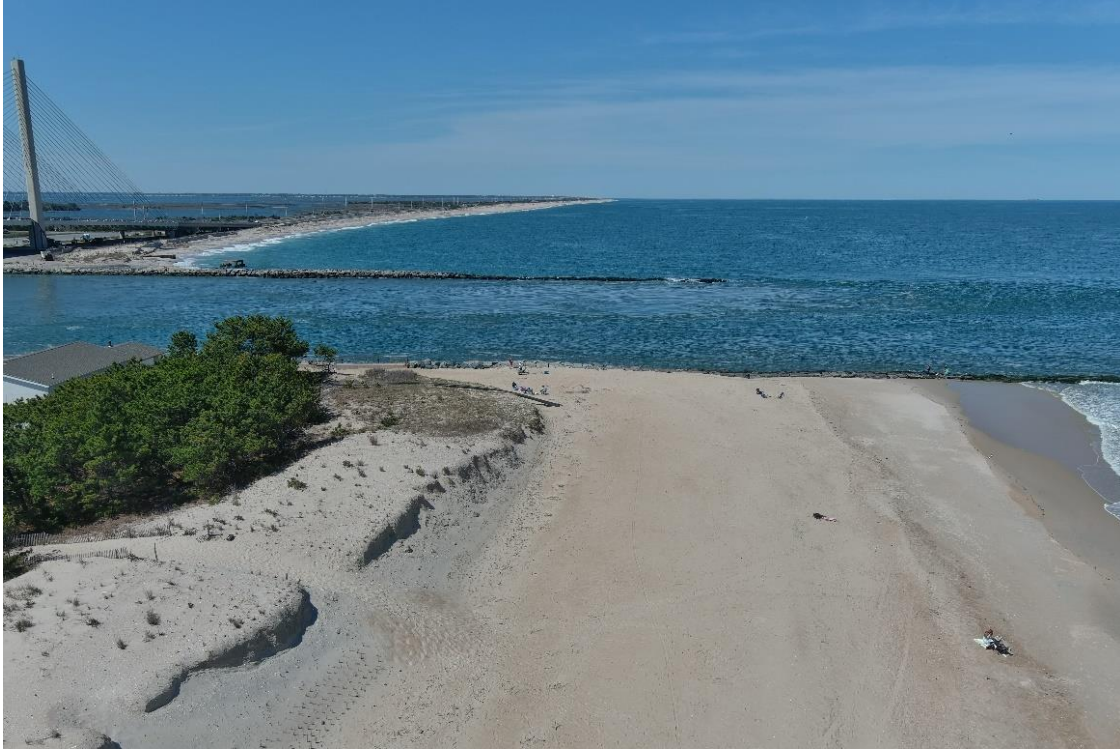
Figure 12C. Aerial view of Delaware Seashore State Park - South (4/16/2024, 14:38) looking north at Indian River Inlet and the north jetty.

Figure 11C shows an aerial view of Delaware Seashore State Park – South approaching high tide looking north from the day-use beach. Indian River Inlet and the north jetty are visible in the photo.

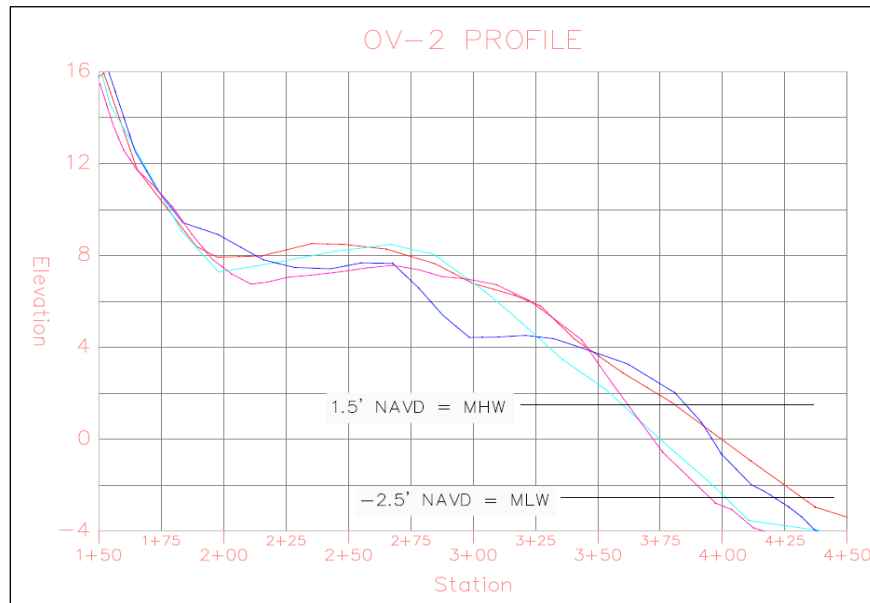
Figure 12B. Beach Profiles at Oceanview, LRP OV-2.

Pink: Summer 2022, Cyan: Winter 2023, Red: Summer 2023, Blue: Winter 2024.

2024 seasons is observed at both LRP lines. In Figure 12B, the Winter 2024 profile shows upper dune face scarping and erosion of sand to the intertidal zone. Figure 12C shows an aerial view of Oceanview at high tide looking north.

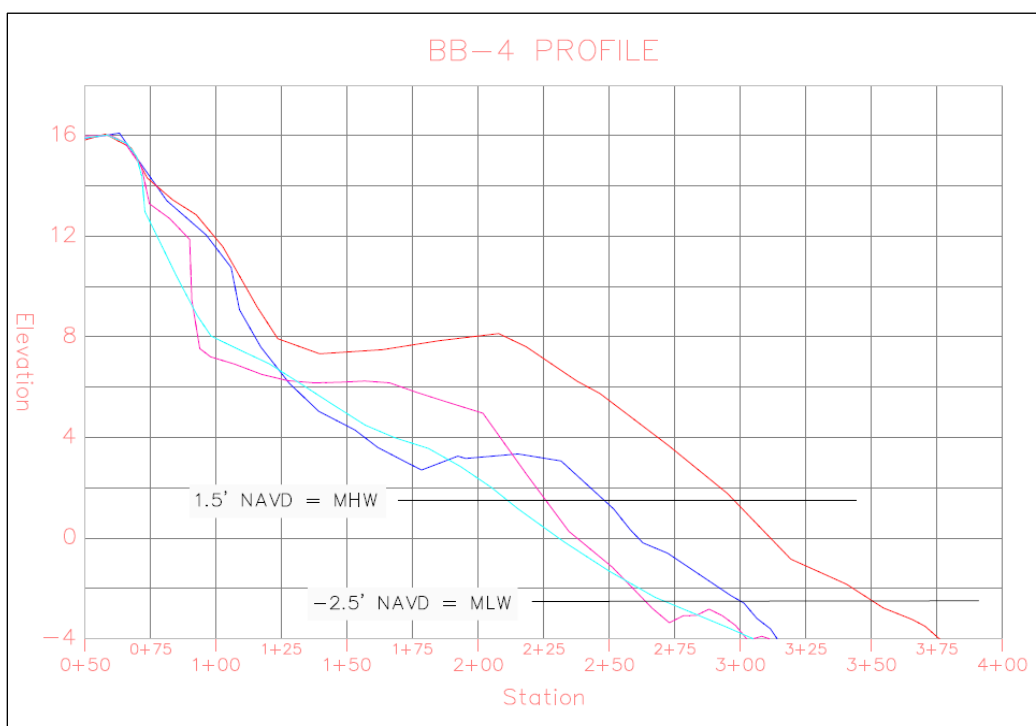
Figure 13B. Beach Profiles at Bethany Beach, LRP BB-4.

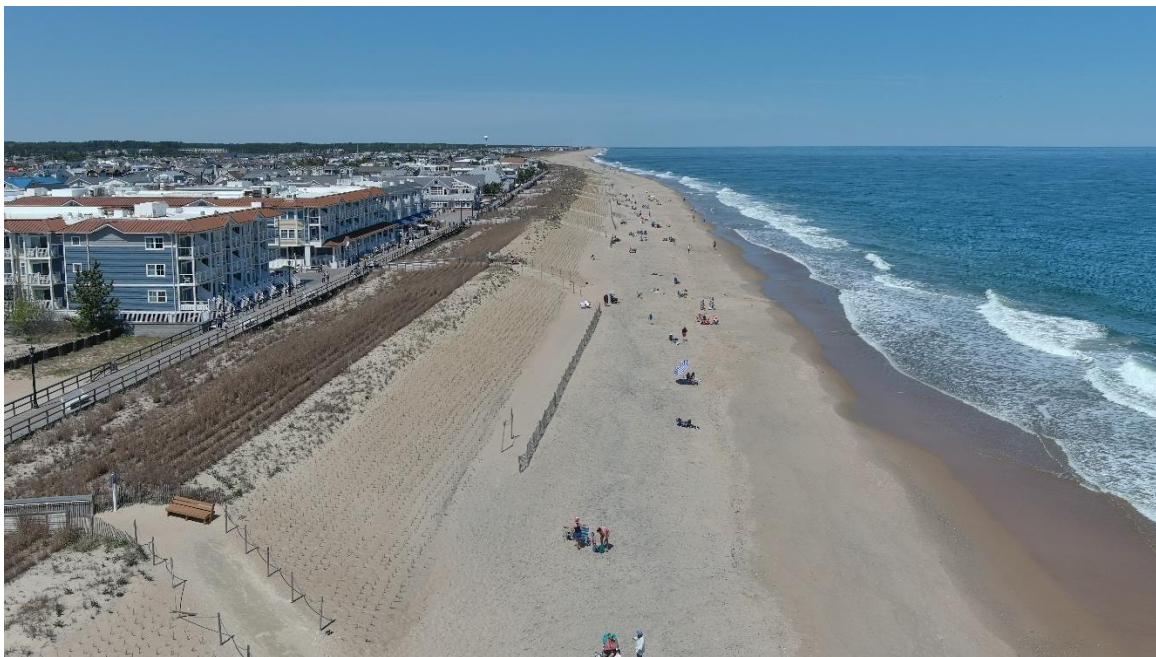
Figure 13C. Bethany Beach (4/16/2024, 13:38) approaching high tide, looking north

Figure 13C shows an aerial view of the town of Bethany Beach looking north while approaching high tide. One of the main beach crossovers and the Bethany Beach Boardwalk are visible in the photo.

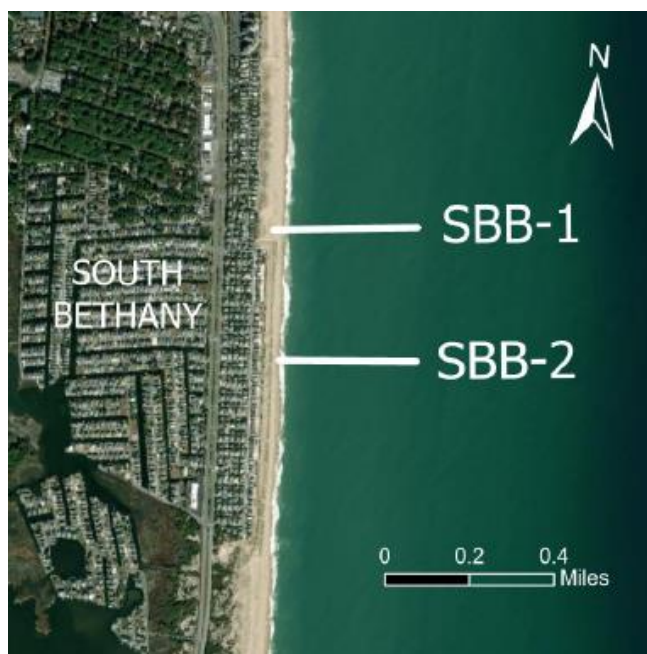
Figure 14A. LRP lines at South Bethany Beach

South Bethany Beach (SBB) is an incorporated, residential town located south of the Sea Colony and Middlesex private beach communities that separate this area from Bethany Beach. There are two LRP lines (SBB-1 and SBB-2) located along this coastline that extends approximately 4,000 feet.

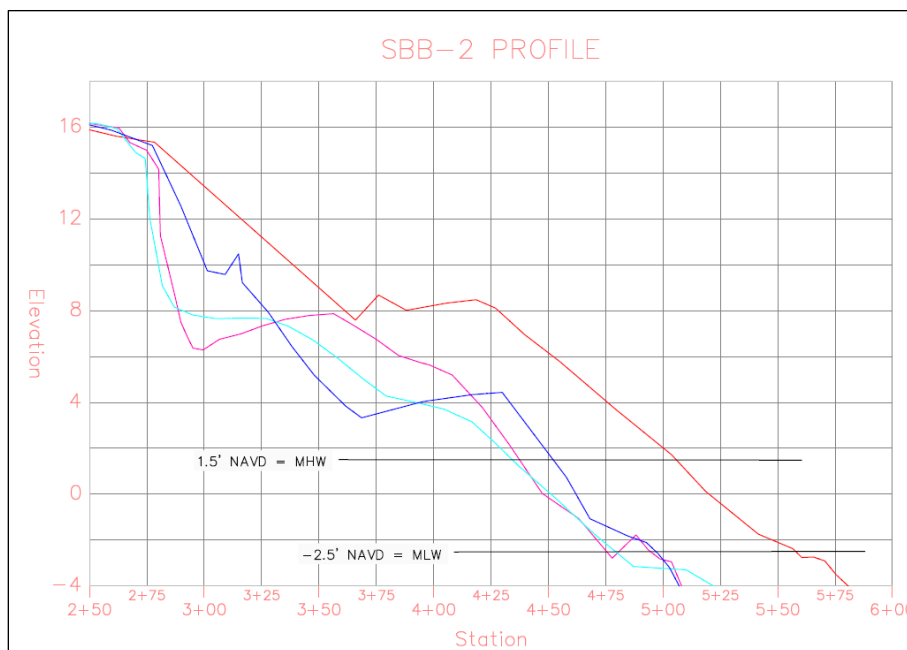
Figure 14B. Beach Profiles at South Bethan Beach, LRP SBB-2.

The average beach volumes determined for South Bethany Beach are shown in Table 14. As part of the federally authorized Delaware Coastal Storm Risk Management Projects described above, South Bethany was last nourished in July 2023. Beach profiles demonstrate the typical seasonal trends with volume loss during fall/winter followed by volume recovery during the summer months. Figure 14B clearly shows accretion of the Summer 2023 nourished profile, followed by a severely eroded Winter 2024 profile that reflects the impacts of TS Ophelia on the shoreline.

Pink: Summer 2022, Cyan: Winter 2023, Red: Summer 2023, Blue: Winter 2024.

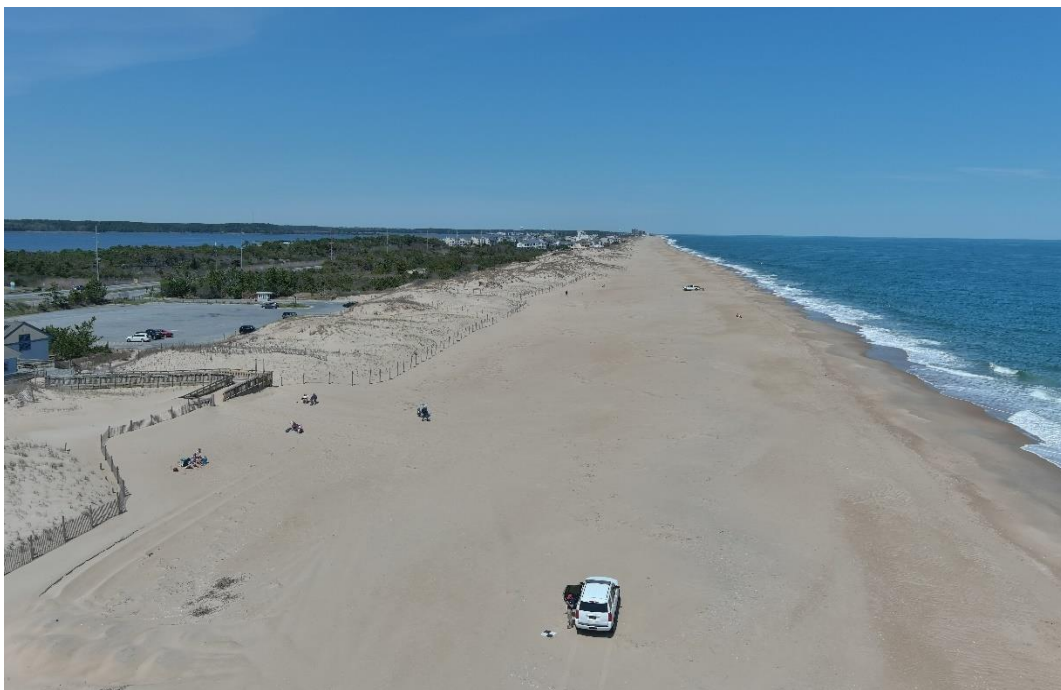
Figure 15C. Fenwick Island State Park (4/16/24, 13:14) approaching high tide, looking north.

Figure 15C shows an aerial view of Fenwick Island State Park from the main day-use beach area. This site is located between LRP lines FW-3 and FW-4.

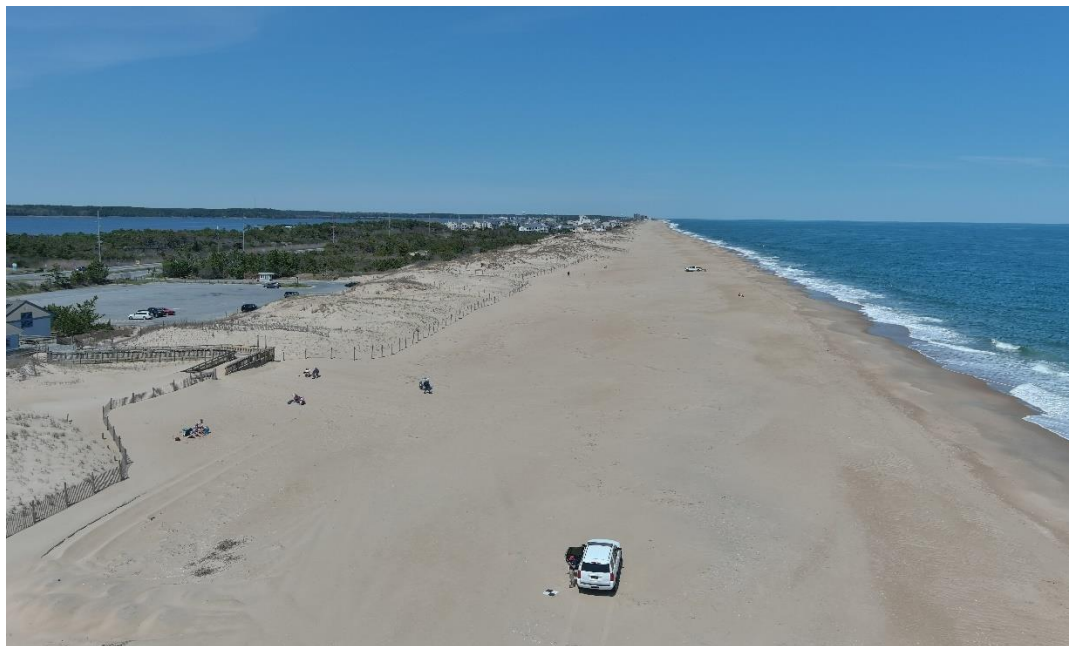
Fenwick Island (4/16/2024 at 13:14)

Photo taken from Fenwick Island State Park approaching high tide looking north.

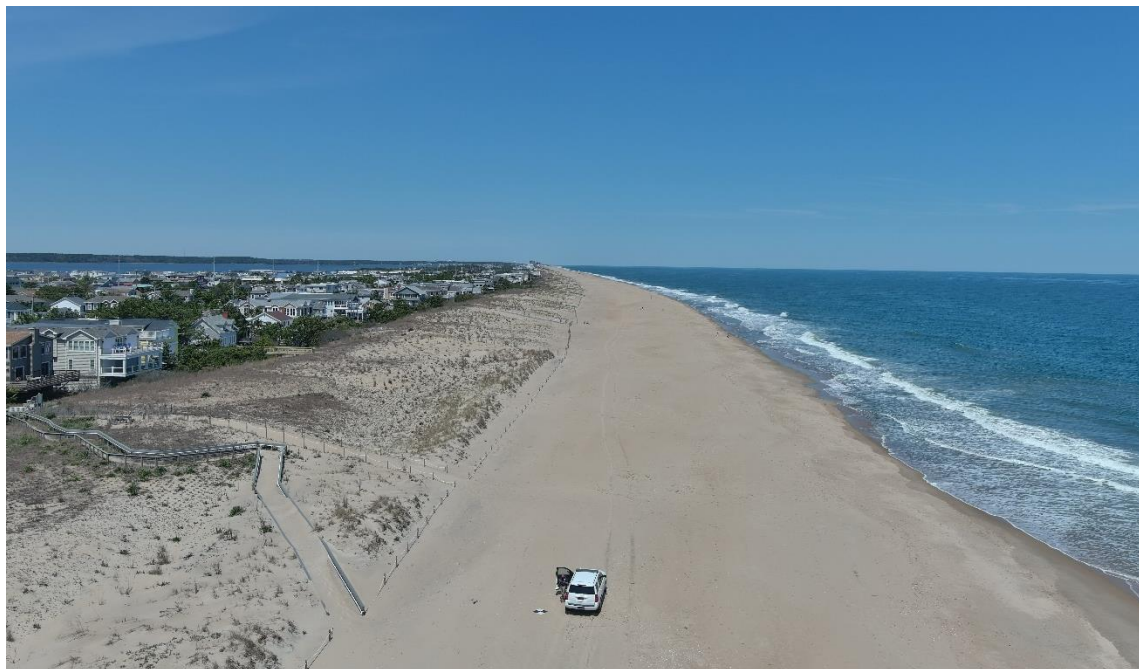
Fenwick Island (4/16/2024 at 13:08) continued.

Photo taken from the Town of Fenwick Island approaching high tide looking north.

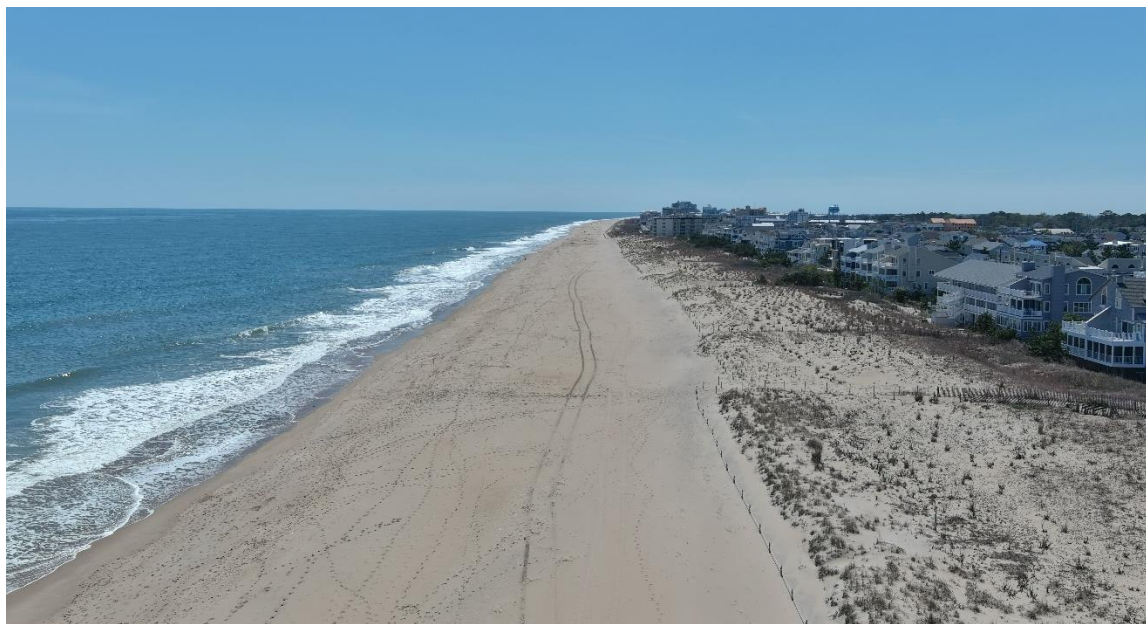
Photo taken from the Town of Fenwick Island approaching high tide looking south at the Delaware-Maryland state boarder.
