2024 – 2025 Season

# Delaware Annual Beach Change Report: Bay Coast

**Prepared by:**  
Delaware Department of Natural  
Resources and Environmental Control

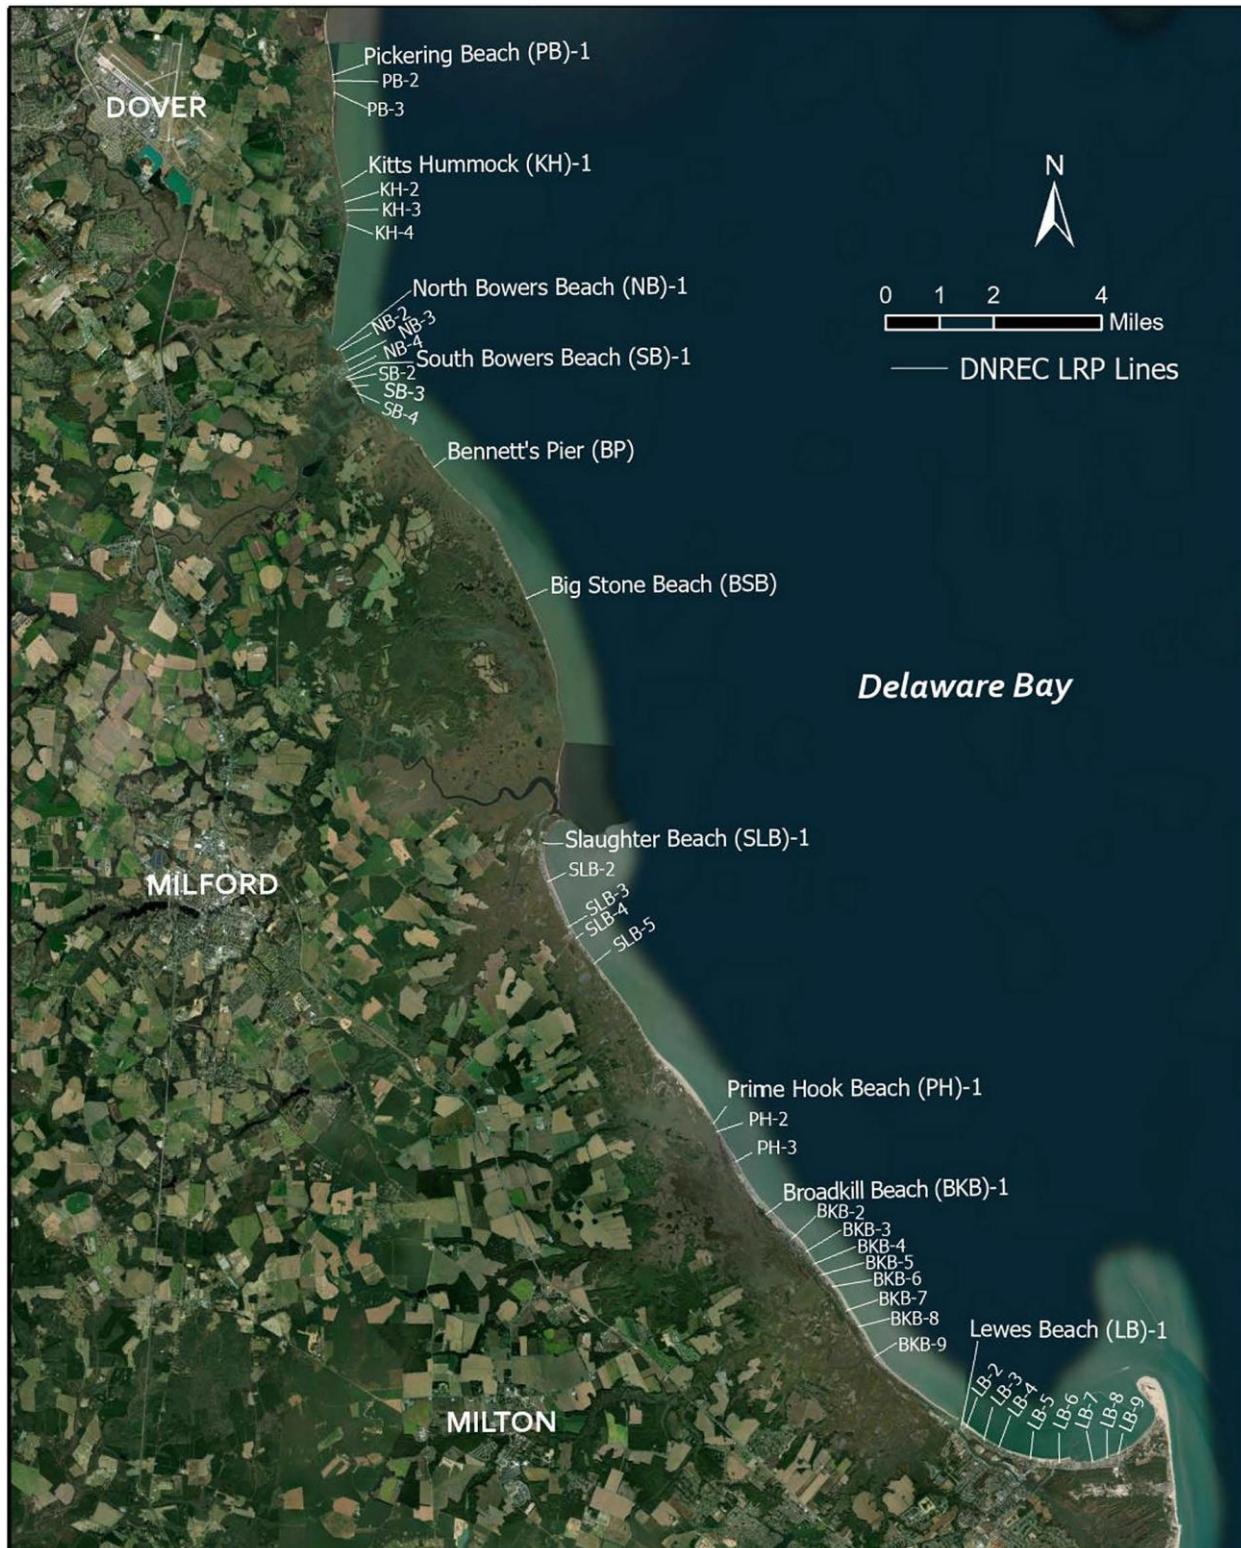
Figure 1: Bay Coast Survey Location Map

Monitoring beach change over time is a key component to shoreline management. During summer and winter seasons, beach profiles are measured along the Delaware Bay coast. Topographic and bathymetric data are collected from the dune out to a nearshore wading depth of about 4-feet using a RTK Trimble System paired with GPS. This system tracks the location and elevation of the ground where data points are collected. Figure 1 is a map showing the 43 profiles or Location Reference Point (LRP) lines from Pickering Beach, Kent County to Lewes Beach, Sussex County. In earlier reports, Cape Shores was considered a separate beach community and designated as LRP lines CS-1 through CS-3. As of this report, Cape Shores is included as part of Lewes Beach and defined as LB-7 through LB-9.

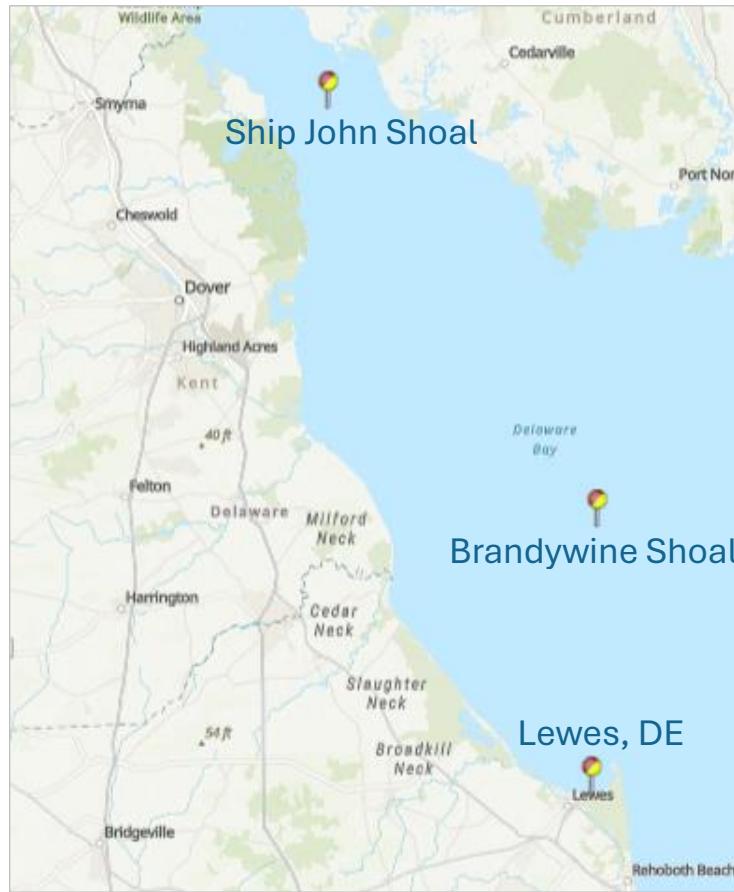
Figure 3: NOAA Water Level Stations in Delaware Bay

While significant storm events have impacted the Delaware Bay coastline, data from NOAA water level stations can be used to determine peak storm elevations. NOAA provides real-time water level information that is updated every six minutes from three locations in Delaware Bay [6]. Figure 3 shows these stations from north to south as Ship John Shoal, NJ; Brandywine Shoal Lighthouse, DE; and Lewes, DE.

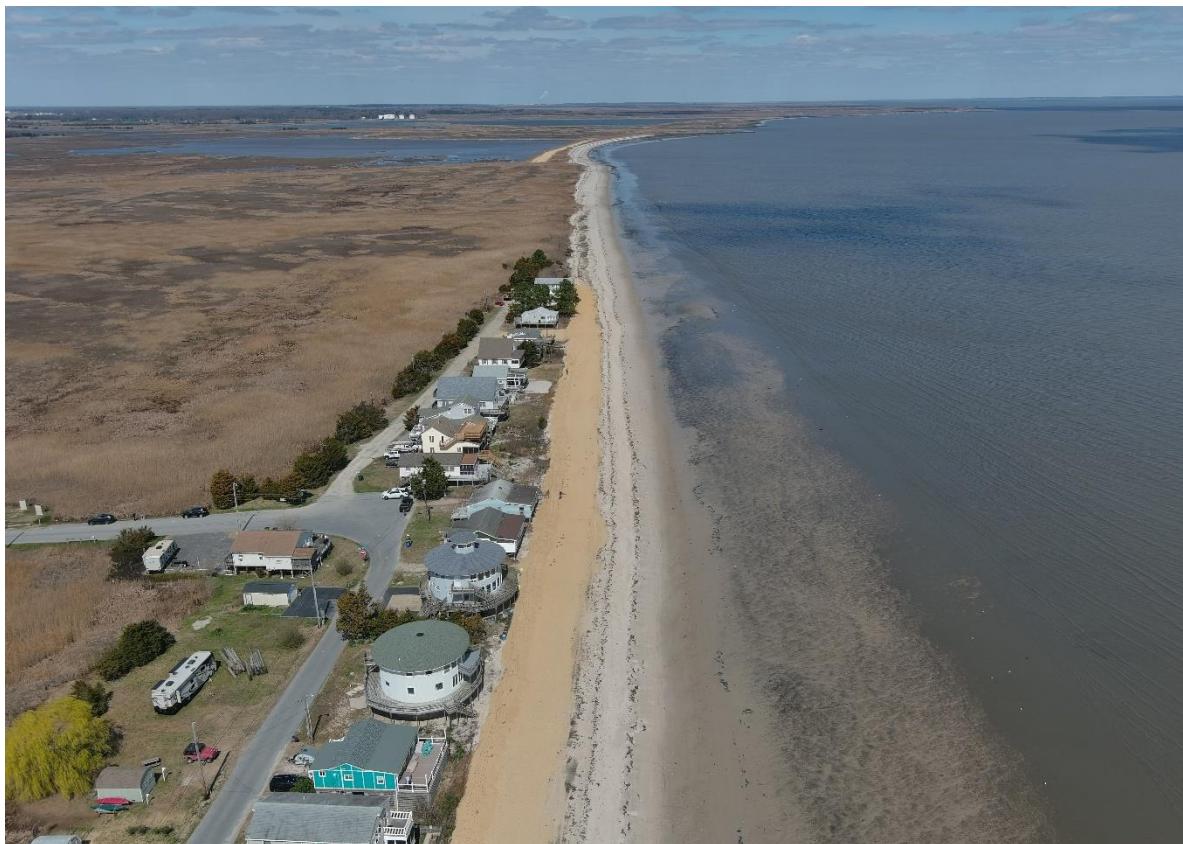
An aerial view of the Pickering Beach shoreline is shown in Figure 6C. This photo was taken following completion of the emergency beachfill project described above.

Figure 6C. Aerial view of Pickering Beach (03/19/2024, 12:24) at low tide, looking north.

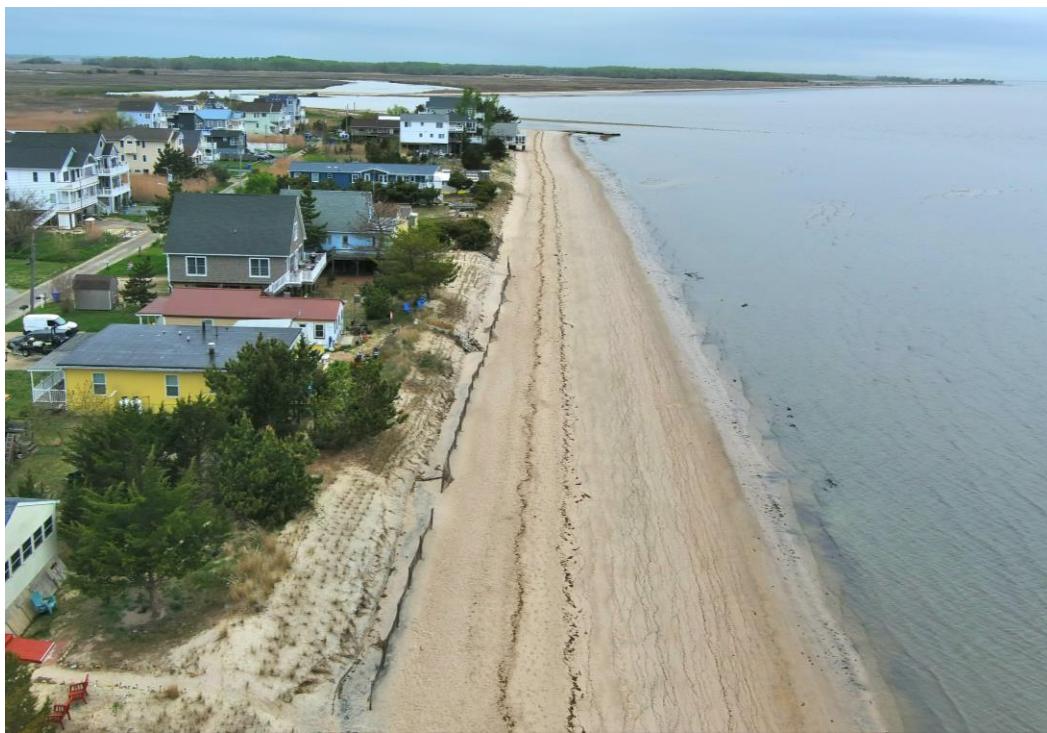
Figure 8C shows an aerial view of North Bowers Beach. The northern jetty and St. Jones River are visible in the background.

Figure 8C. North Bowers (4/17/2024, 12:06) nearing low tide, looking north.

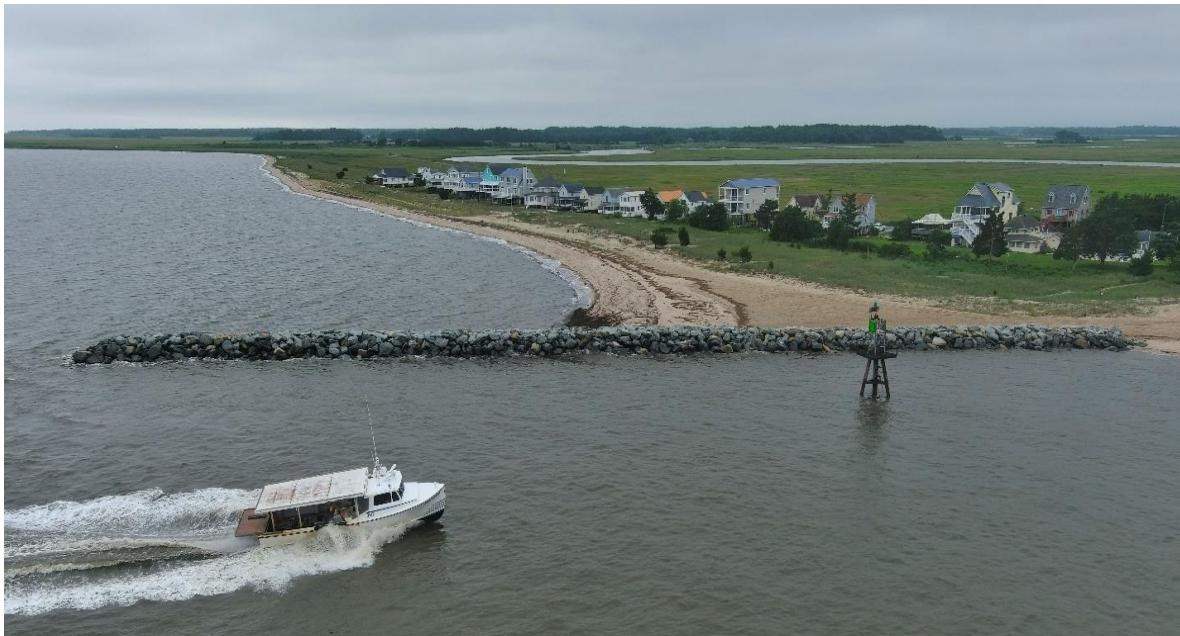
Figure 9D shows the newly rehabilitated Murderkill River (south) jetty and South Bowers Beach. The volume accumulation at LRP line SB-1, due to the jetty repair, is observed in the photo.

Figure 9D. Aerial view of South Bowers Beach (6/16/2025, 12:58) and the newly rehabilitated jetty, looking south from the Murderkill River inlet.

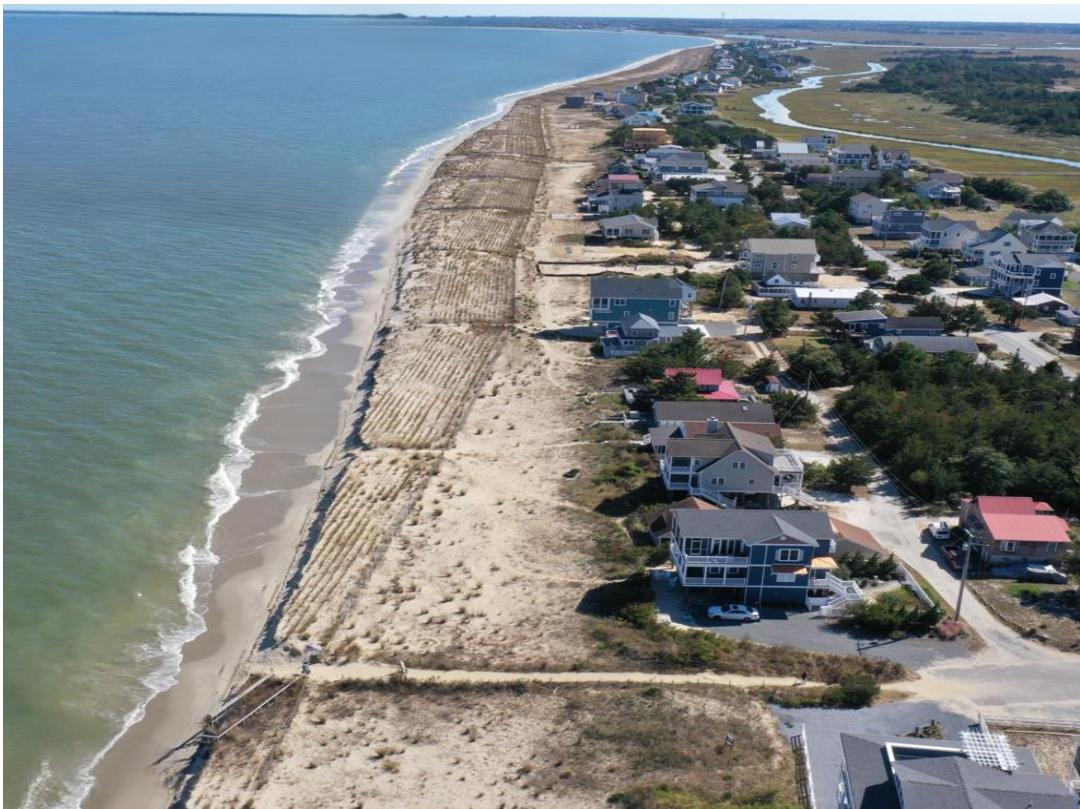
Figure 14D shows an aerial view of Broadkill Beach. Severe scarping near the Route 16 crossover is visible in the foreground.

Figure 14D. Broadkill Beach (10/9/2024, 8:56) approaching high tide,  
looking south

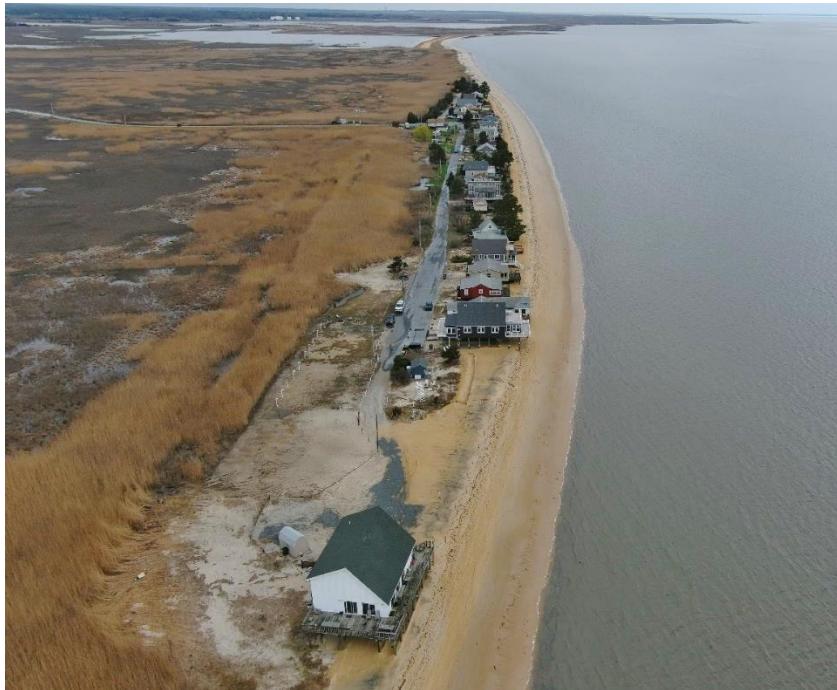
Approaching low tide looking north. Photo taken a couple weeks after an emergency beach fill project.
