2024 – 2025 Season

Delaware Annual Beach Change Report: Ocean Coast

Prepared by:
Delaware Department of Natural
Resources and Environmental Control

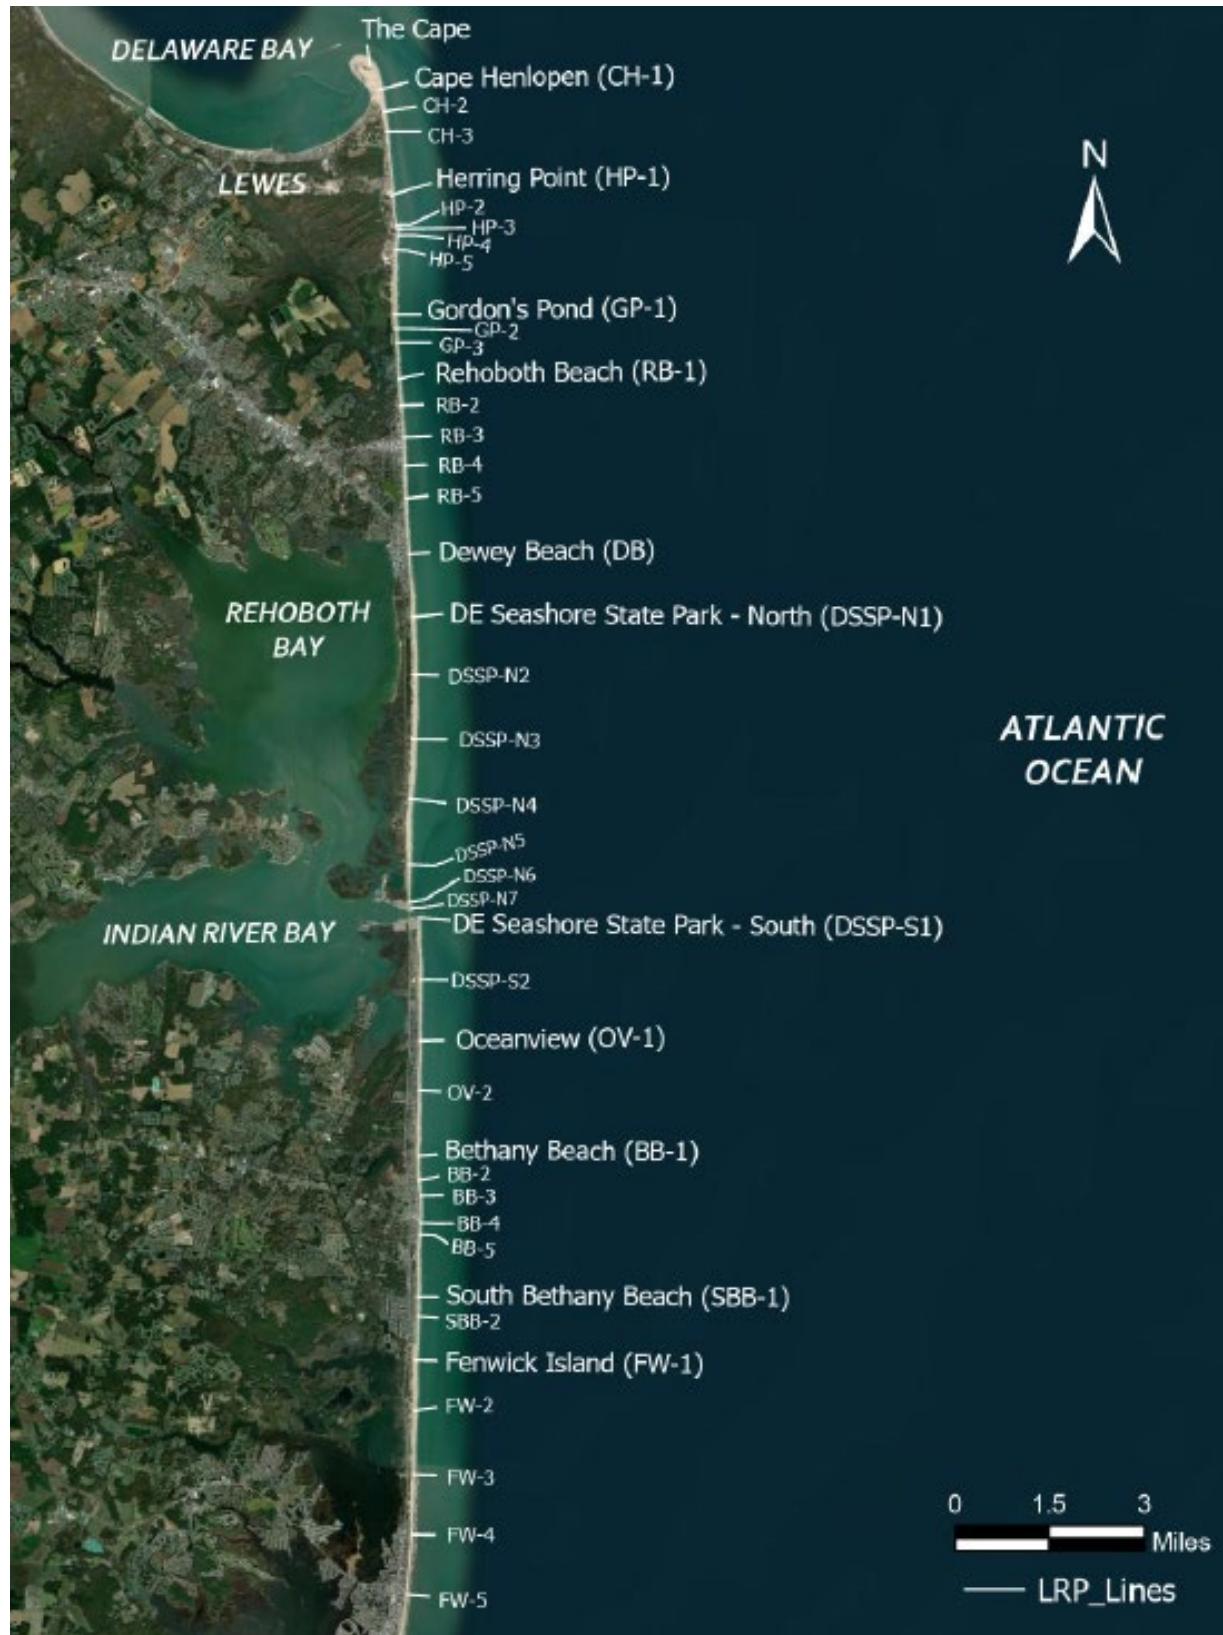
Figure 1: Ocean Coast Survey Location Map

Monitoring beach change over time is a key component to shoreline management. During summer and winter seasons, beach profiles are measured along Delaware's ocean coast. Topographic and bathymetric data are collected from the dune out to a nearshore wading depth of about 4-feet deep using a RTK Trimble System paired with GPS. This system tracks the location and elevation of the ground where data points are collected. This information is combined with bathymetric data collected by a hydrographic survey vessel, which surveys from a depth of about 30-feet to the nearshore area to ensure overlap between the topographic and bathymetric profiles. Locations of the 40 profiles or Location Reference Point (LRP) lines from Cape Henlopen State Park to Fenwick Island are shown in Figure 1.

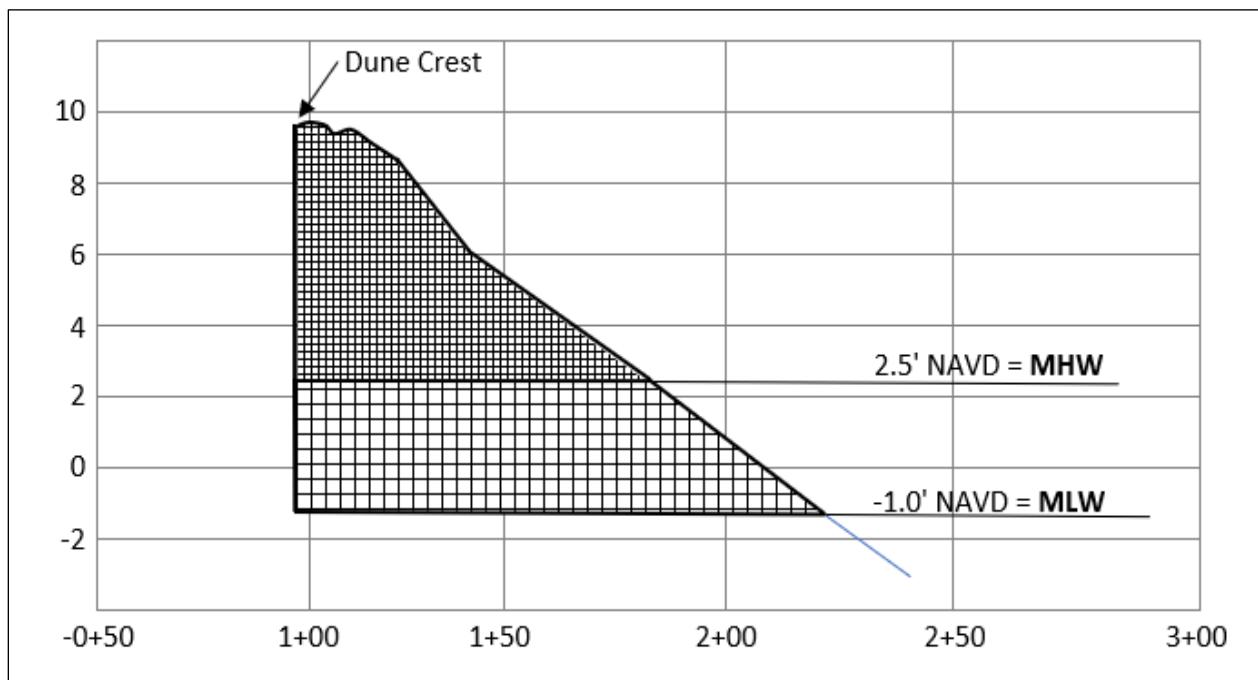
Figure 4: Beach profile sketch showing MHW & MLW contours

resiliency to flooding, overwash, and hazardous wave action. The MLW volume and the comparison of the MHW and MLW volumes are better indicators of seasonal beach change. During the stormy season when the upper beach erodes, sand washes down to the intertidal zone or just offshore. Some of the eroded material that ends up in the intertidal zone may be captured in the MLW data. By comparing the MHW and MLW volumes, seasonal erosion and accretion trends can be identified.

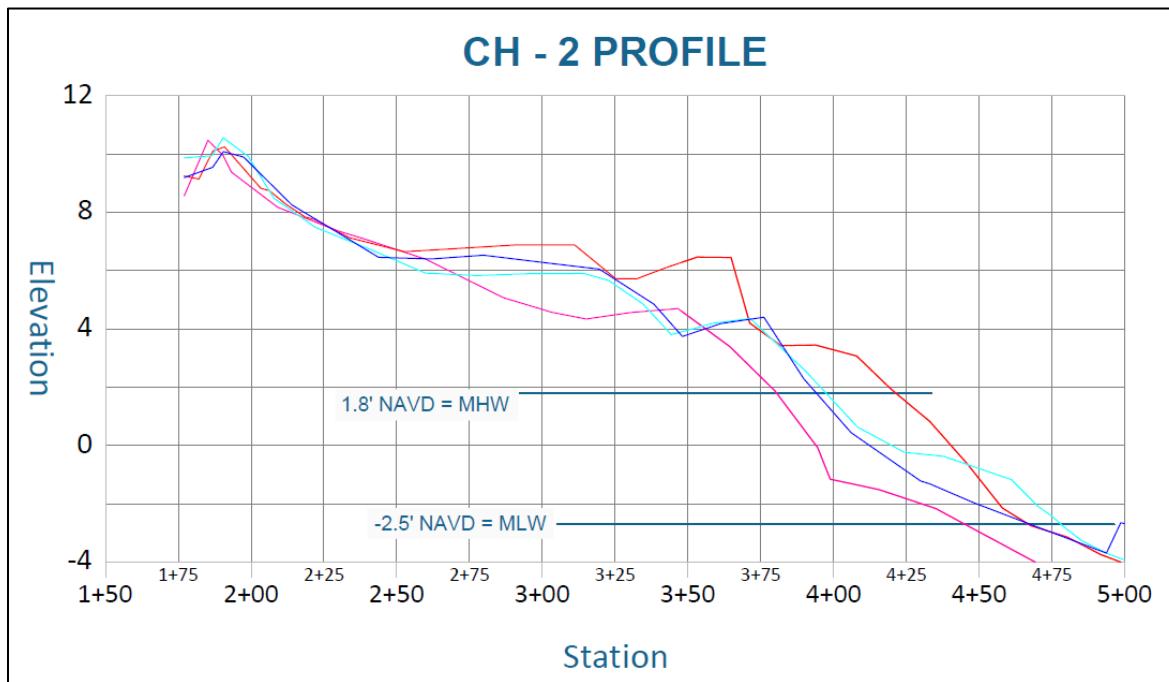
Figure 5B. Beach Profiles at Cape Henlopen, LRP CH-2
Pink: Summer '23, Cyan: Winter '24, Red: Summer '24, Blue: Winter '25

The average beach volumes determined for Cape Henlopen are shown in Table 5. The Delaware coastline was impacted by TS Ophelia on 9/23/2023, prior to the Summer 2023 survey. Therefore, Figure 5B shows an eroded, post-storm profile at LRP line CH-2 followed by accretion during Winter 2024. Accretion continued through Summer 2024 as volume increases were observed in the intertidal zone and dune. Seasonal erosion at CH-2 was evident from the Winter 2025 profile, which appears similar to the Winter 2024 profile. Conversely, LRP line CH-3 eroded continuously from Summer 2023 through Summer 2024 and then accreted volume during Winter 2025. A photo of the point at Cape Henlopen is shown in Figure 5C.

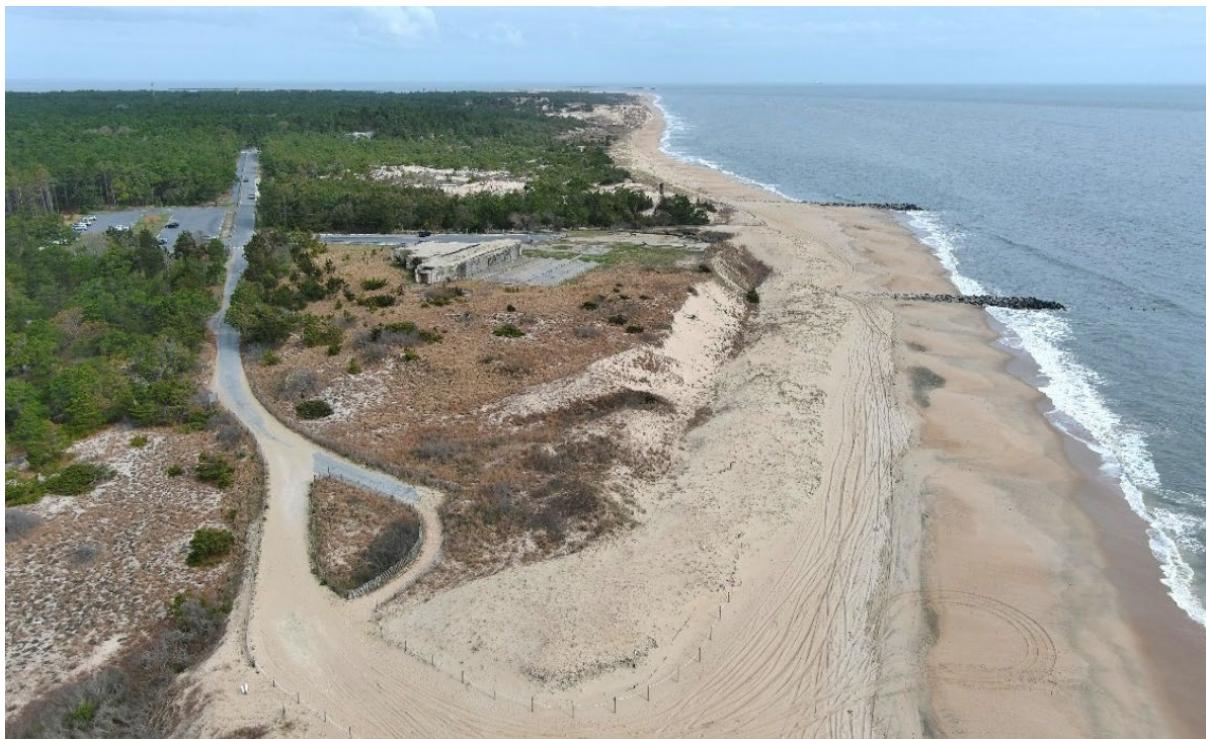
Figure 6C. Herring Point (4/11/2024, 9:40) nearing high tide, looking north.

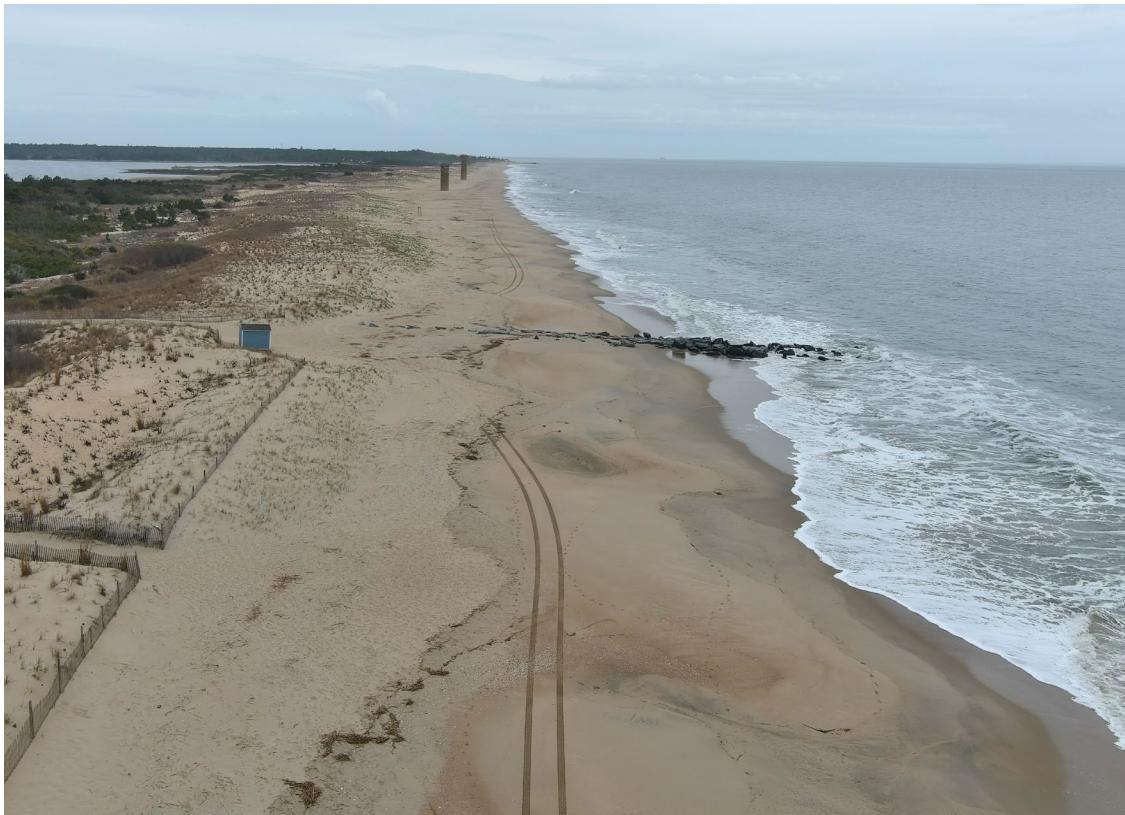
An aerial view of Gordon's Pond beach is shown in Figure 7C. The northern jetty is visible in the center of the photo, and the WWII Observation Towers are shown in the background.

Figure 7C. Aerial view of Gordon's Pond beach (4/11/2024, 9:51) approaching high tide looking north

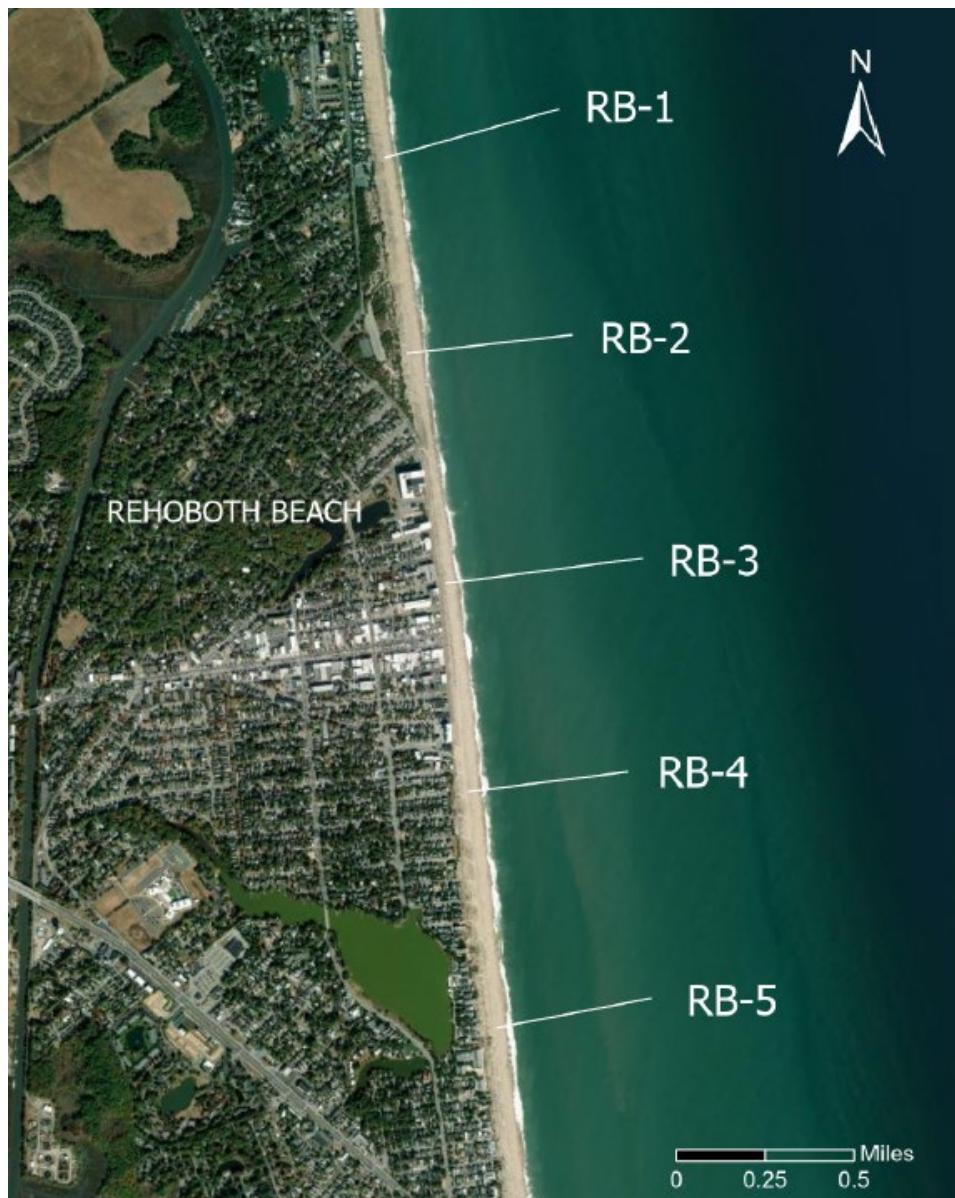
Figure 8A. LRP lines at Rehoboth Beach

Henlopen Acres is a small, incorporated town that lies between North Shores to the north and Rehoboth Beach (RB) to the south. The shoreline is about 1,000 feet in length and contains LRP line RB-1 (Figure 8A). The densely developed incorporated town of Rehoboth Beach accounts for over 9,200 feet of coastline and includes the state-owned northern end (RB-2), known as Deauville and the unincorporated southern region (RB-5), known as Silver Lake. There are nine constructed groins and four additional LRP lines within this stretch of shoreline (Figure 8A).

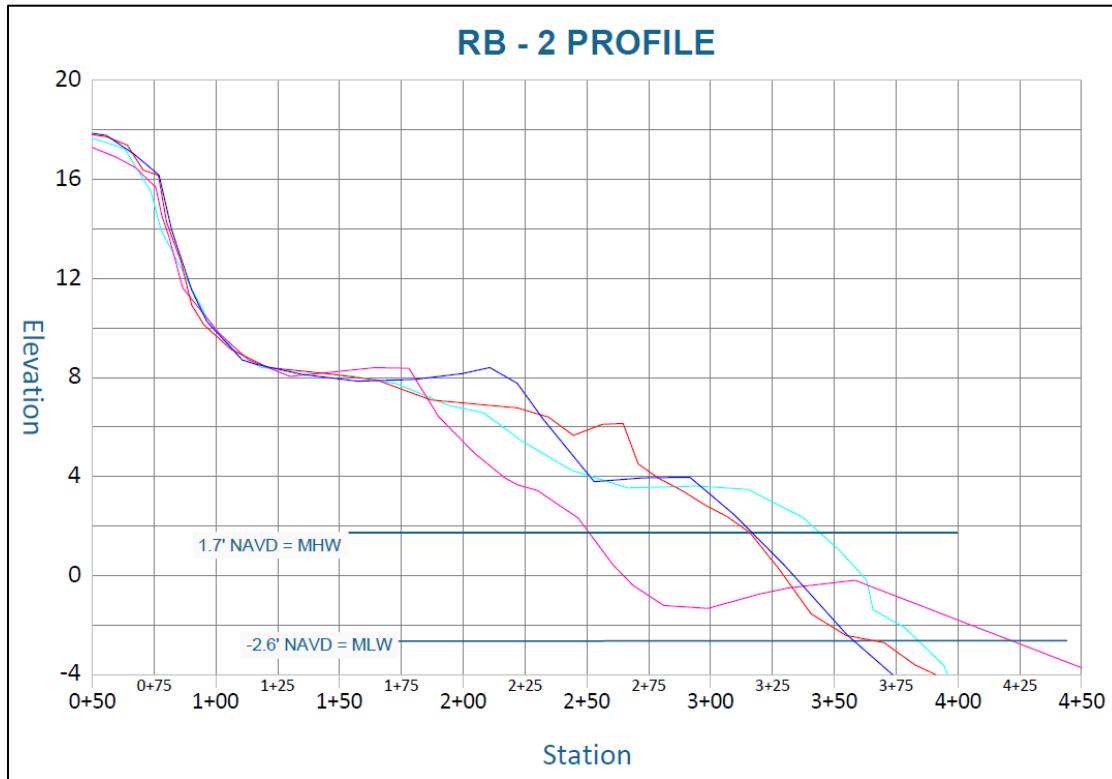
Figure 8B. Beach Profiles at Rehoboth Beach, LRP RB-2
Pink: Summer '23, Cyan: Winter '24, Red: Summer '24, Blue: Winter '25

The average volumes determined for Rehoboth Beach are shown in Table 8. Overall, Rehoboth Beach accreted material throughout the 2024-2025 season. As one of the federally authorized Delaware Coastal Storm Damage Reduction Projects described above, Rehoboth Beach was last nourished in May 2023. Beach nourishment impacted LRP lines RB-2, RB-3, and RB-4 and, in addition to TS Ophelia, influenced the Summer 2023 volume measurements. Comparing the Summer 2023 profiles at RB-2 (Figure 8B) and RB-5 (Figure 8C) demonstrate the importance of periodic nourishment for reducing the effects of coastal storm erosion.

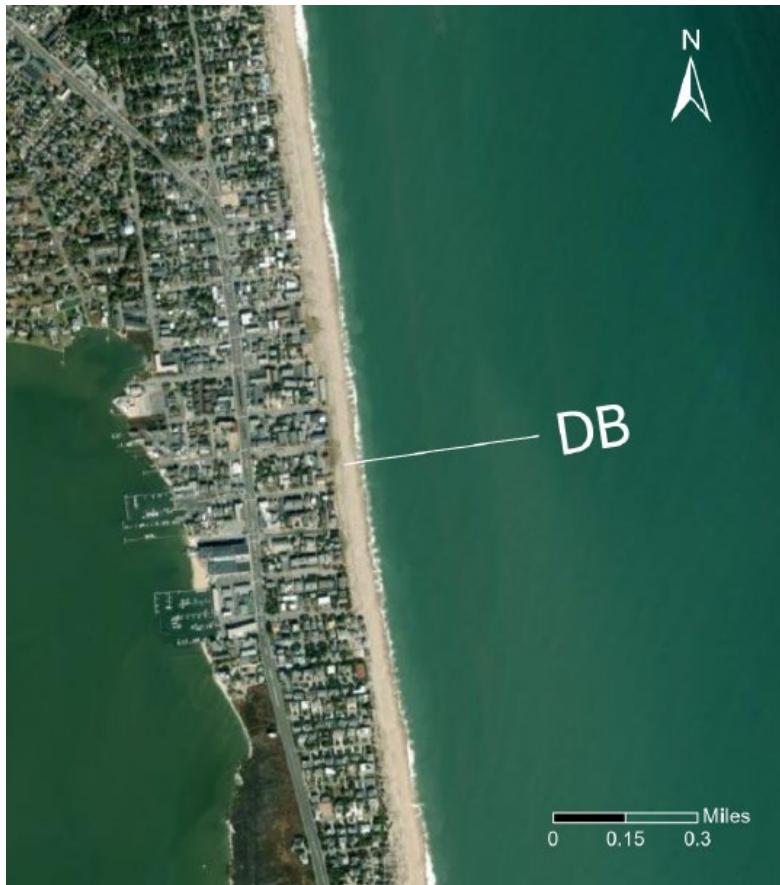
Figure 9A. LRP line at Dewey Beach

Dewey Beach (DB) is located south of the Silver Lake region, which separates Rehoboth and Dewey Beaches. This stretch of coastline is about 7,500 feet in length and contains one LRP line (Figure 9A).

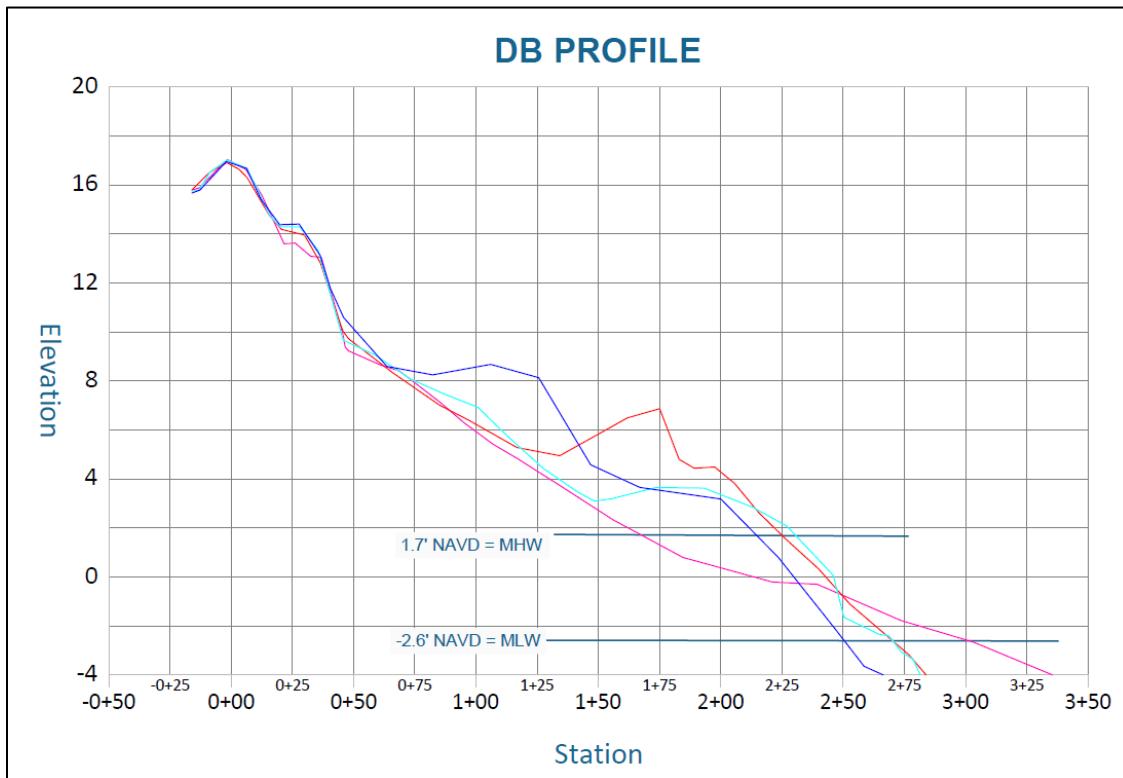
Figure 9B. Beach Profiles at Dewey Beach

The average beach volumes determined for Dewey Beach are shown in Table 9. Similar to Rehoboth, Dewey Beach is one of the federally authorized Delaware Coastal Storm Damage Reduction Projects described above and was last nourished in May 2023. The impacts due to TS Ophelia are represented in the Summer 2023 profile. Net accretion was measured in subsequent seasonal surveys, and Figure 9B suggests material from the intertidal zone accreted above the MHW line during Summer 2024. Accretion continued, including formation of a berm, in Winter 2025 (Figure 9B). An aerial view of Dewey Beach is shown in Figure 9C.

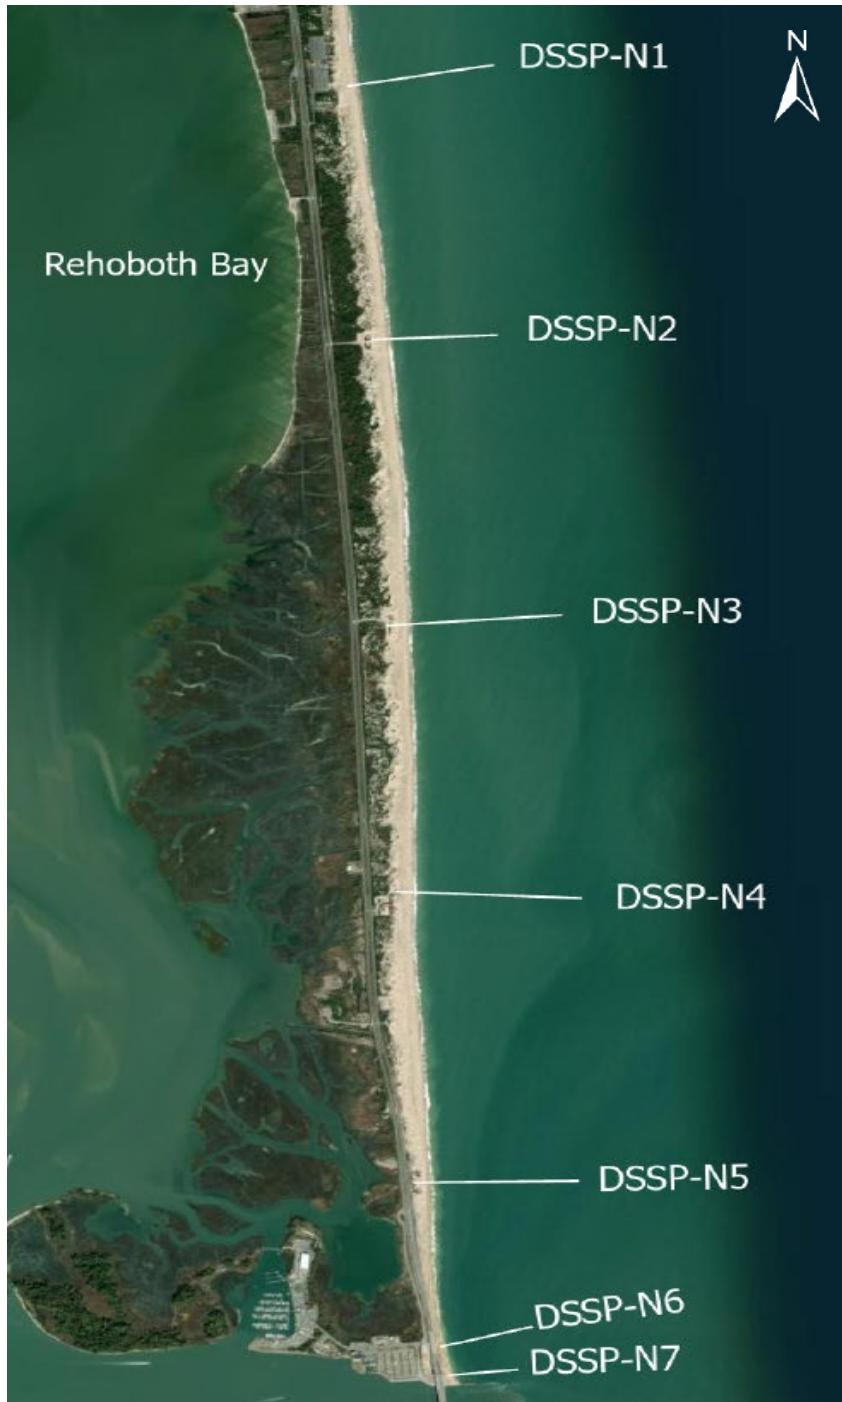
Figure 10A. LRP lines at Delaware Seashore State Park - North

Delaware Seashore State Park - North of Indian River Inlet (DSSP-N) spans five miles and contains seven LRP lines that are evenly spaced, except for the two closest to the north jetty (Figures 10A, 10B). This area is located south of Dewey Beach and extends from Tower Road to Indian River Inlet.

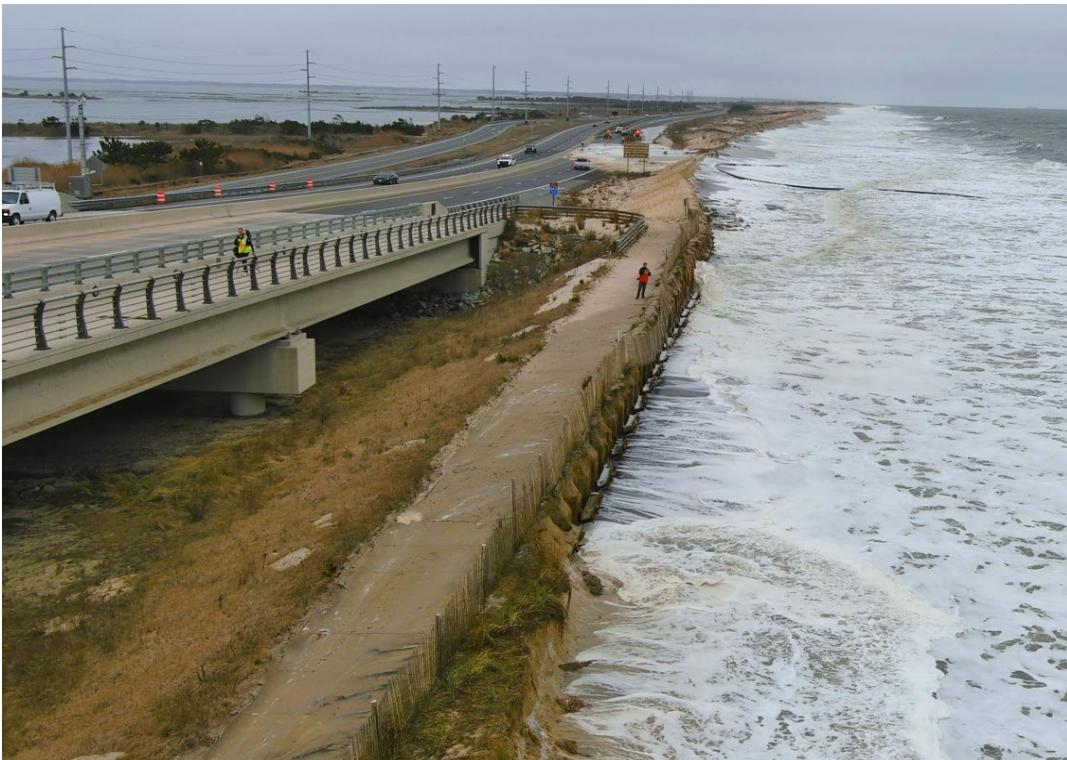
Considerable erosion during Summer 2024 was also measured at LRP lines DSSP-N6 and DSSP-N7, which are situated closest to the north jetty. Due to the lack of sediment supply, as described above, this area is known to be erosive and continued to deteriorate following TS Ophelia. The dune breached twice in 2024 resulting in flooding and closure of Delaware State Route 1, an evacuation route, for several hours. Figure 10D was taken during the first dune breach on 3/26/2024 and shows no visible beach above the high tide line (foreground) as ocean water floods the northbound lane. Figure 10E provides a closer view of the second dune breach on 8/17/2024 that also resulted in flooding and closure of the roadway.

Figure 10D. North Inlet Beach (3/26/2024) at high tide looking north. Ocean water covers the NB Rt 1 lane just beyond the Inlet Bridge, visible on the left.

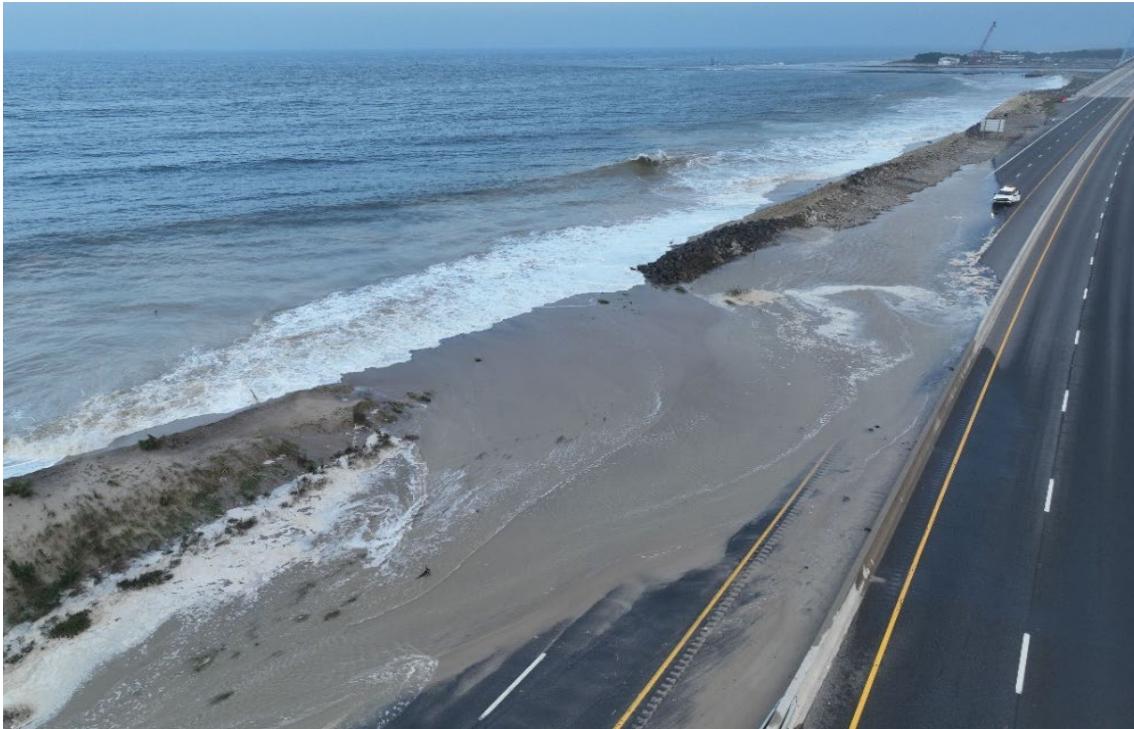
Figure 10E. DE Seashore State Park - North Inlet Beach (8/17/2024) at high tide looking south. The Rt 1 northbound lane is closed as ocean water breaches the dune and floods the roadway.

Given the Sand Bypass Facility was inoperable, DNREC was relying on truck-hauled sand from inland sources for beach repairs, but this method could no longer keep up with the rapid rate of erosion. Therefore, an emergency dredging and beach repair project was initiated in Fall 2024 that was completed just prior to the Winter 2025 survey. Nearly 480,000 cubic yards of dredged sand from the inlet flood shoal was used to repair up to 5,000 linear feet of shoreline. Figure 10F demonstrates the drastic difference between the seasonal profiles at DSSP-N7, especially before and after the large-scale nourishment project. Volunteers helped to plant American beach grass (*Ammophila breviligulata*) on the newly constructed beach during Spring 2025 (Figure 10G).

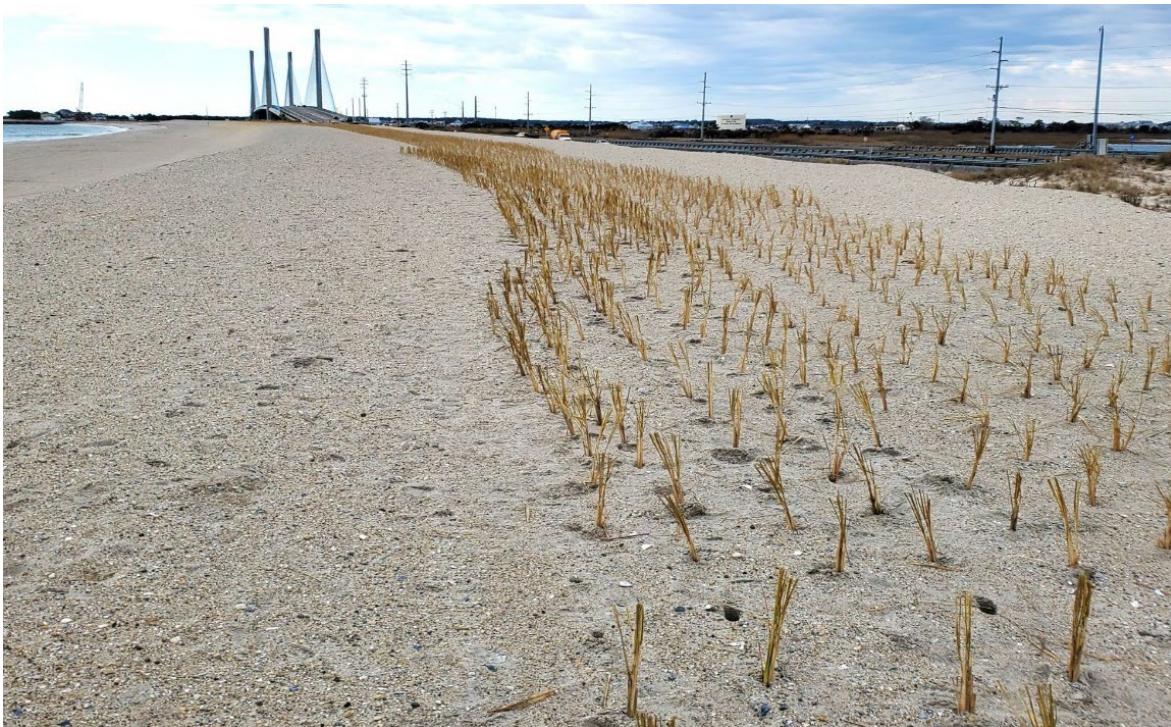
Figure 10G. DE Seashore State Park - North Inlet Beach (3/26/2025) looking south at the repaired dune with newly planted *American Beach Grass*.

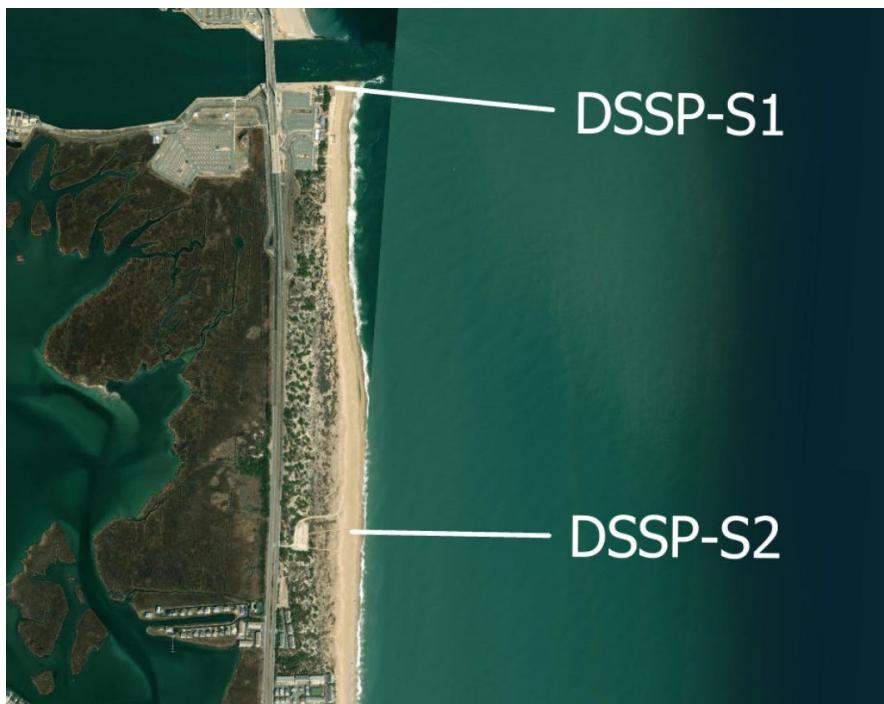
Figure 11A. LRP lines at Delaware Seashore State Park - South

Delaware Seashore State Park – South of Indian River Inlet (DSSP-S) is approximately one-mile long with two LRP lines located at the south inlet day-use area and 3'Rs Beach (Figure 11A).

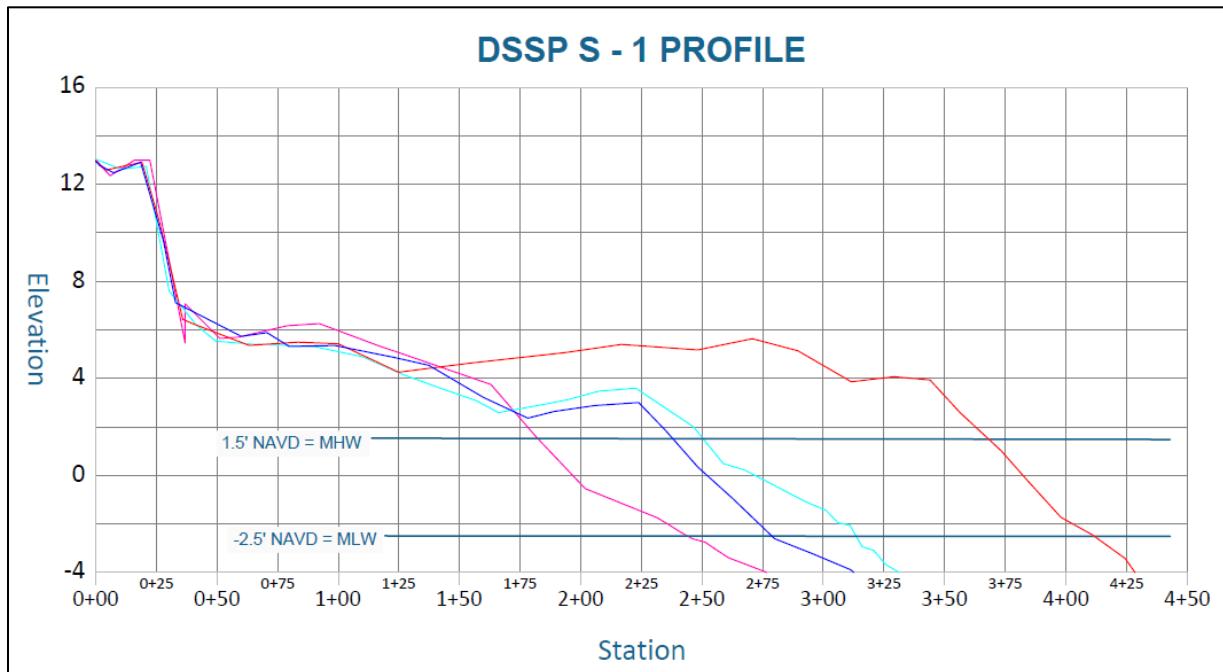
Figure 11B. Beach Profiles at Delaware Seashore State Park, LRP DSSP-S1
Pink: Summer '23, Cyan: Winter '24, Red: Summer '24, Blue: Winter '25

The average beach volumes determined for Delaware Seashore State Park - South are shown in Table 11. It should be noted that surveys were collected south of Indian River Inlet on 9/20/2023, prior to TS Ophelia; therefore, impacts from the storm are not captured in the Summer 2023 profiles. Surveys of LRP lines DSSP-S1 and DSSP-S2 show similar patterns of accretion from Summer 2023 through Summer 2024, followed by erosion in Winter 2025. Directly adjacent to the south inlet jetty is DSSP-S1, which accreted considerably in Summer 2024 as sand that moved onshore was trapped by the jetty. However, all this volume was lost in the subsequent Winter 2025 profile as sand likely washed out along the jetty following the winter storms. Figure 11B demonstrates the significant shift in beach volumes observed between seasons at DSSP-S1.

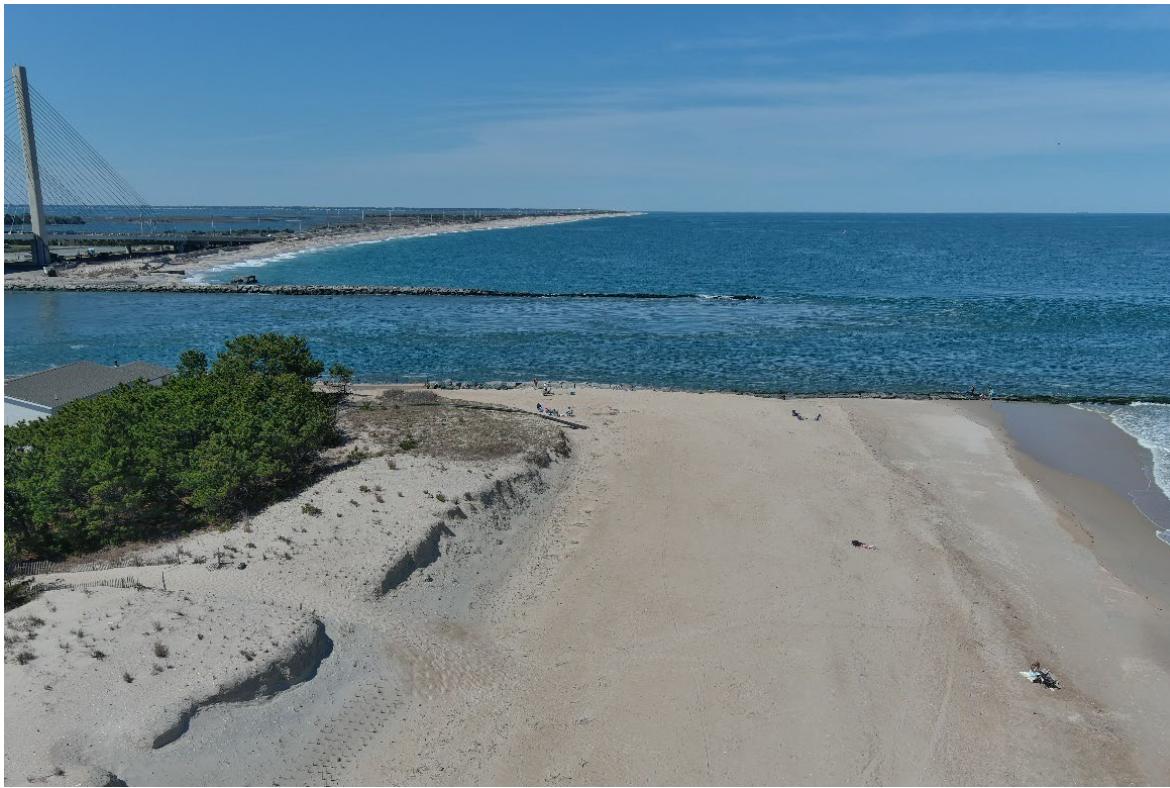
Figure 11C shows an aerial view of Delaware Seashore State Park – South approaching high tide looking north from the day-use beach. Indian River Inlet and the north jetty are visible in the photo.

Figure 11C. Aerial view of Delaware Seashore State Park - South (4/16/2024, 14:38) looking north at Indian River Inlet and the north jetty.

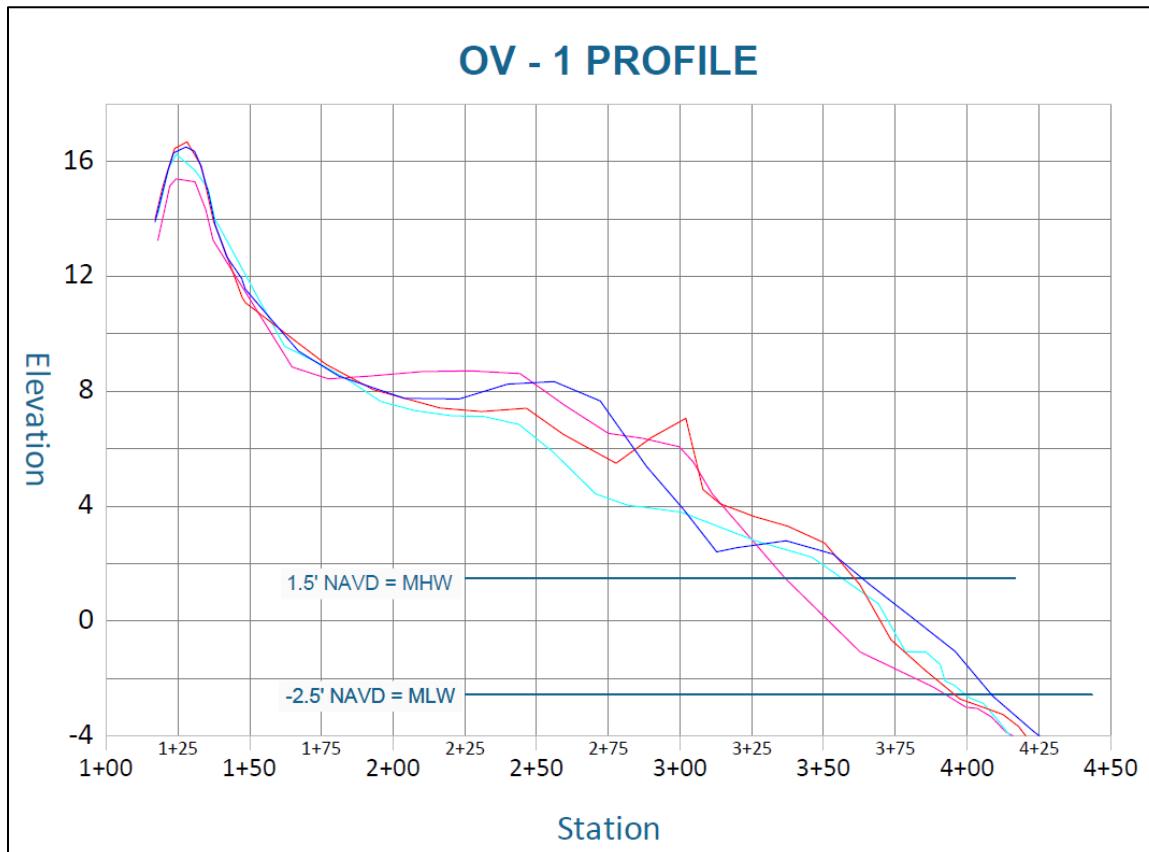
Figure 12B. Beach Profiles at Oceanview, LRP OV-1

Average beach volumes determined for Oceanview are shown in Table 12. Overall, Oceanview beach experienced the expected seasonal patterns of erosion and accretion in the Winter 2024 and Summer 2024 profiles, respectively. Given the Winter 2024 profile reflects the impacts of TS Ophelia, Figure 12B demonstrates dune erosion and nearshore accretion at LRP line OV-1 as sand washed down into the intertidal zone. The dune re-gained volume during Summer 2024 and then shifted landward the subsequent winter season, creating a berm (Figure 12B). Nearshore accretion also continued through Winter 2025. Figure 12C shows an aerial view of Oceanview looking northward at high tide.

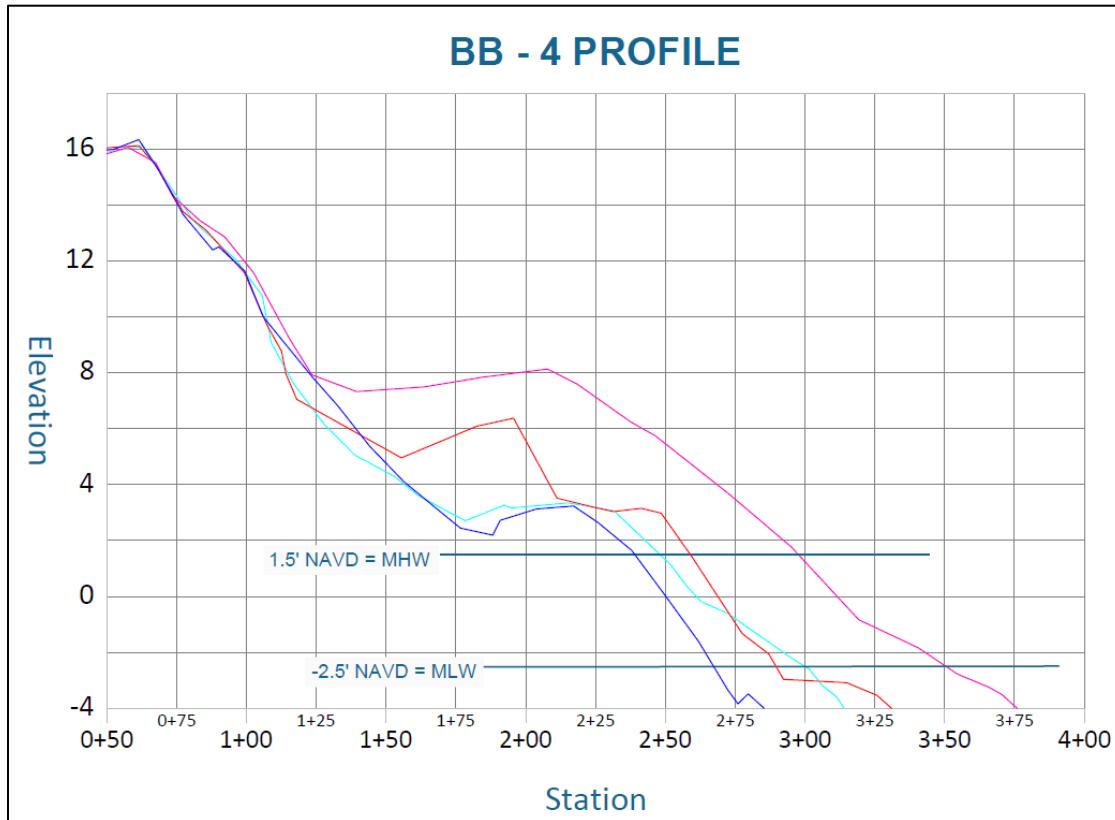
Figure 13B. Beach Profiles at Bethany Beach, LRP BB-4
Pink: Summer '23, Cyan: Winter '24, Red: Summer '24, Blue: Winter '25

The average beach volumes determined for Bethany Beach are shown in Table 13. As one of the federally authorized Delaware Coastal Storm Damage Reduction Projects described above, Bethany Beach was last nourished in July 2023. Renourishment is reflected in the Summer 2023 profiles for LRP lines BB-2 through BB-5. Significant erosion was measured in the subsequent Winter 2024 survey due to the erosive effects of TS Ophelia; however, Bethany Beach began to recover some of the volume lost by Summer 2024. While LRP lines in the northern, private section of Bethany Beach (BB-1 and BB-2) continued to accrete during Winter 2025, erosion was measured along the stretch of developed shoreline (BB-3, BB-4, and BB-5). Volume loss at LRP line BB-4 was the most drastic as Figure 13B demonstrates erosion of the dune and landward shift in the scarped nearshore area. Survey data suggest BB-4 is generally eroding overtime as volume loss was measured between the annual summer and winter surveys.

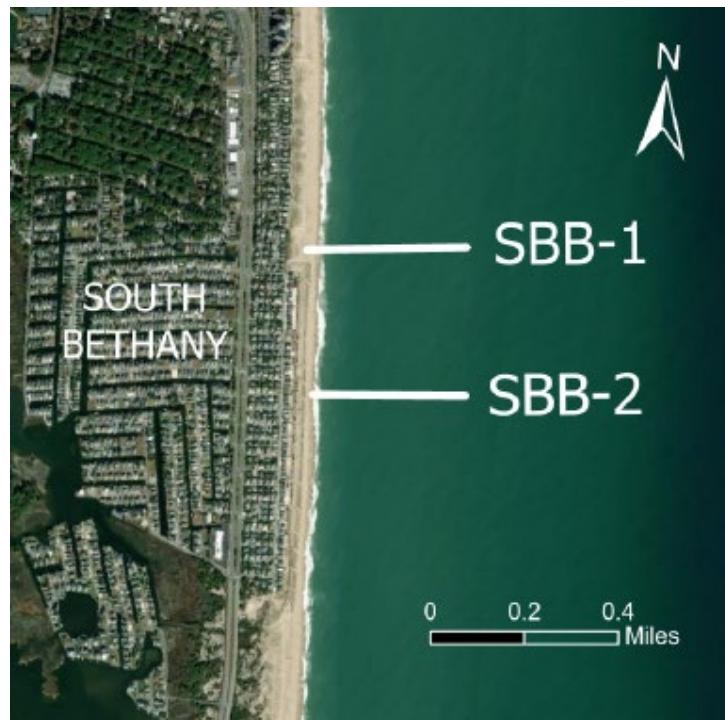
Figure 14A. LRP lines at South Bethany Beach

South Bethany Beach (SBB) is an incorporated, residential town located south of the Sea Colony and Middlesex private beach communities that separate this area from Bethany Beach. There are two LRP lines (SBB-1 and SBB-2) located along this coastline that extends approximately 4,000 feet.

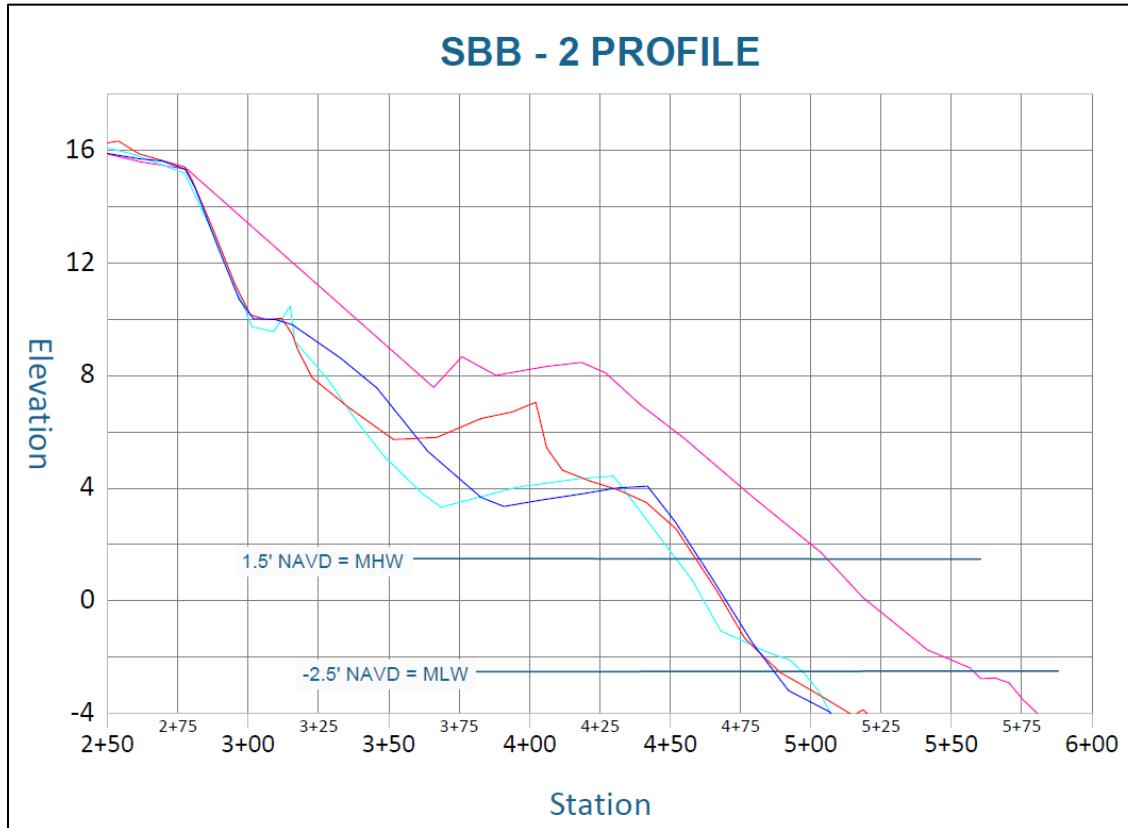
Figure 14B. Beach Profiles at South Bethany Beach, LRP SBB-2
Pink: Summer '23, Cyan: Winter '24, Red: Summer '24, Blue: Winter '25

The average beach volumes determined for South Bethany Beach are shown in Table 14. As part of the federally authorized Delaware Coastal Storm Damage Reduction Projects described above, South Bethany was last nourished in July 2023. Renourishment was captured in the Summer 2023 survey followed by volume loss during Winter 2024. Figure 14B shows the significant difference between the Summer 2023 and Winter 2024 profiles at LRP line SSB-2 mainly due to the erosive effects of TS Ophelia. The berm recovered some of the lost volume during Summer 2024, and while most of this material eroded during Winter 2025, Figure 14B shows some volume accretion in the upper dune.

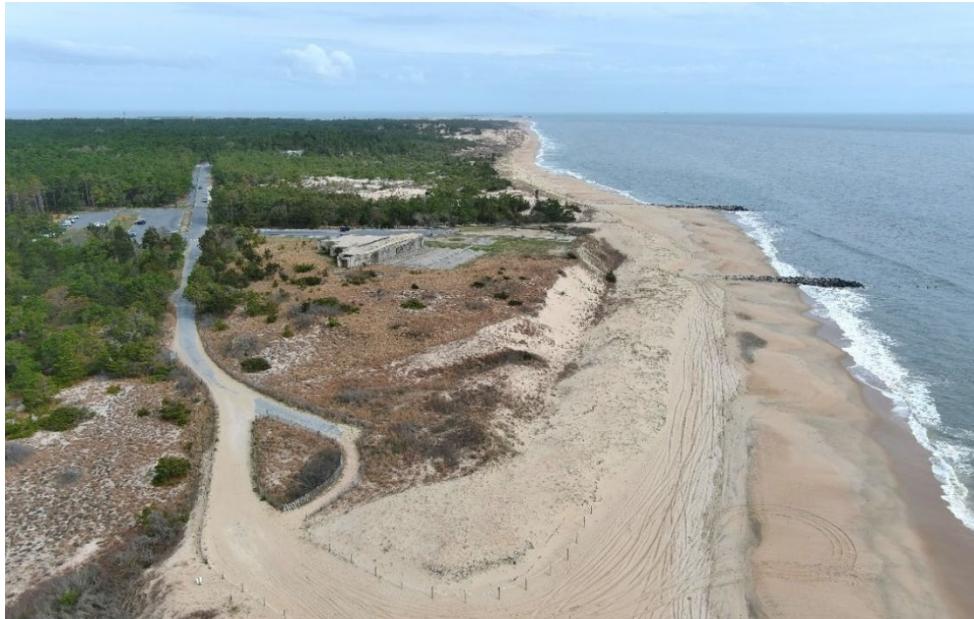
Herring Point (4/11/2024 at 9:40)

Photo taken approaching high tide looking north at the jetties.
