2024 – 2025 Season

Delaware Annual Beach Change Report: Ocean Coast

Prepared by:
Delaware Department of Natural
Resources and Environmental Control

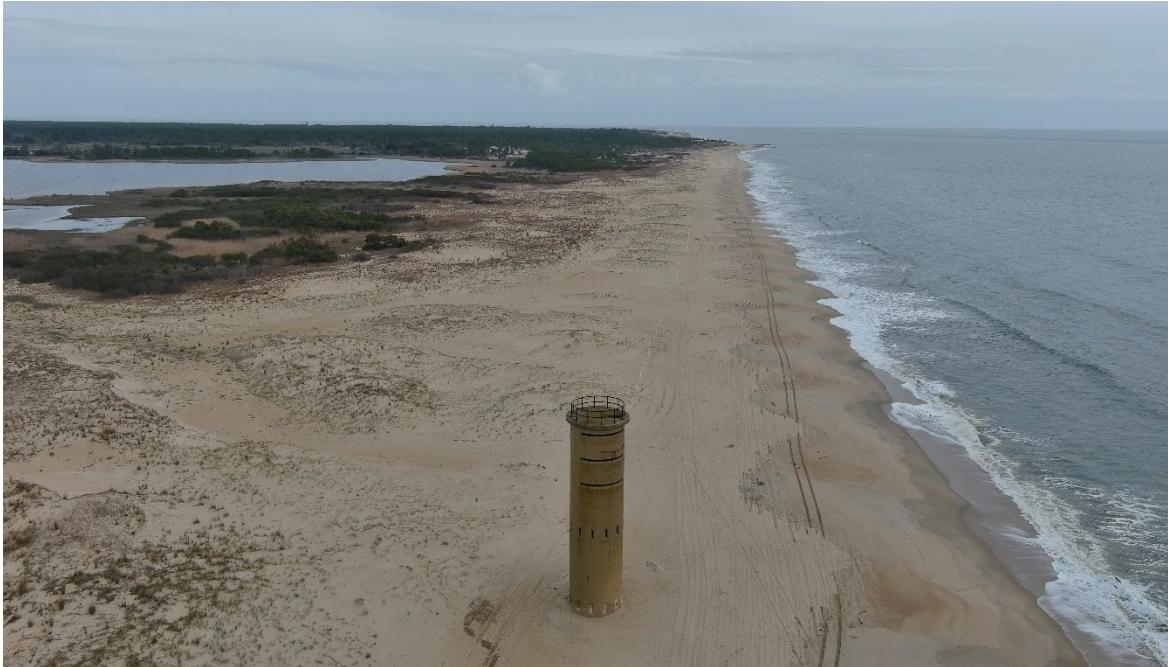
Gordon's Pond (04/11/2024 at 9:46)

Photo taken approaching high tide looking north. Observation Tower #6 appears in the foreground.

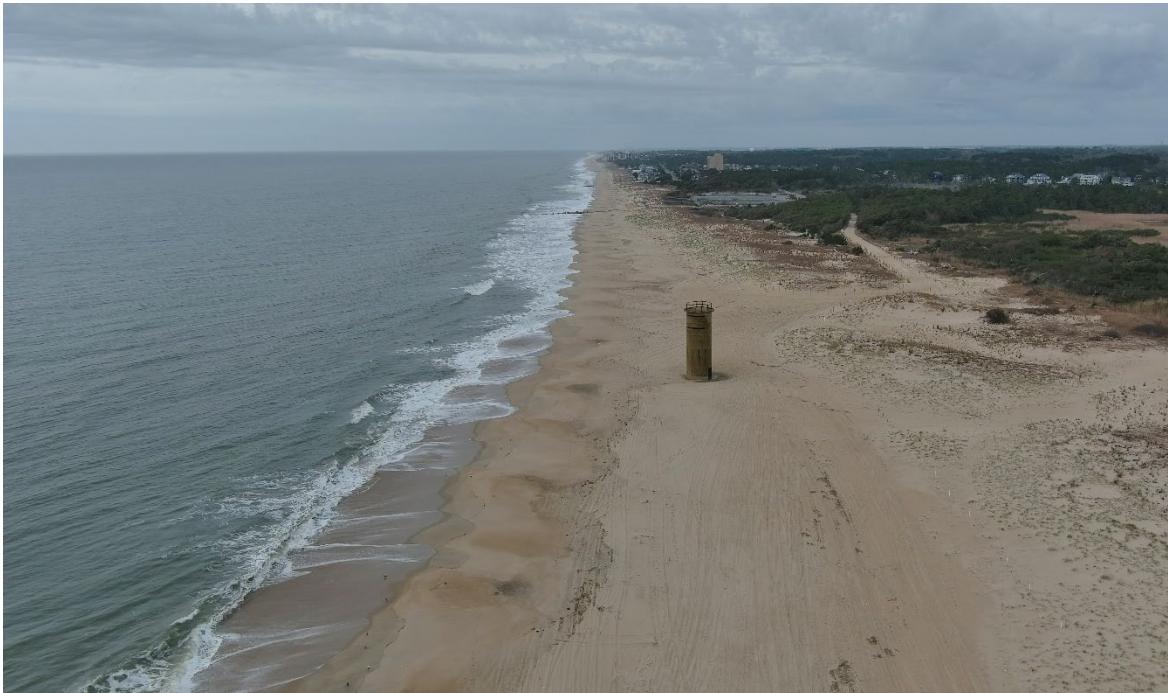
Photo taken approaching high tide looking south. Observation Tower #5 is visible.

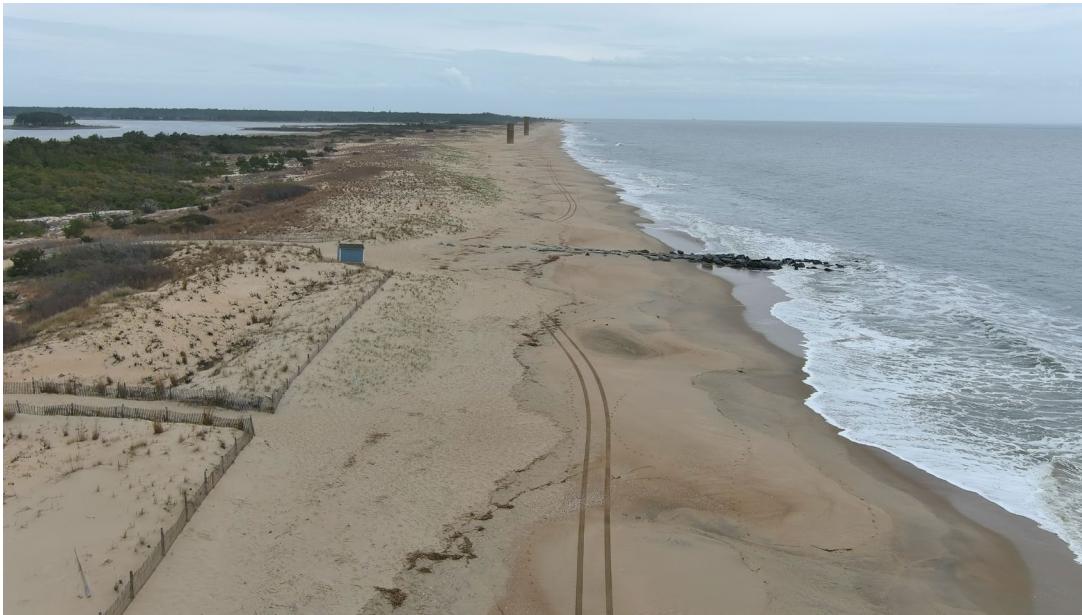
Gordon's Pond (04/11/2024 at 9:51)

Photo taken approaching high tide looking north. Observation Towers #5 and #6 are seen in the background.

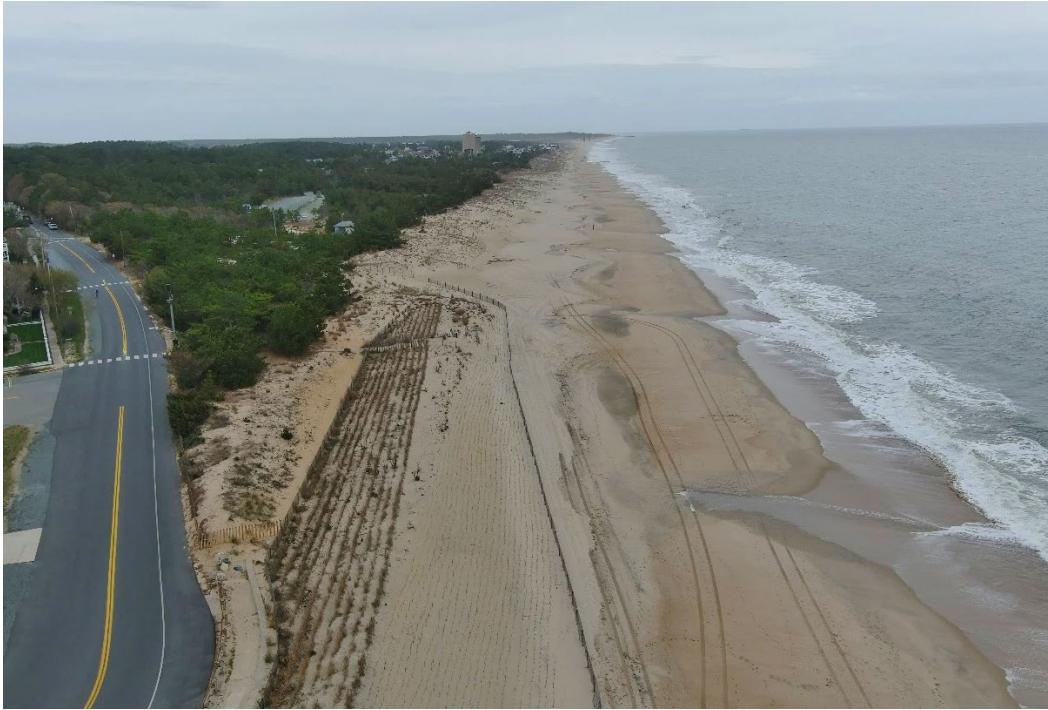
Rehoboth Beach (04/11/2024 at 9:59)

Photo taken approaching high tide looking north at Deauville Beach.

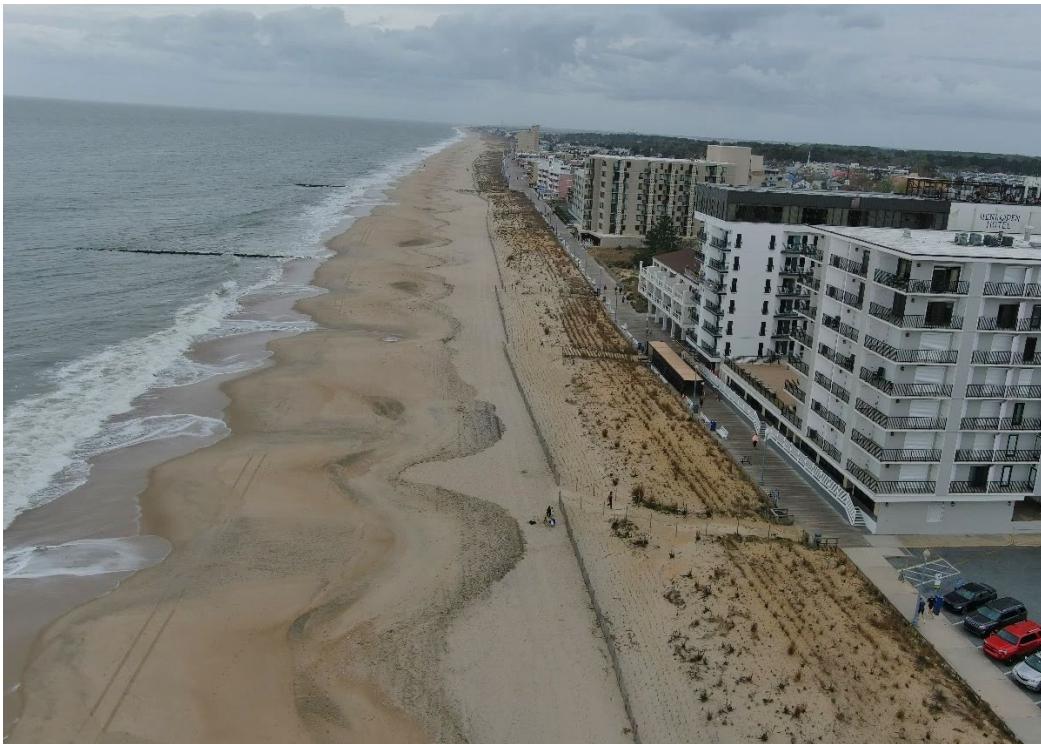
Photo taken approaching high tide looking south. Two groins are visible as well as the northern end of the Rehoboth Boardwalk.

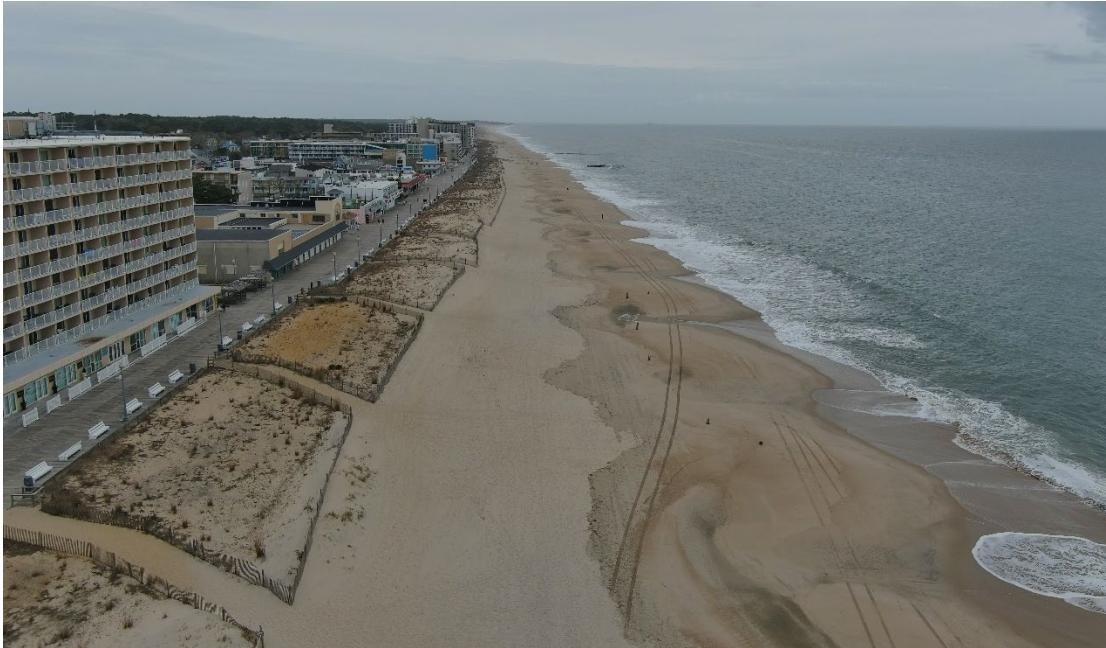
Rehoboth Beach (04/11/2024 at 10:03)

Photo taken approaching high tide looking north. The two groins are seen in the background.

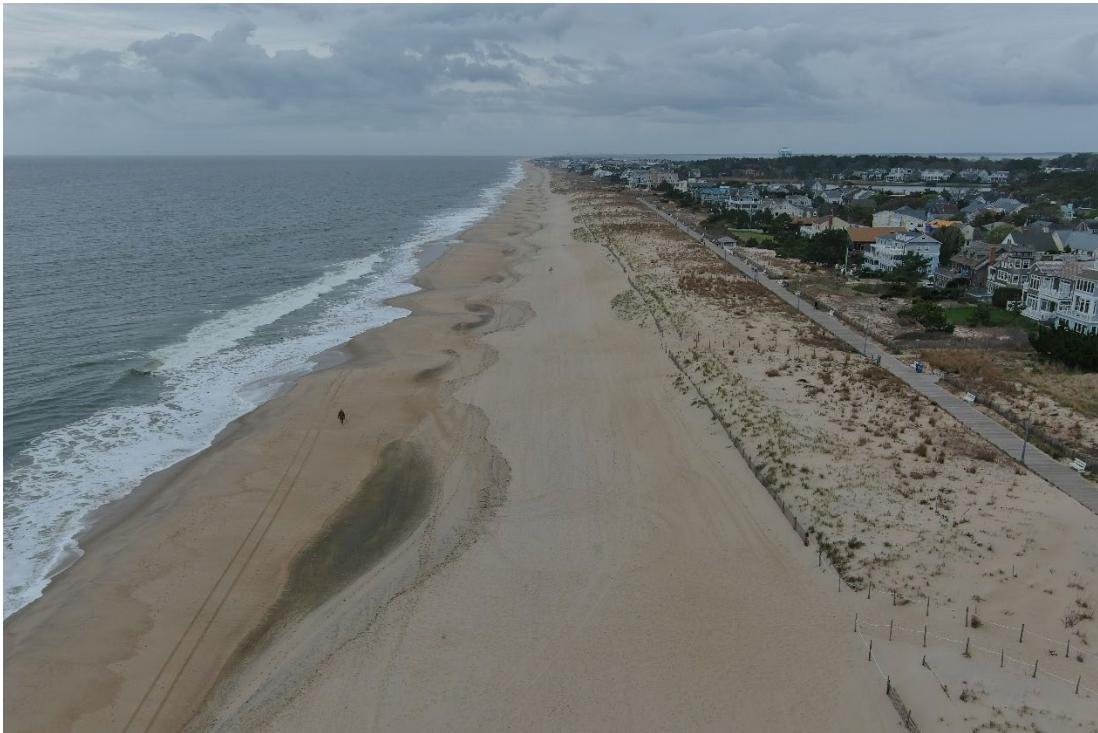
Photo taken approaching high tide looking south at the southern end of the Rehoboth Boardwalk.

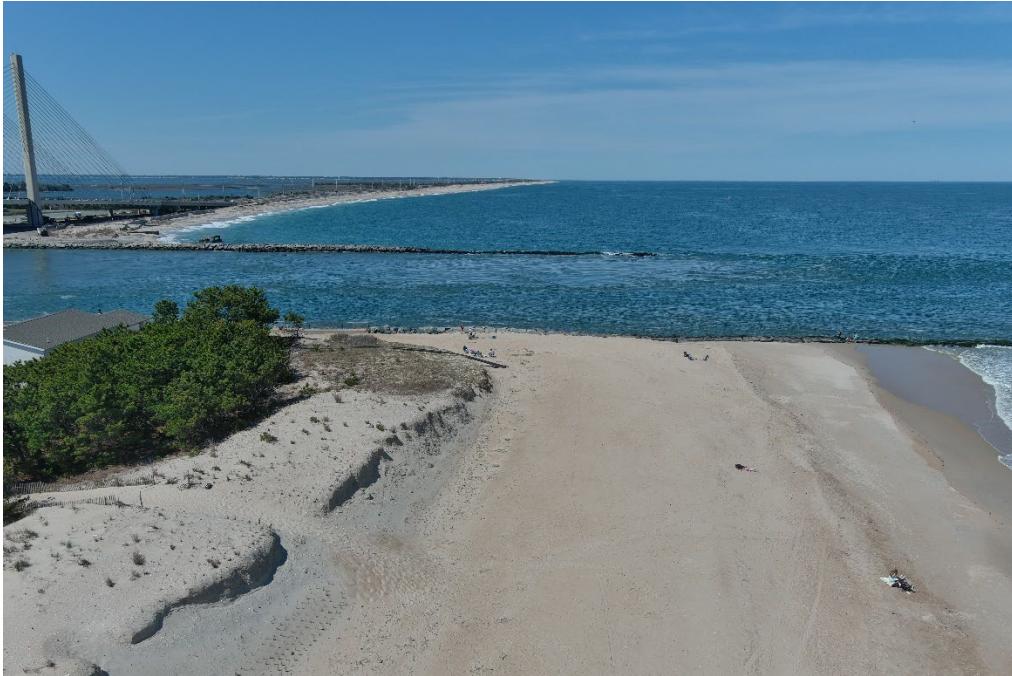
Delaware Seashore State Park - South (4/16/2024 at 14:38)

Photo taken from the southside Inlet beach approaching high tide looking north. The Indian River Inlet and north jetty are visible.

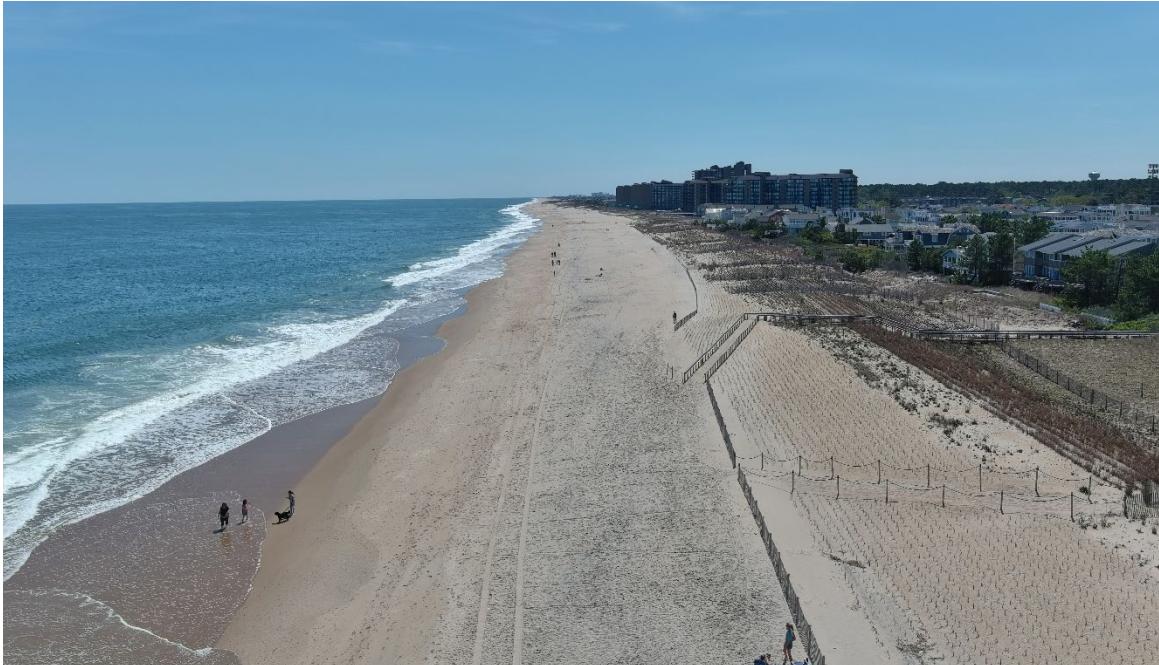
Photo taken from the Town of Bethany Beach approaching high tide looking south. The tall, Sea Colony Condominiums are visible.

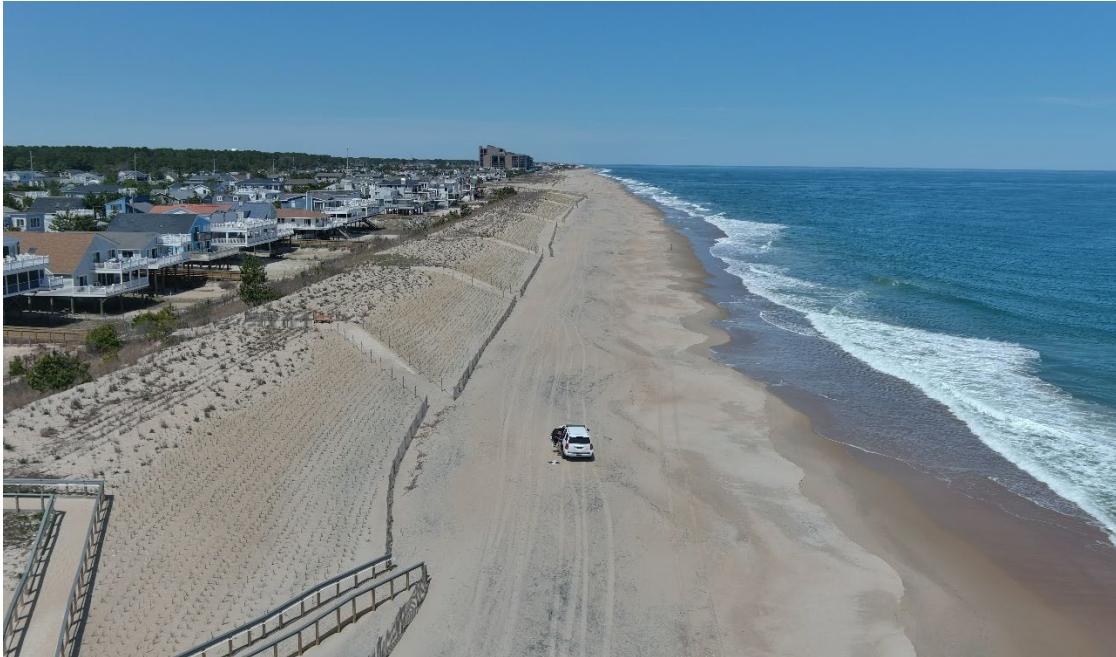
South Bethany Beach (4/16/2024 at 13:27)

Photo taken from South Bethany Beach approaching high tide looking north. The Sea Colony Condominiums are visible in the background.

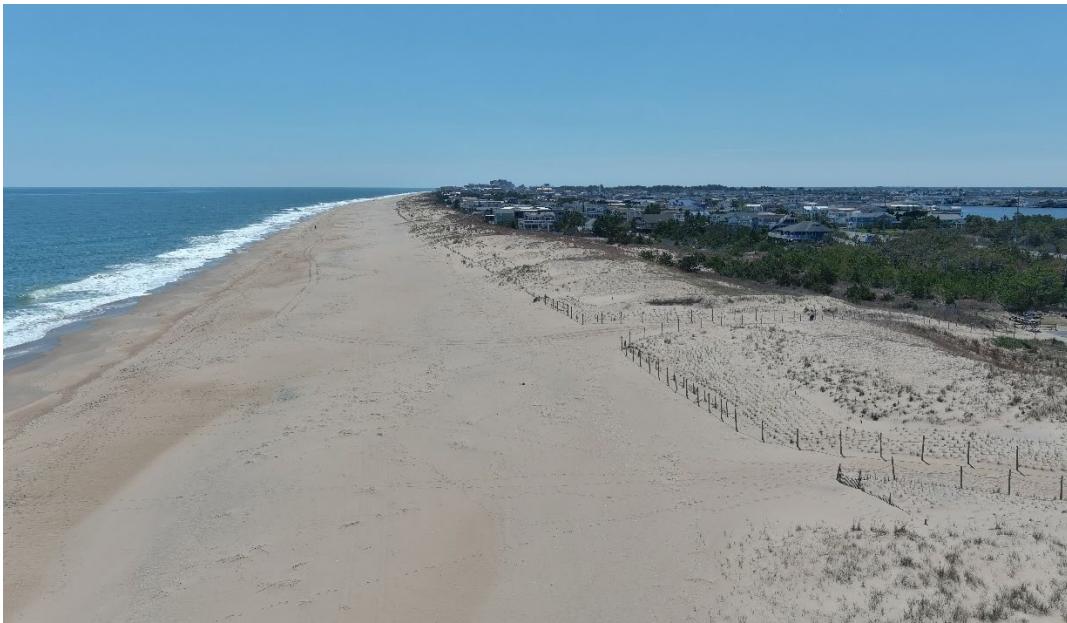
Photo taken from Fenwick Island State Park approaching high tide looking south.

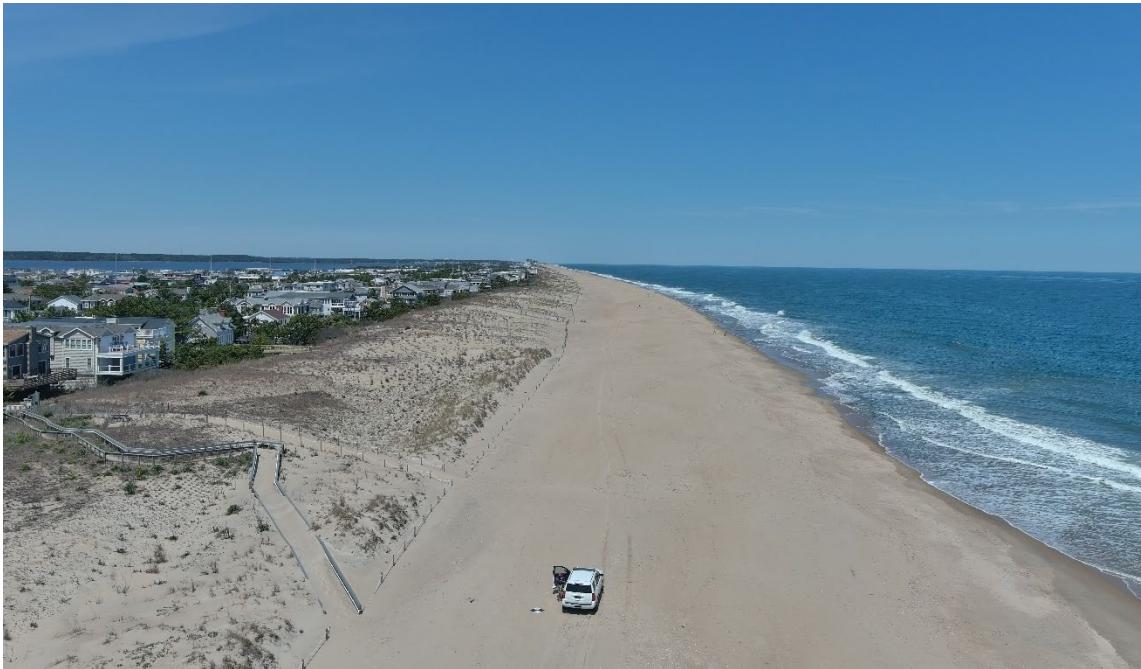
Fenwick Island (4/16/2024 at 13:08) continued.

Photo taken from the Town of Fenwick Island approaching high tide looking north.

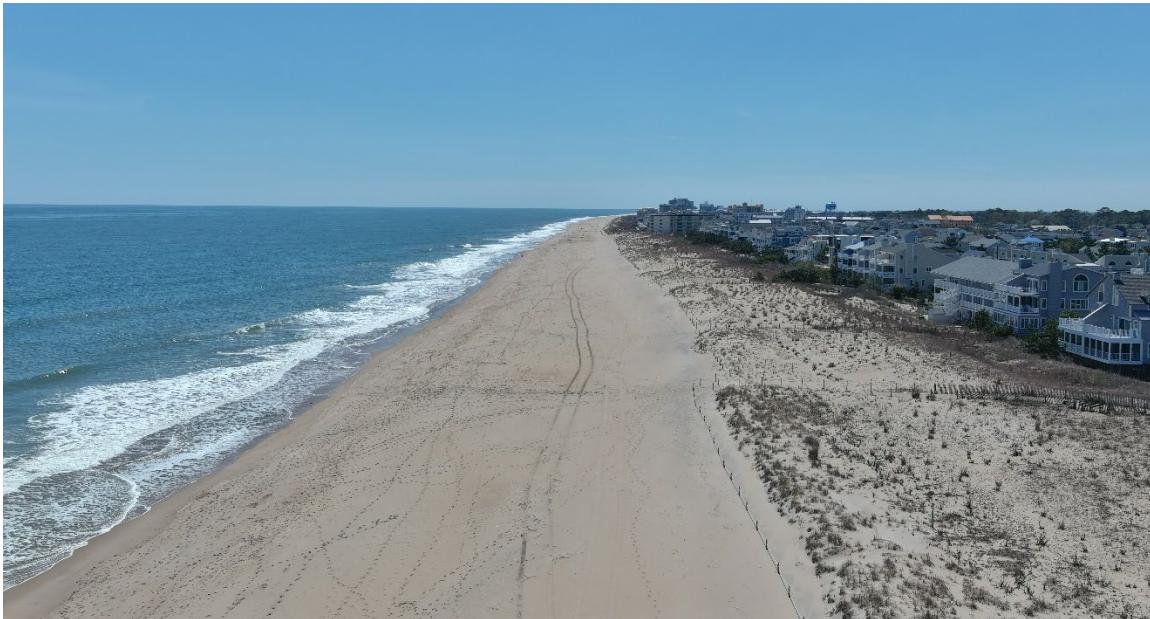
Photo taken from the Town of Fenwick Island approaching high tide looking south at the Delaware-Maryland state border.
