RE: Duffield Associates, LLC Project No. 10692.CJ
Federal Consistency Form
650 Churchmans Road
New Castle, Delaware

Coastal Zone Management Act Federal Consistency Form

Project/Activity Name:	650 Churchmans Road
-------------------------------	---------------------

WAREHOUSE FULFILLMENT DISTRIBUTION CENTER
NEW CASTLE HUNDRED - NEW CASTLE COUNTY, DE

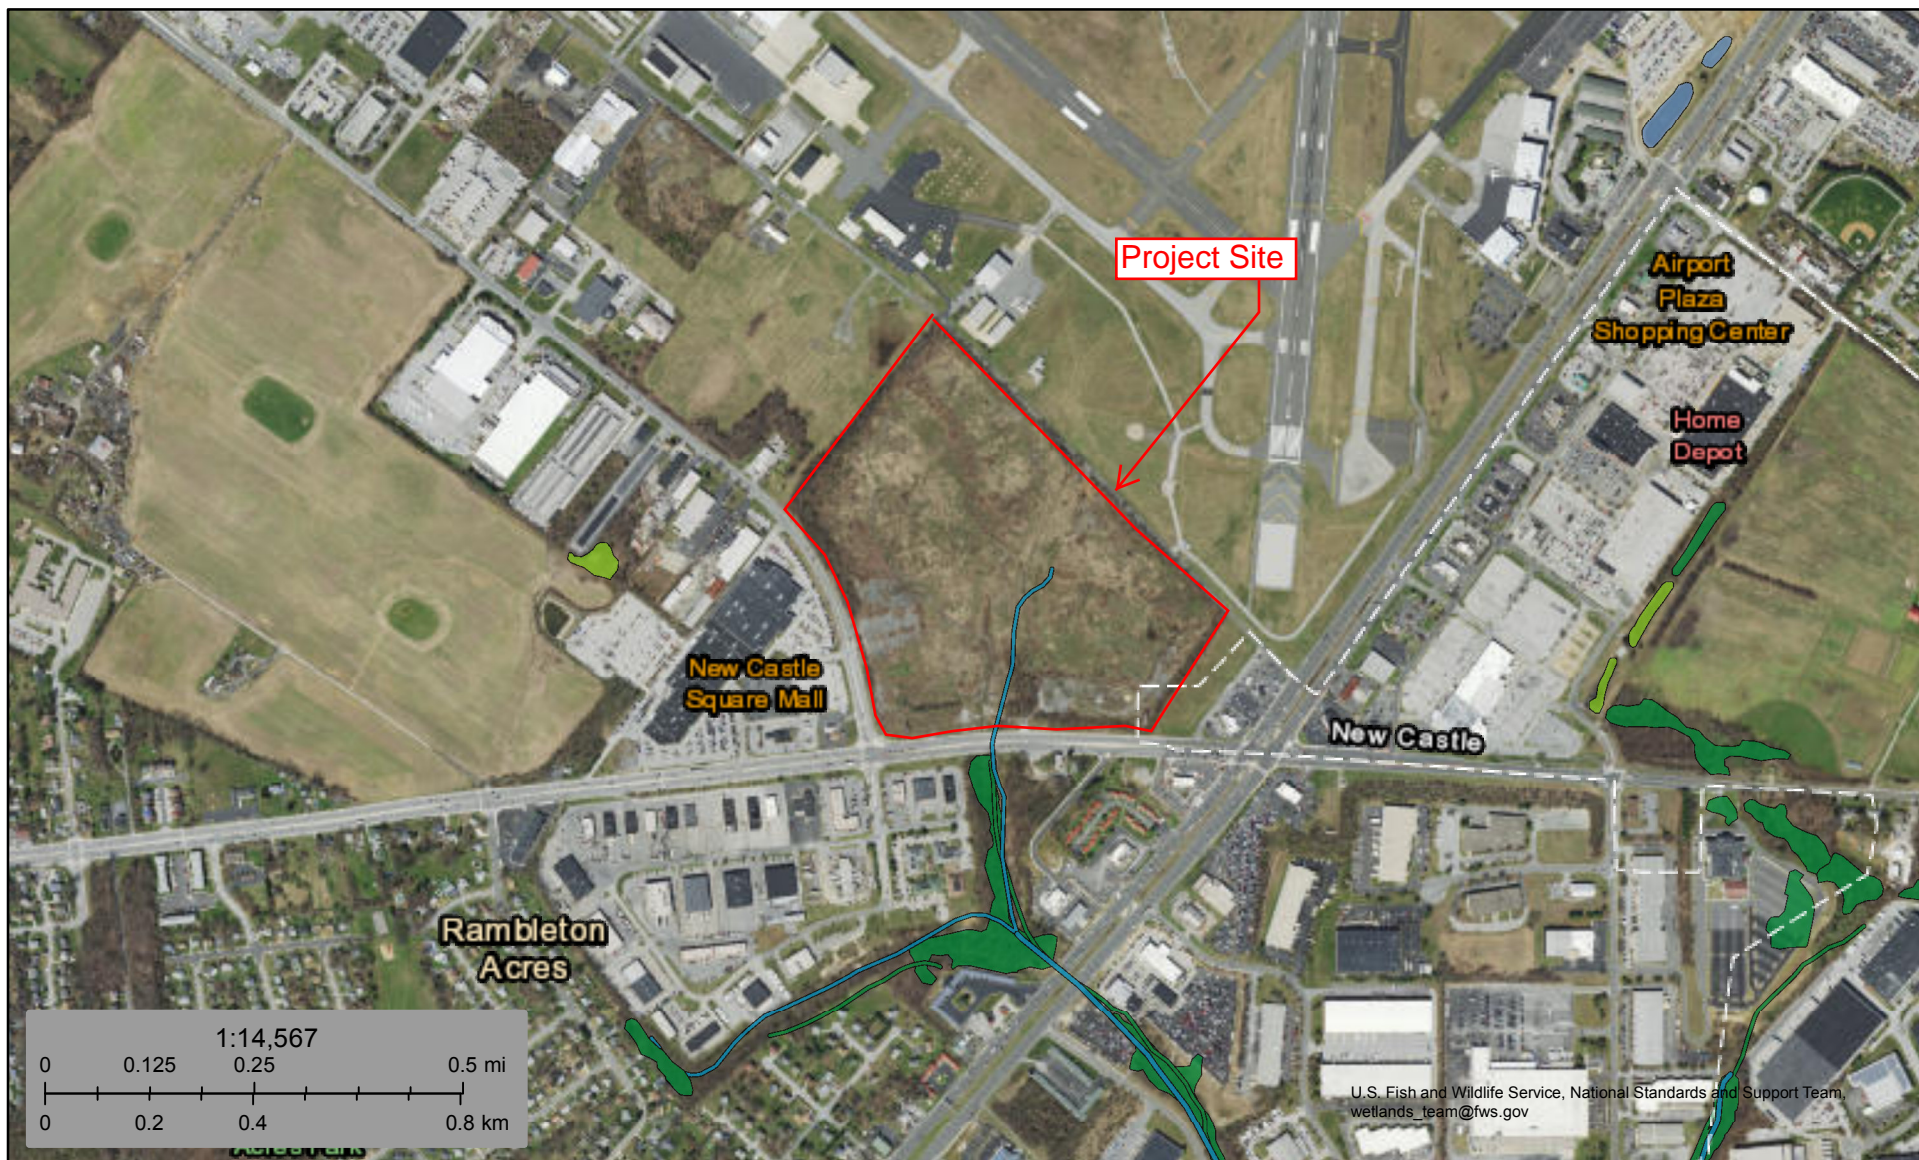
FIGURE 2: NWI MAP

Online NWI Mapping (Figure 2) indicates that a Riverine, Intermittent, Streambed, Seasonally Flooded (R4SBC) wetland is mapped in the southern portion of the project site. The riverine system appears to drain into Army Creek, which is a tributary of the Delaware River. The NWI Map does not show the small pond depicted in the center of the project site by the USGS Map.

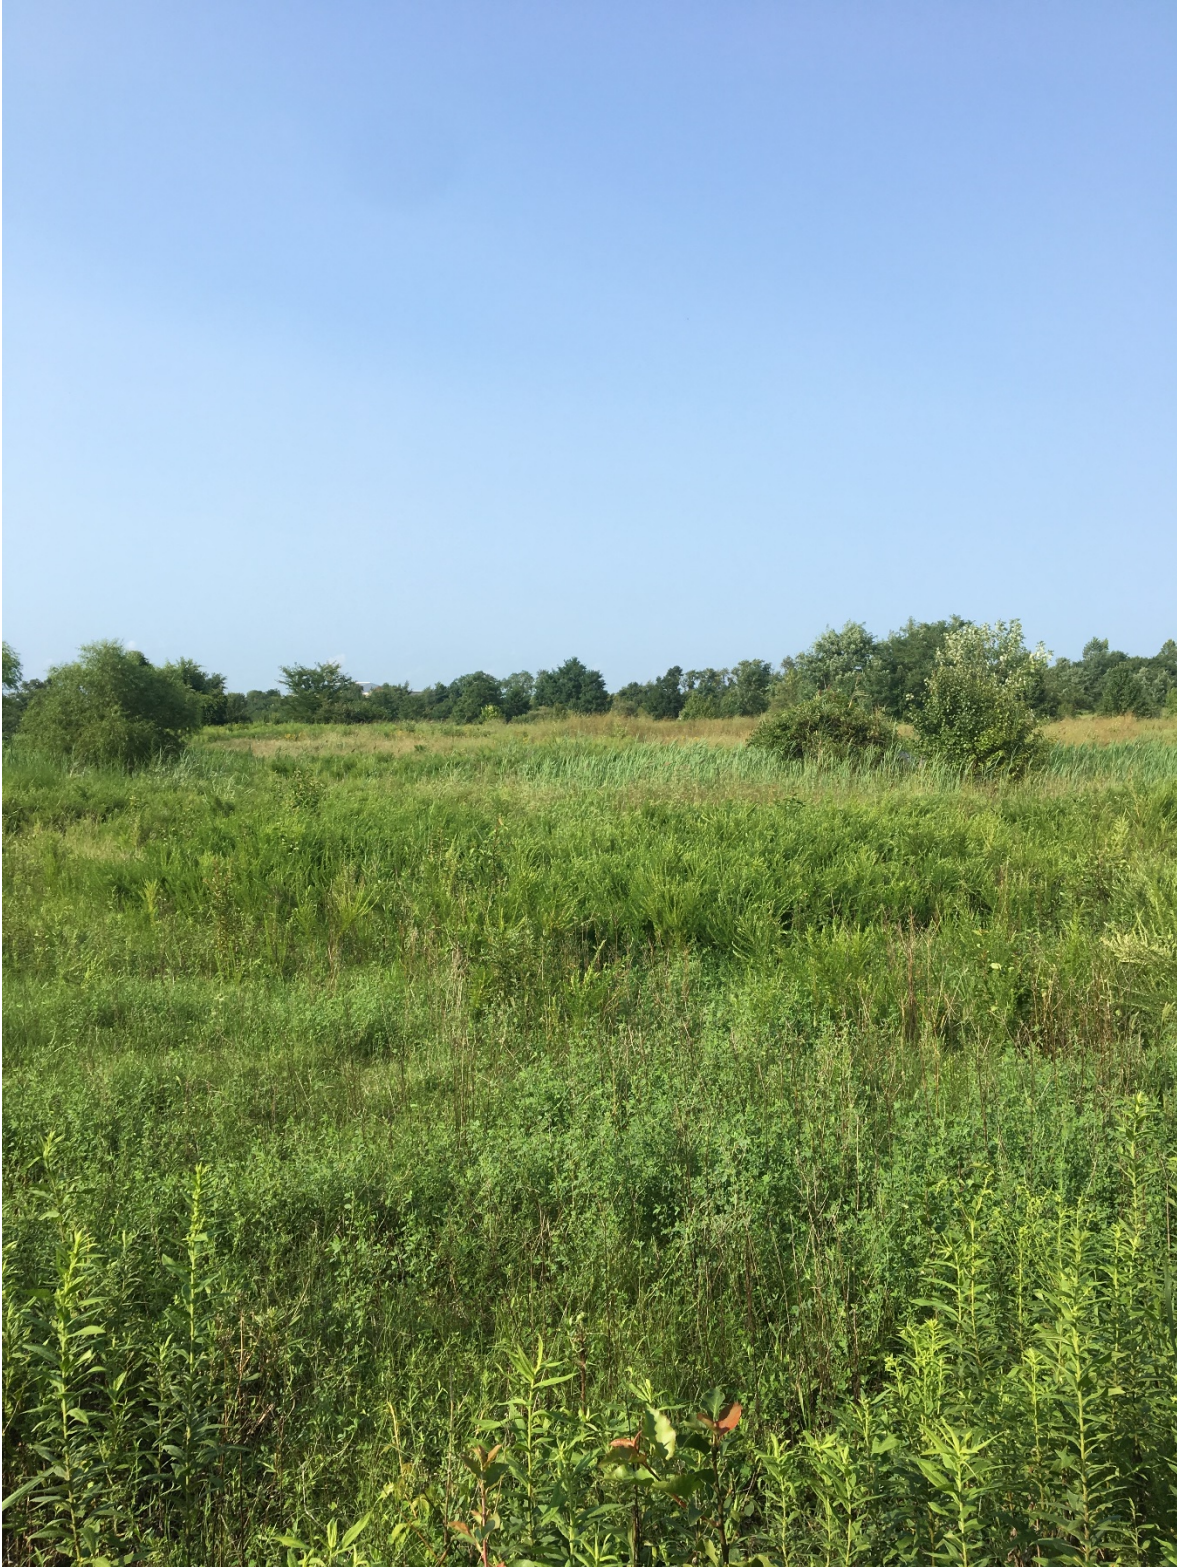
Photograph 1: Shrub-scrub uplands on the project site, looking north.

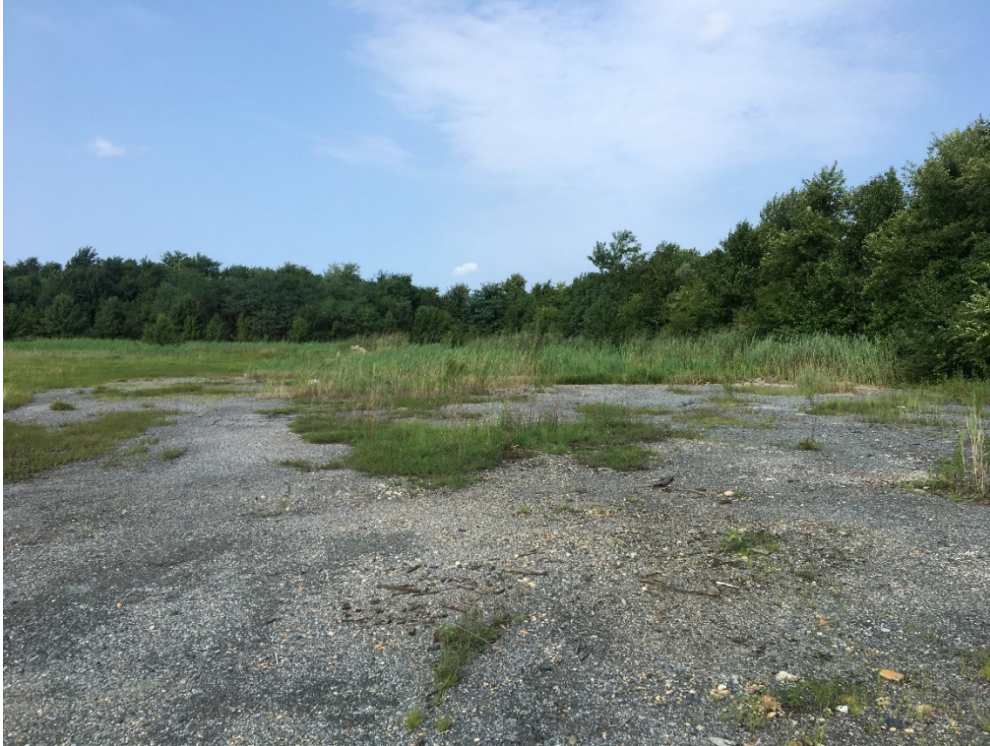
Photograph 2: Overgrown paved areas on the project site.

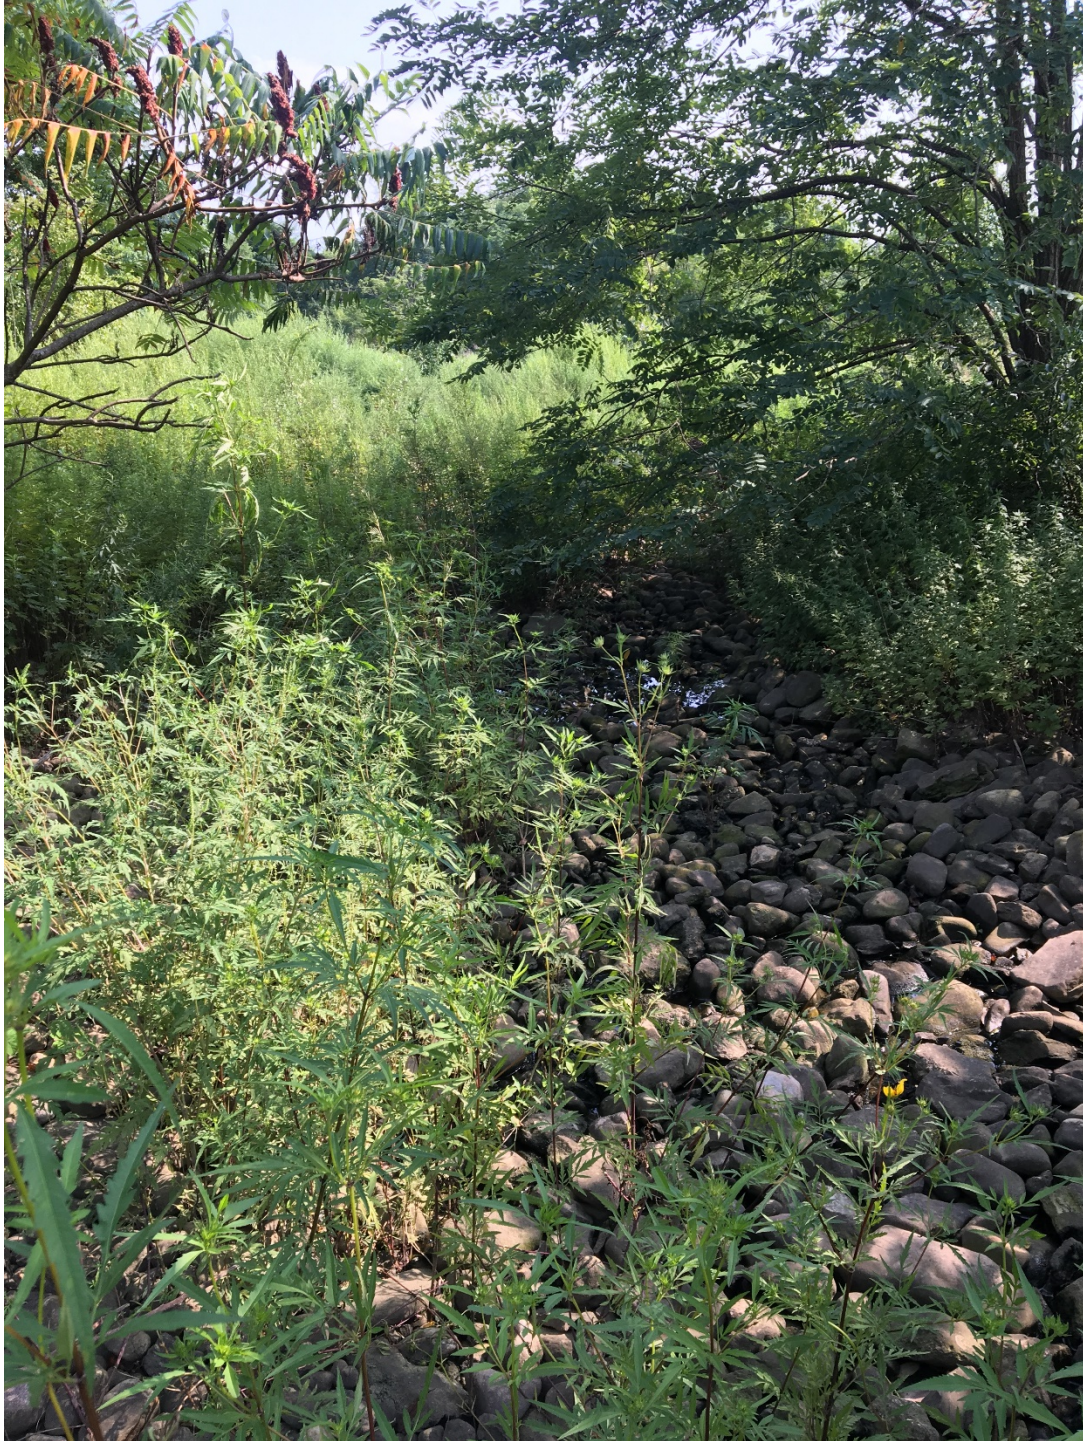
Photograph 3 : Location of Data Point 2 and gravel swale on the project site, looking north. Flow from the swale drains southward into the riverine system.

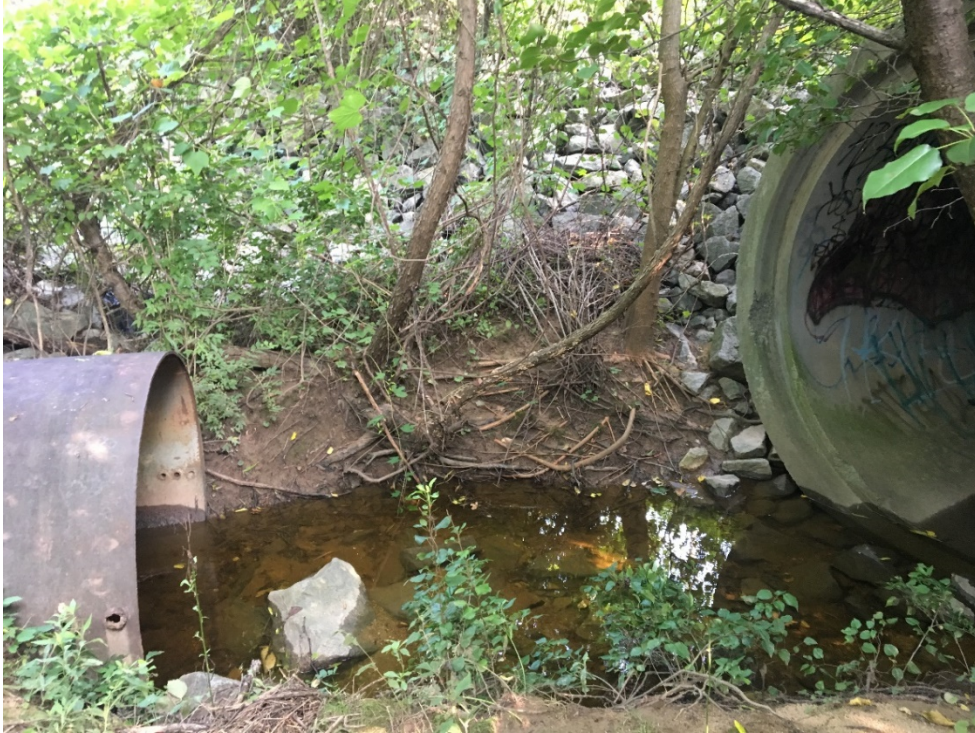
Photograph 4: Flow from the pipe then travels through a second pipe. The second pipe transports flow off the project site, where it eventually drains into Army Creek.

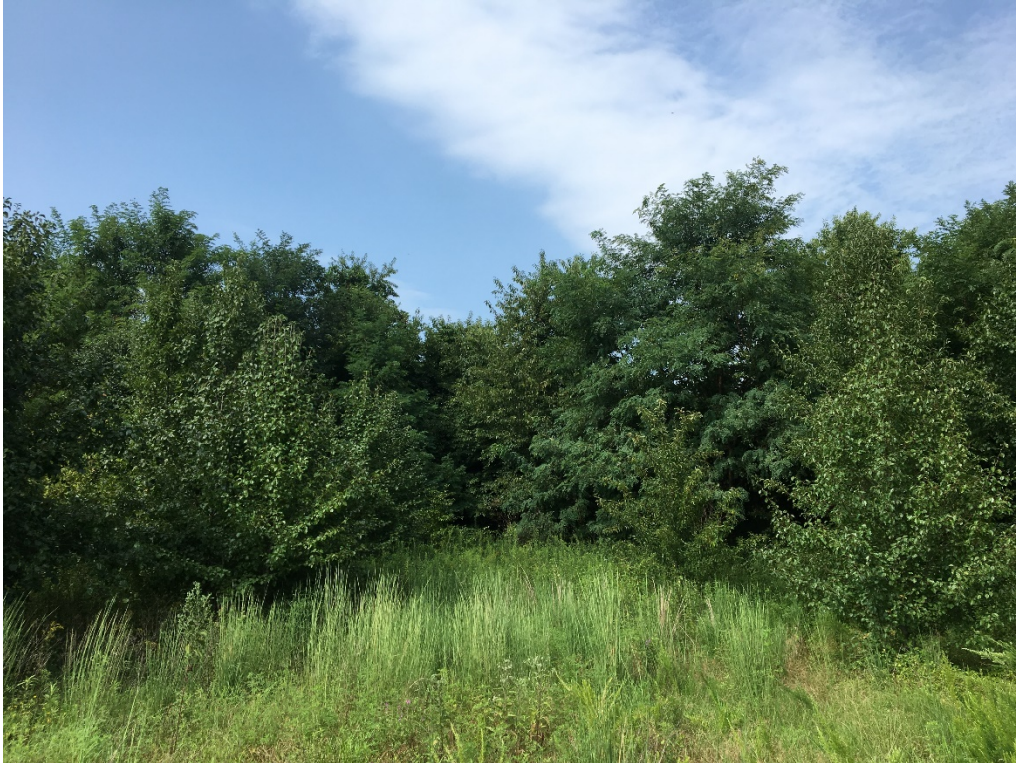
Photograph 5: Location of Data Point 1, looking north. Data Point 1 was taken in the northeast corner of the project site.

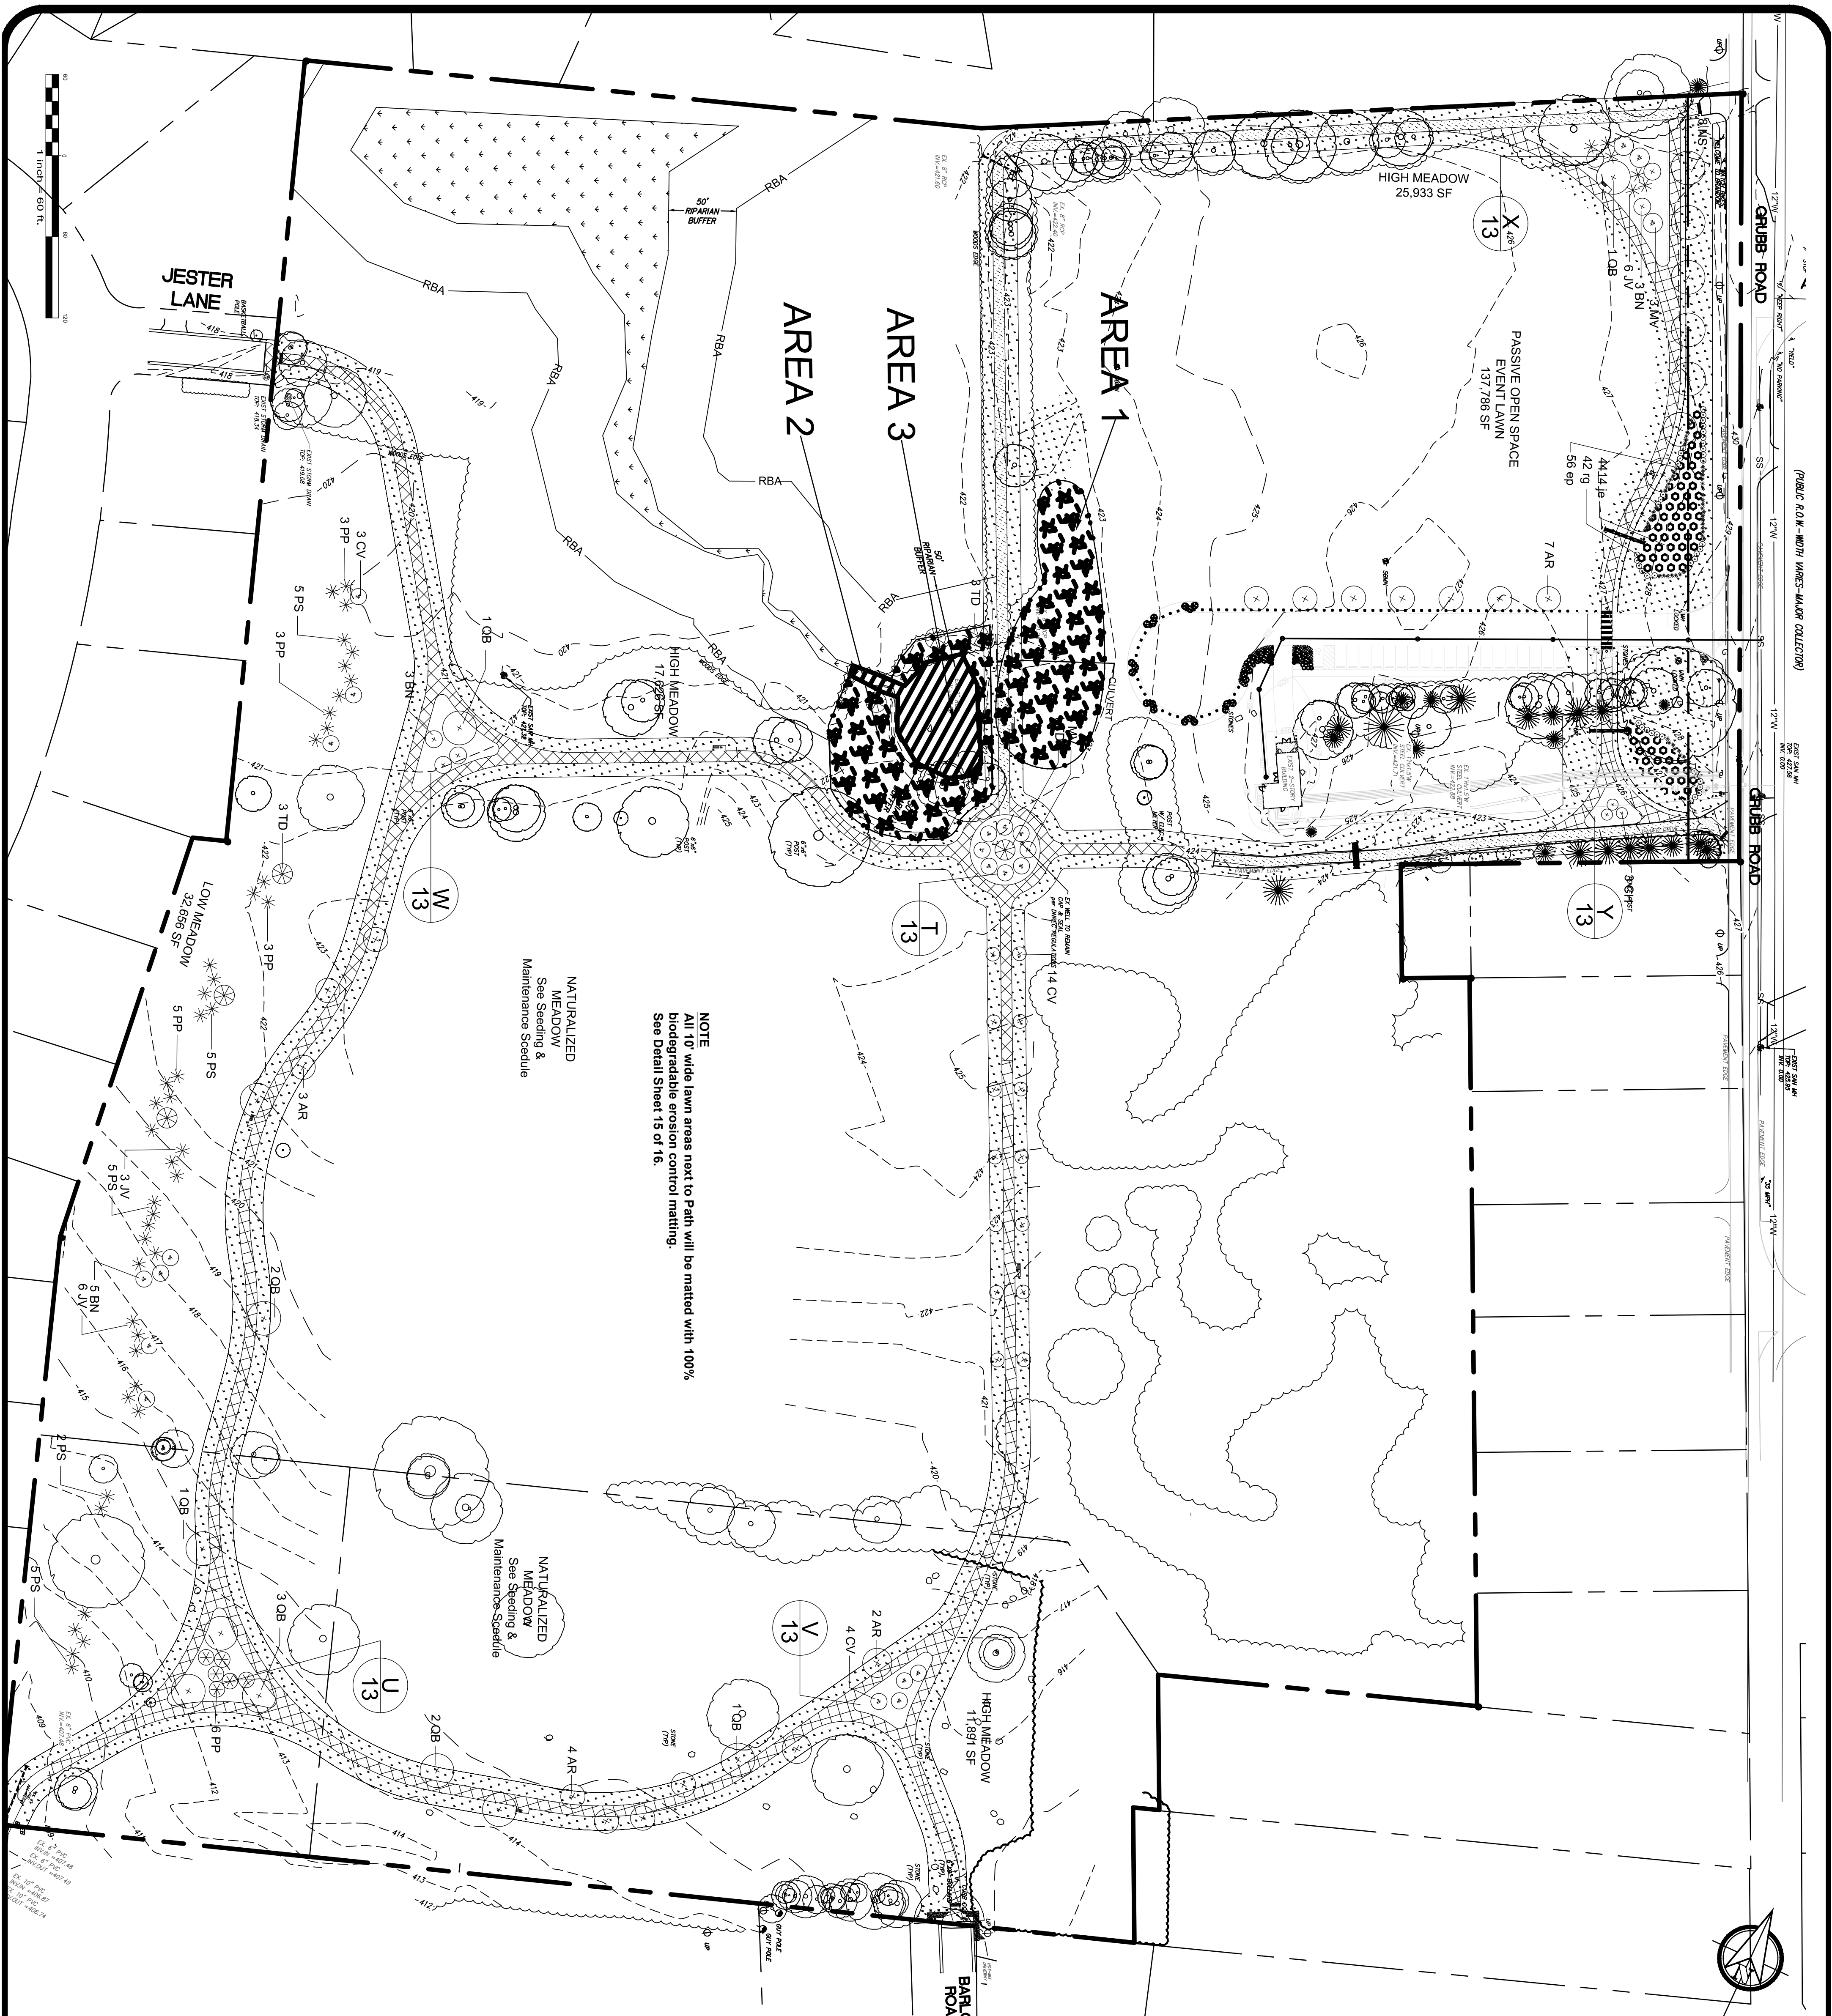
NOTE
 All 10' wide lawn areas next to path will be matted with 100% biodegradable erosion control matting. See Detail Sheet 13 of 16.

NATURALIZED MEADOW
 See Seeding & Maintenance Schedule

1. GRADE THE PASTURE TO ENHANCE THE CONCEALED LANDFORM WHICH WILL INCREASE WATER STORAGE AND PROMOTE THE ESTABLISHMENT OF WETLANDS.
 2. SEE RECOMMENDED PLANT LIST - PREFERENCE GIVEN TO PLANTS WITH AESTHETIC AND WILDLIFE VALUE.

2. GRADE THE PASTURE TO INCREASE SHADE AROUND THE POND AND CREATE MORE VEGETATION DIVERSITY. SEE RECOMMENDED PLANT LIST. PREFERENCE WILL BE GIVEN TO PLANTS WITH AESTHETIC AND WILDLIFE VALUE.
