Appendix 18

HARVEY AND HARVEY LANDFILL PROPERTY WILMINGTON, DELAWARE

SIRS ID: DE-0047

PCB Mass Loading Phase II
Harvey and Harvey Landfill Property
SIRS ID: DE-0047
Newport, Delaware

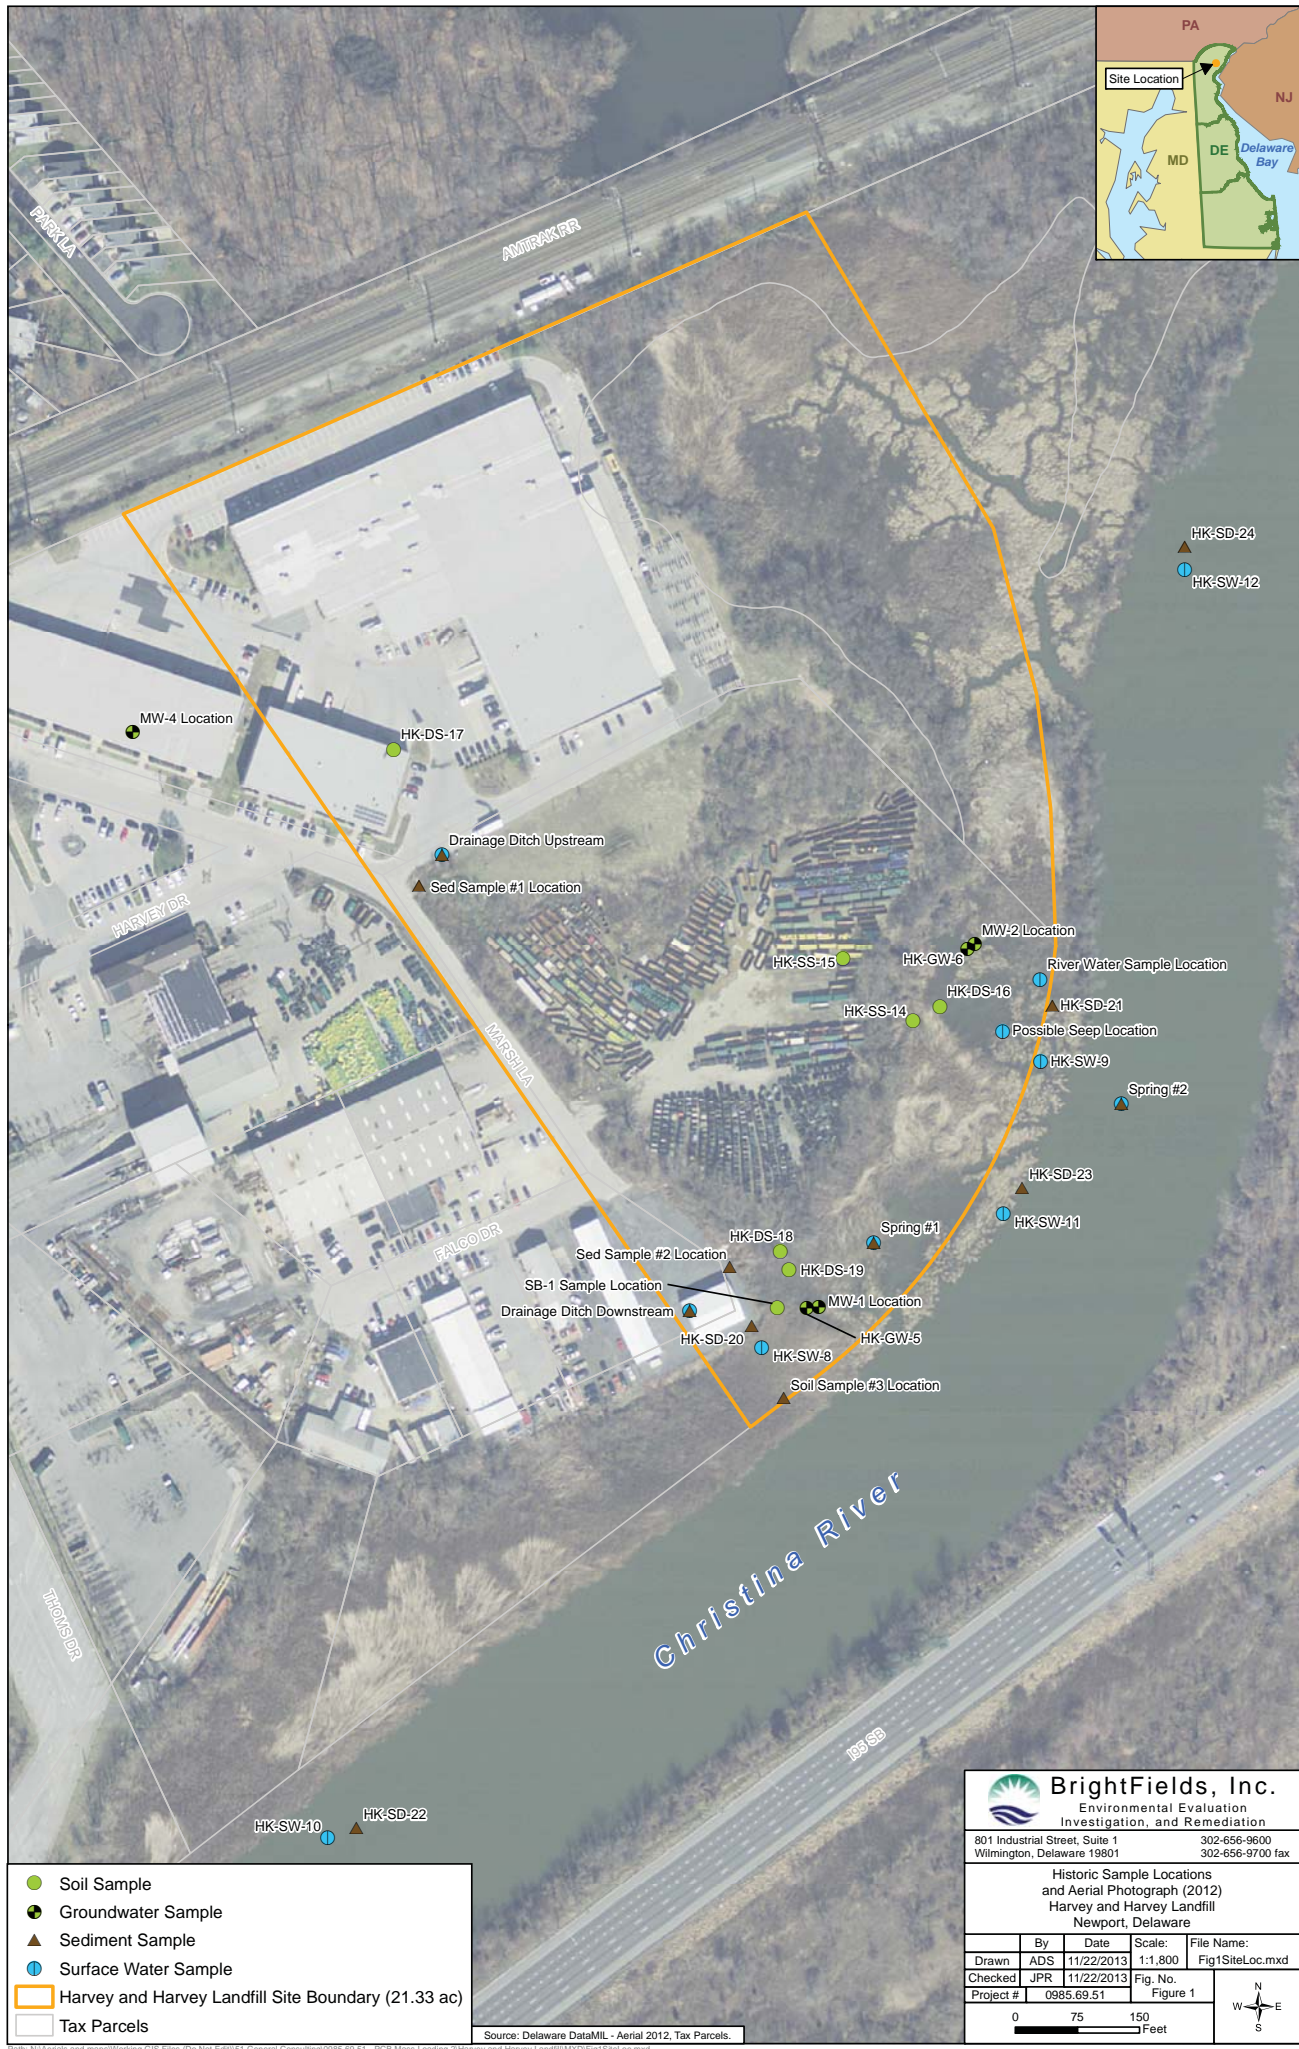
By	Date	Scale:	File Name:
Drawn	ADS 11/22/2013	1:1,800	Fig1SiteLoc.mxd
Checked	JPR 11/22/2013	Fig. No.	
Project #	0985.69.51	Figure 1

Historic Sample Locations
and Aerial Photograph (2012)
Harvey and Harvey Landfill
Newport, Delaware

The Harvey and Harvey Landfill Property is located at 420 Marsh Lane in Newport, Delaware (Figure 1). The site is approximately 21.3 acres in size and consists of two parcels (#2000500002 and #2000700001). The property currently is owned by Edgar Thomas Harvey Jr., President of Harvey Development Company.

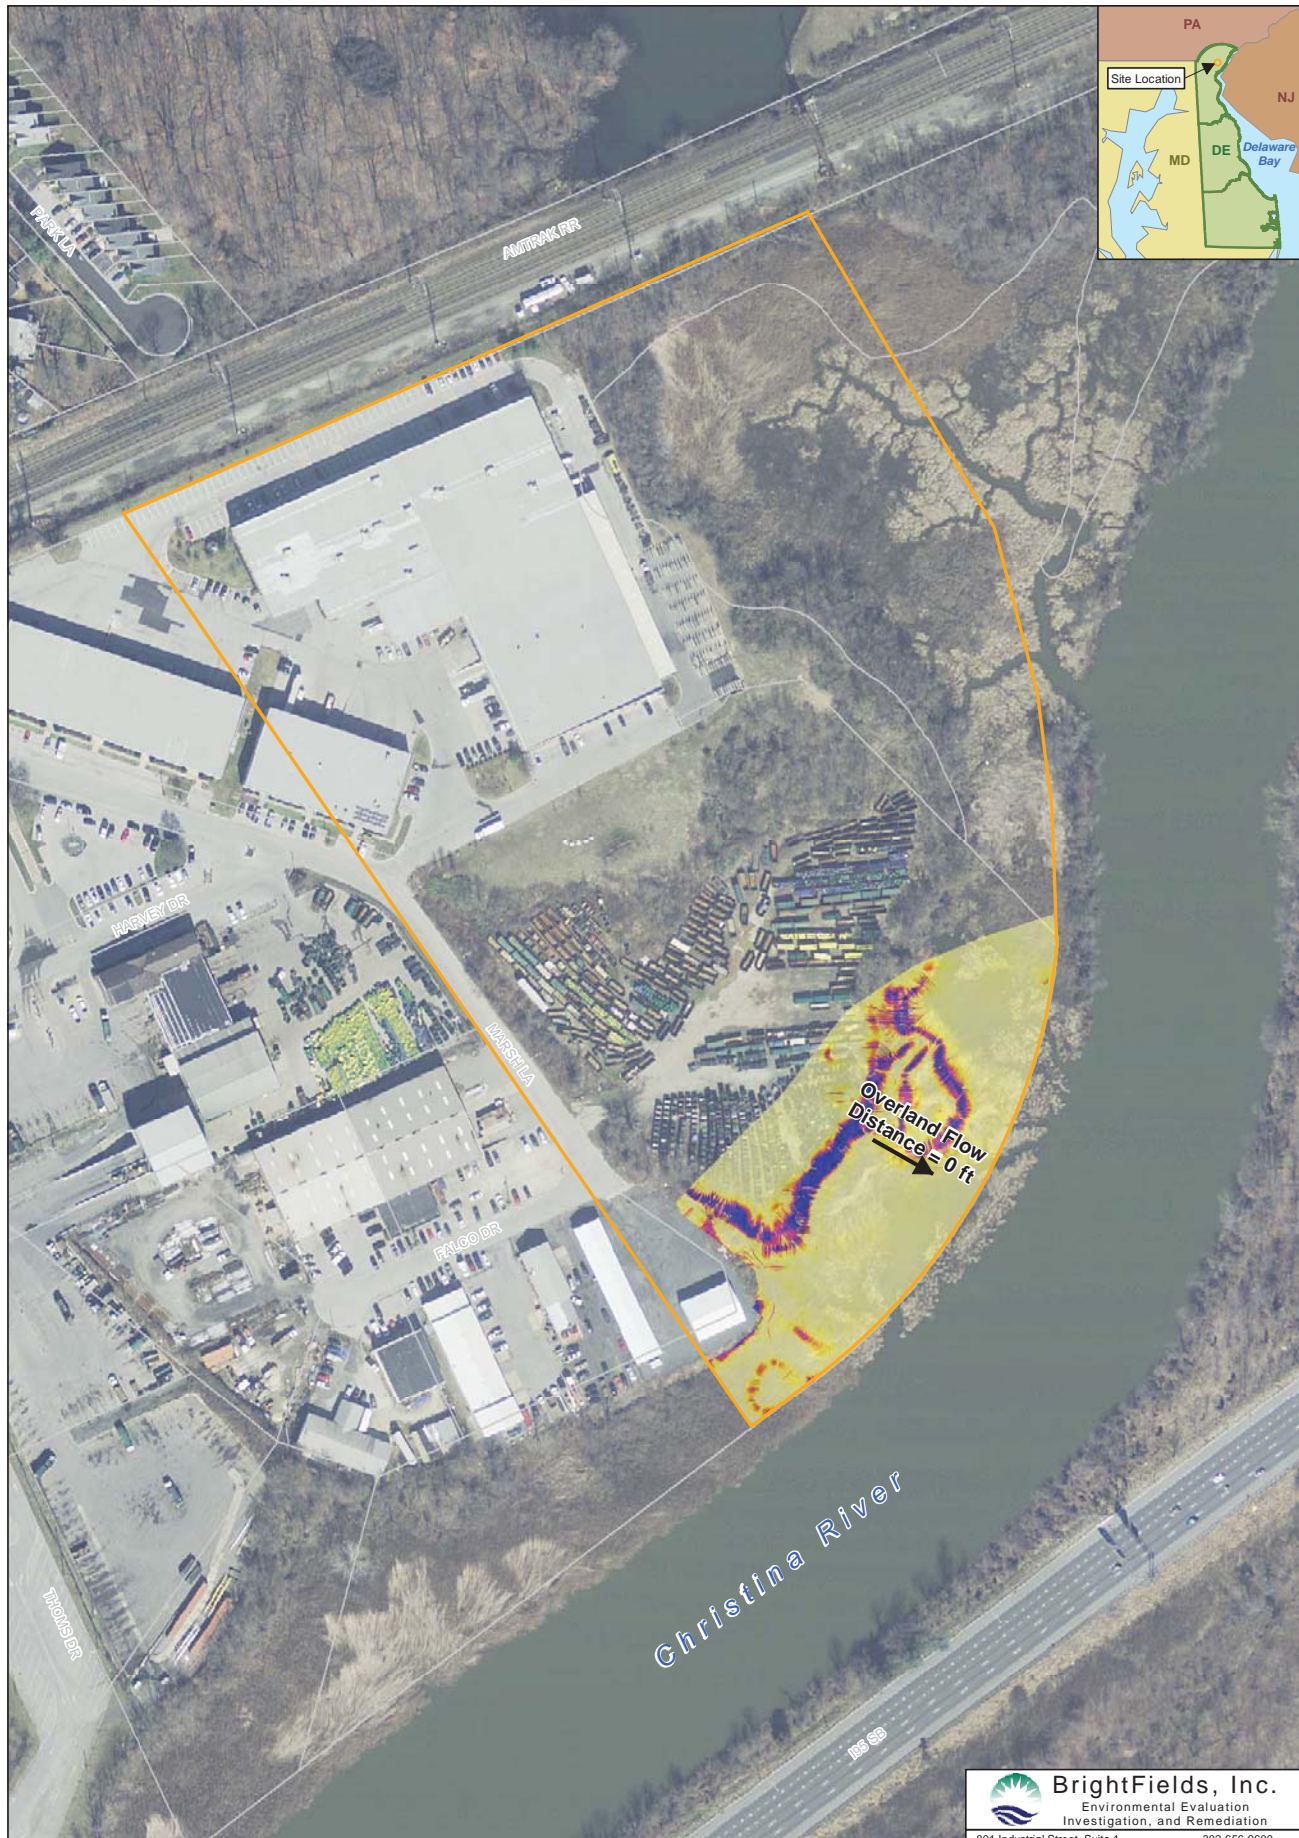
Drawn	By	Date	Scale:	File Name:
ADS	ADS	6/18/2014	1:1,800	Fig6SoilLoss.mxd
Checked	By	Date	Fig. No.	
KEP	KEP	6/18/2014	Figure 6	
Project #	0985.69.51

→ Overland Flow
 [Orange Outline] Harvey and Harvey Landfill Site Boundary (21.33 ac)
 [White Outline] Tax Parcels
 Tons/Year/Acre of Soil Loss Estimated
 High : 26.72
 Low : 0

Soil Loss Estimates
 Harvey and Harvey Landfill
 Newport, Delaware

P = support practice factor (dimensionless)	1	No documentation was provided indicating that any sediment and erosion controls are in place.
A = average annual soil loss estimate (ton/ac-yr)	0.34	The average soil loss estimate was generated by ArcGIS using the input factors listed above.
Erodible Area (acres)	3.1	The erodible area was calculated based on the pervious surfaces within the area of concern polygon for surface soil (Figure 6).

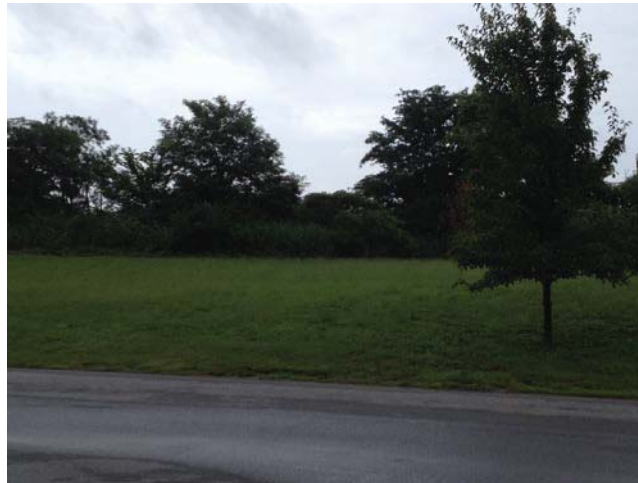
South of the building where the land slopes upwards gently and is densely vegetated at the top.

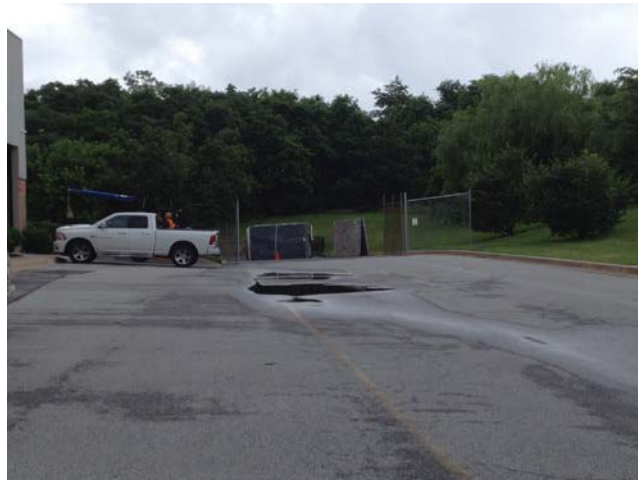
The western portion of the site at the edge of the parking lot and the beginning of a heavily wooded area.

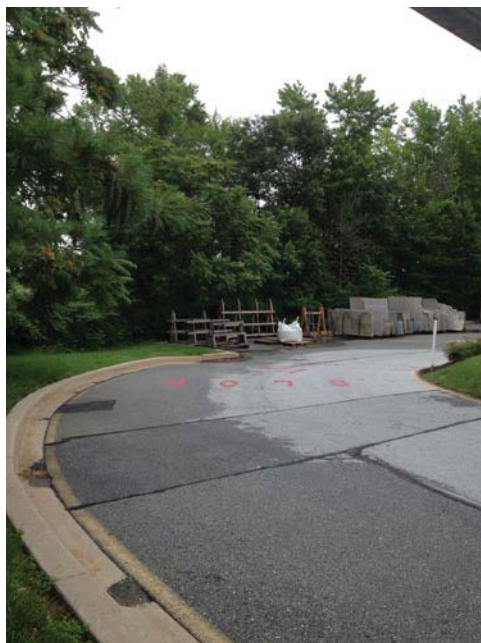
South of the railroad tracks in the northern portion of the site.

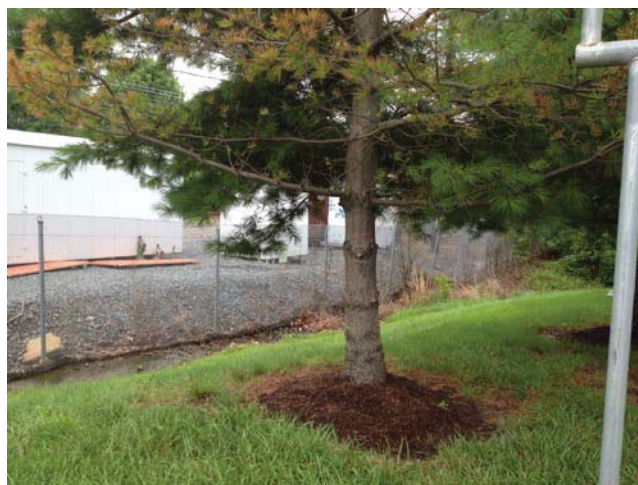
Slope downwards towards the railroad tracks in the northern portion of the site.
