White Clay Creek Dams Analysis of Chemical Contaminants in Sediments

Delaware Department of Natural Resources and Environmental Control

**Watershed Assessment & Management Section
and
Remediation Section**

July 2023

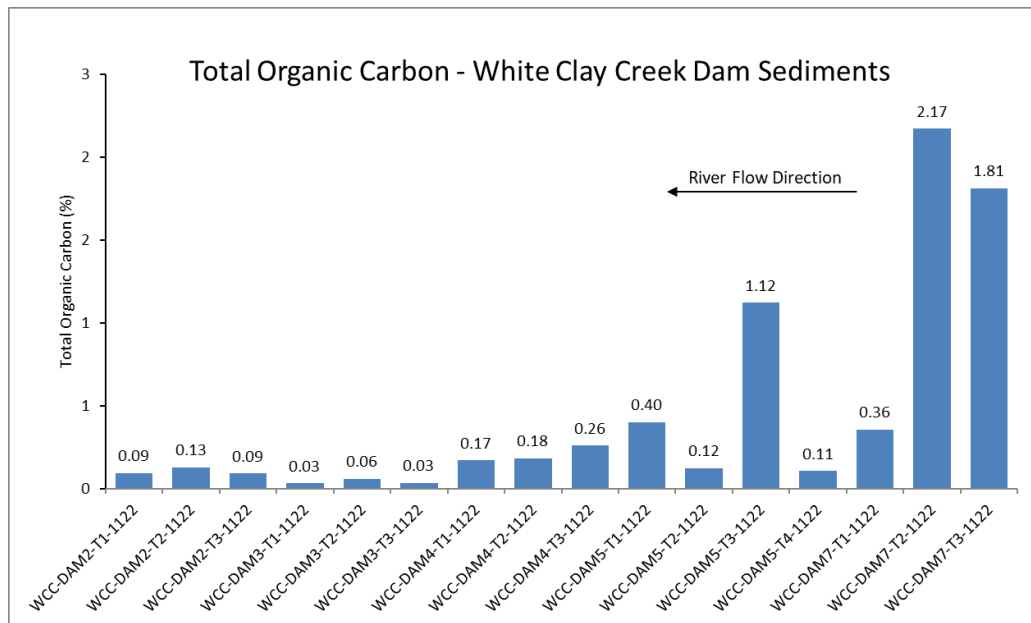
The grain size compositions of the White Clay Creek dam sediment transect samples ranged from 1.4 to 35.4 percent gravel, 31.1 to 94.8 percent sand, 1.3 to 38.5 percent silt, and 0.8 to 17.0 percent clay (Table 3-1). Total organic carbon (TOC) content ranged from 312 milligrams per kilogram (mg/kg) (0.03%) to 21,700 mg/kg (2.17%). The distribution of TOC in the samples is shown in the plot below.

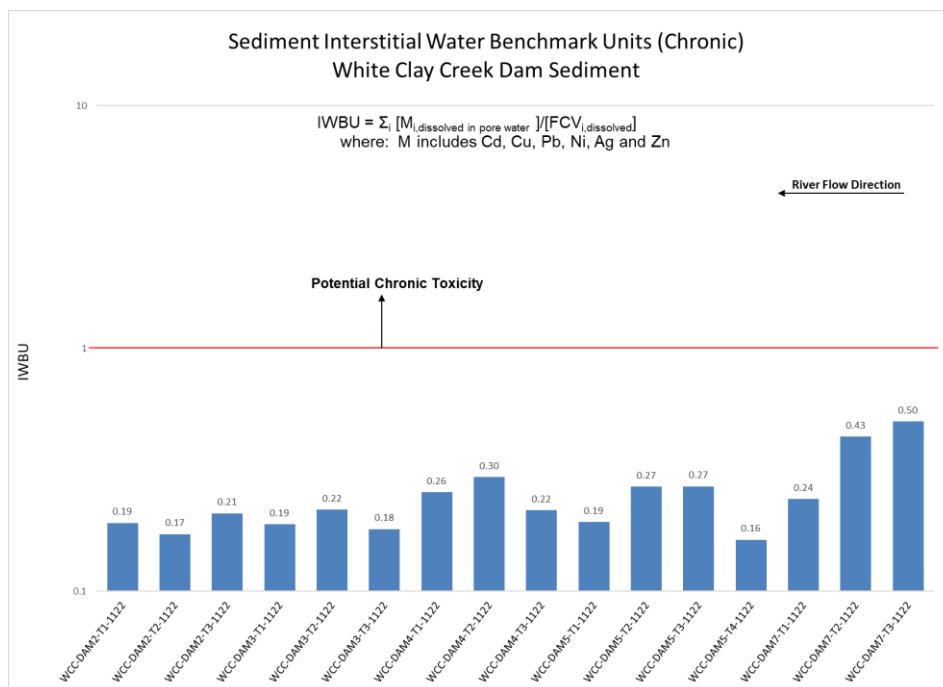
Each of the 16 composite samples from White Clay Creek dam sediments had IWBU values for acute and chronic toxicity less than 1. Close examination of the data indicates that IWBU values, although low, are dominated by copper and cadmium in all cases (Dam #2, Dam #3, Dam #4, Dam #5, and Dam #7).

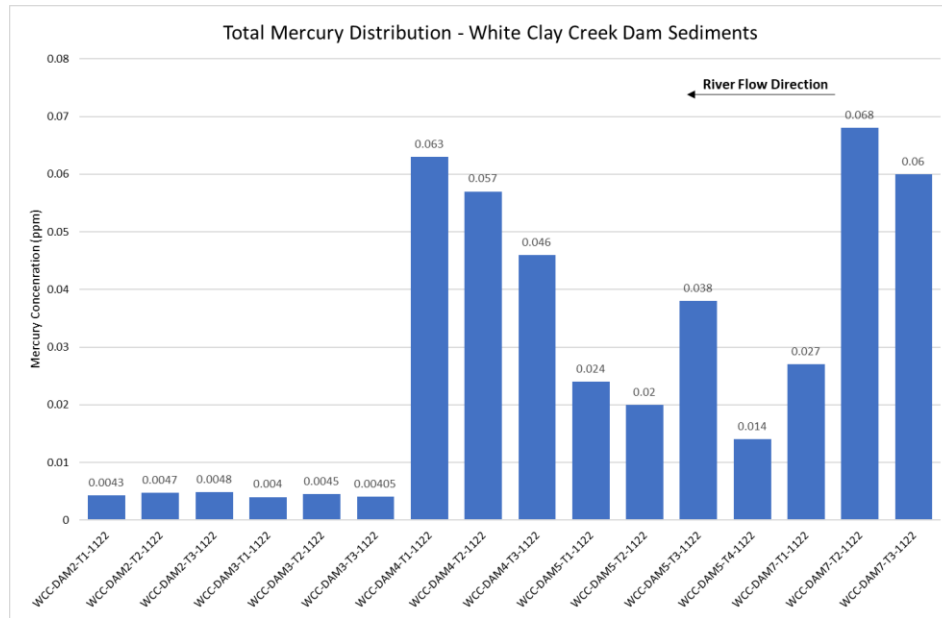
Total mercury was detected in 10 of the 16 sediment samples collected from the White Clay Creek at concentrations exceeding method detection limits. Concentrations ranged from 0.013 milligrams per kilogram (mg/kg) at Dam 5 Transect 4 to 0.068 mg/kg at Dam 7 Transect 2. The plot below shows total mercury concentration in sediments at each sample location. Concentrations plotted for Dams #1, #2, and #3 were set at ½ of the laboratory method detection limit.

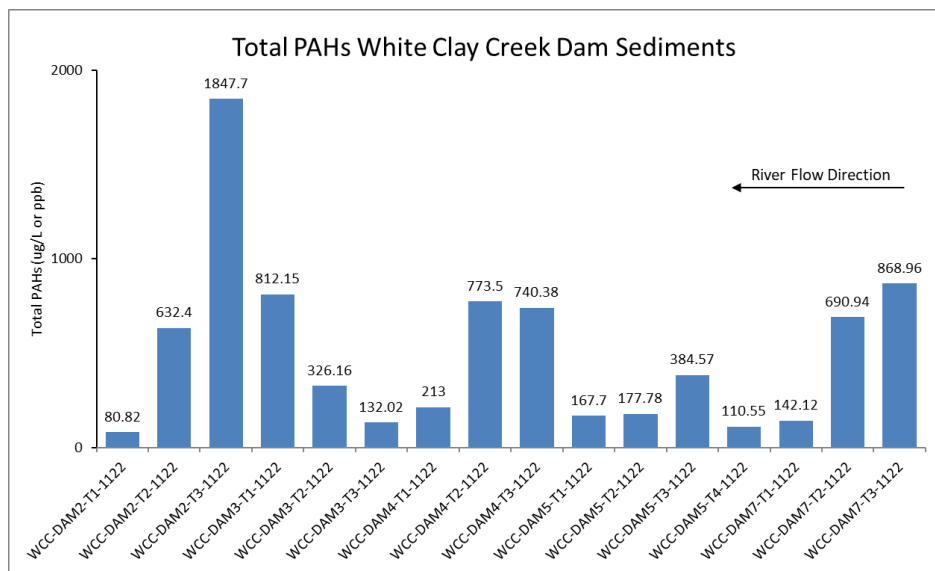
Total PAHs were detected in each of the samples collected, at concentrations between 80.8 ppb and 1,847.7 ppb. The plot below shows the distribution of total PAHs across the study area.
