**Naamans Creek  
Flood Abatement Study**

**Final Report**

December 1999

Duffield Associates, Inc.  
Consultants in the Geosciences  
5400 Limestone Road  
Wilmington, Delaware 19808

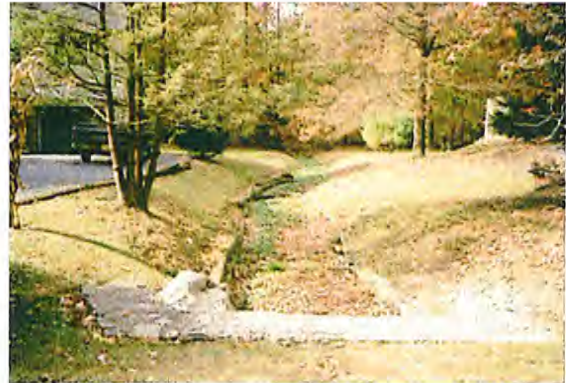
#### **Station PMB1**

Station PMB1 was located at the headwaters of the Main Branch of Naamans Creek, approximately 200 feet upstream of the crossing of Robin's Road in Bethel Township, Pennsylvania. The sampling station was located at the treeline between two residential houses. The drainage area upstream from the station is predominantly forested. A discharge pipe leading from one of the houses had been directed into the stream at the sampling station.

The Main Branch of Naamans Creek at this point in the watershed had been severely affected by channelization and by blockage of flow by grass-clipping and leaf-debris deposits. There was no noticeable velocity of flow at the time of sampling. This station had a low amount of canopy coverage in comparison to the other stations sampled, allowing a high degree of macrophytes to dominate the aquatic community.

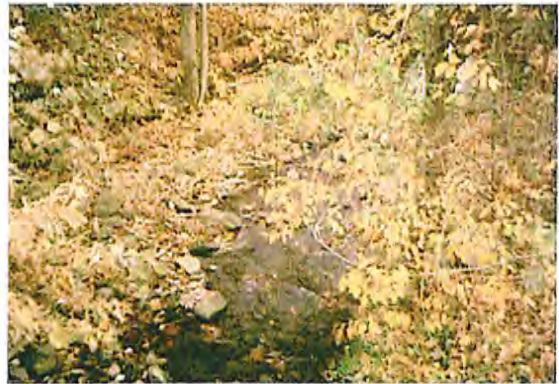
#### **Station PEB2**

Station PEB2 was located near the intersection of Larkin Road and Woodstream Road, just downstream of a large residential development called Willowbrook. The East Branch of Naamans Creek maintains a riparian corridor of approximately 300 feet in width, which runs through Willowbrook, continues through the

sampling station, and extends downstream past the Glen Estates and Timber Creek residential developments. Station PEB2 was approximately 1.6 miles downstream of the headwaters of the East Branch of Naamans Creek. Station PEB2 was a control station for this aquatic habitat assessment.

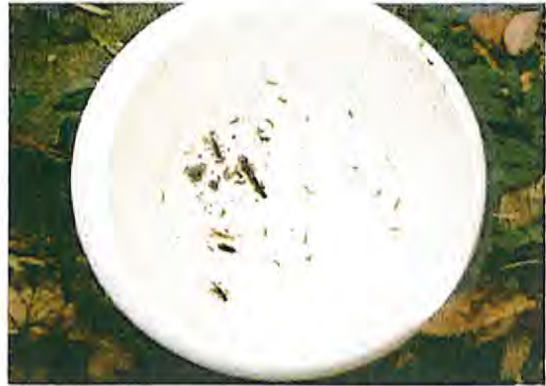
Figure 2.7 indicates that the habitat-assessment score for Station PEB2, at 119.5, was above average for all sampled stations. Good to fair scores were assessed for most habitat parameters; however, some indications of erosion in the form of root undercutting and exposed roots were observed. Silt and gravel deposits were also noted covering the substrate. It appeared that silt deposition was not yet limiting the habitat quality for pollution-intolerant species such as mayflies, stoneflies, and caddisflies, as all were commonly present in the sample.

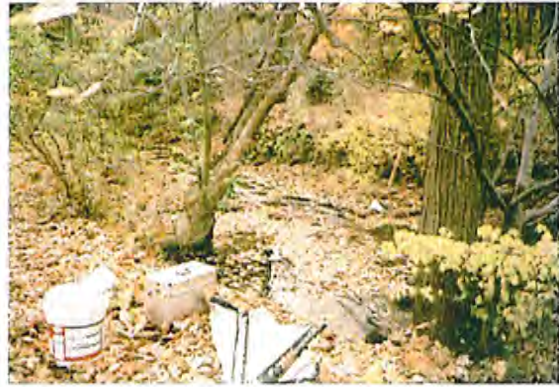
## Station PWB5

Station PWB5 was located near the confluence of the West Branch and East Branch of Naamans Creek, just 250 feet upstream from the I-95 bridge at the Peppermill Inn on Pennsylvania Route 491 (Naamans Creek Road).

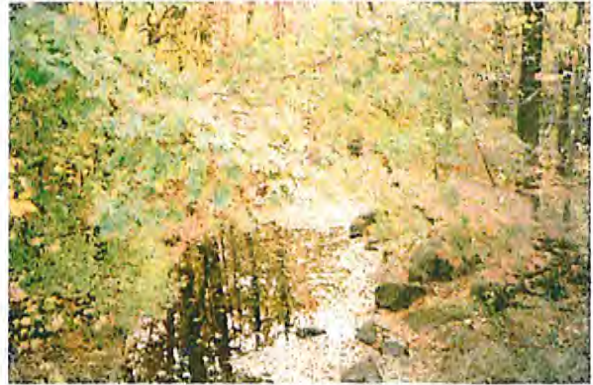
##### **Station PSB8**

Station PSB8 was located on Sharon Drive in the residential development of Sharon, at the Pennsylvania/Delaware boundary. The station was positioned in the headwaters within a wide riparian corridor just downstream from a man-made wetland/detention facility adjacent to the stream. Station PSB8 was a control station for this aquatic habitat assessment.

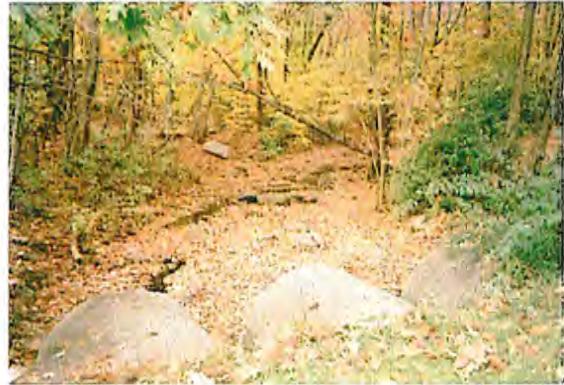
#### **Station DSB3**

Station DSB3 was located on Stone Crop Road in the residential development of Channin, in Delaware. Station DSB3 was approximately 2,400 feet downstream of Station PSB8. Like PSB8, a forested corridor of approximately 200 feet in width surrounded Station DSB3.

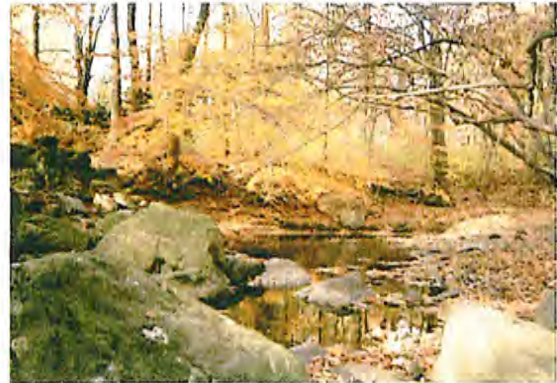
#### **Station DSB4**

Station DSB4, which was located 400 feet downstream of Marsh Road (RD 3) in Arden, Delaware, was approximately 1.45 miles downstream of Station DSB3. A very wide band of undisturbed forested habitat surrounded station DSB4 on both banks. A residence and a large concrete bridge structure were located 400 feet upstream of this station. The forested corridor associated with Hanby Park continued downstream of the station.

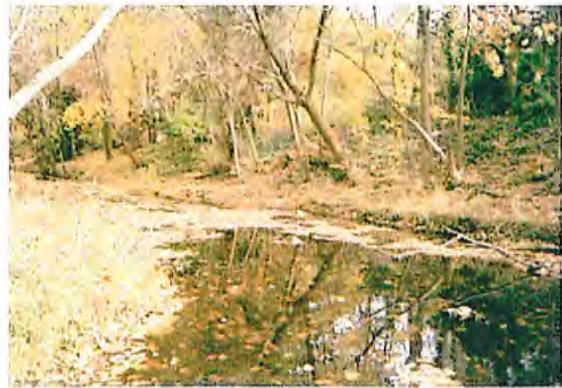
### **Station DSB6**

Station DSB6 was located on Darley Road downstream of I-95 in Claymont, Delaware. Station DSB6 was approximately 2.75 miles downstream of Station DSB4. A large concrete culvert was noted extending from the bank approximately 400 feet upstream from the station. A sanitary sewer manhole was located on the stream bank directly adjacent to the station.

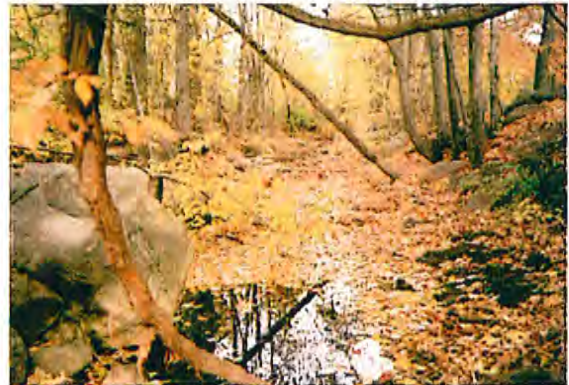
#### **Station DUT7**

Station DUT7 was located along Peachtree Drive in GreenTree. Just upstream from Station DUT7 was a concrete culvert elevated 1.0 to 2.0 feet above the streambed.
