BAY BEACH COASTAL DRAINAGE ENGINEERING EVALUATION

Delaware Department of Natural Resources and
Environmental Control
Division of Watershed Stewardship
89 Kings Highway
Dover, DE 19901

December 2014

URS Corporation
12420 Milestone Center Drive, Suite 150
Germantown, MD 20876

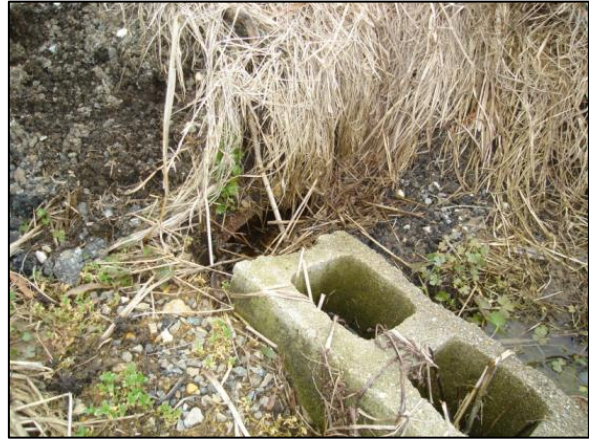
Drainage ditch at Kitts Hummock Beach filled with debris.

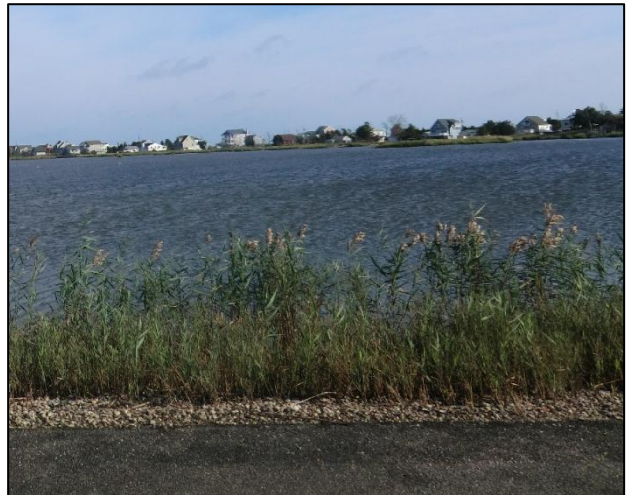
Prime Hook Wildlife Refuge and Prime Hook Beach

For the purpose of this project, large-scale solutions are considered to be engineering solutions that involve berms and floodwalls. When localized drainage solutions did not appear to be effective, URS developed large-scale solutions such as creating berms/floodwalls that tie to high ground to protect the communities from frequent marsh flooding (e.g., PH_01, PH_06, and BK_02). A berm/floodwall

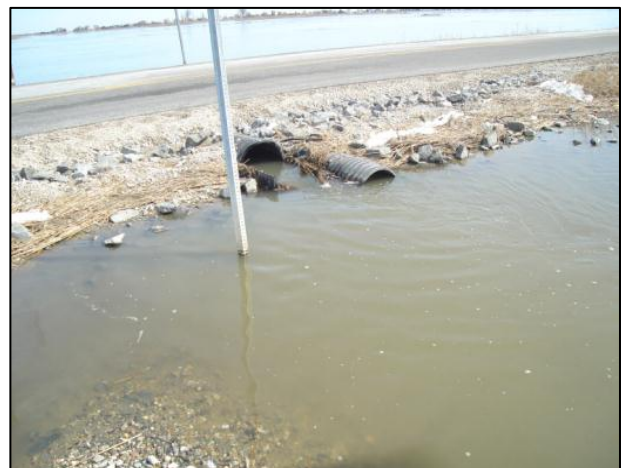
Sedimentation and existing storm drain pipes at Prime Hook Road (PH_11)

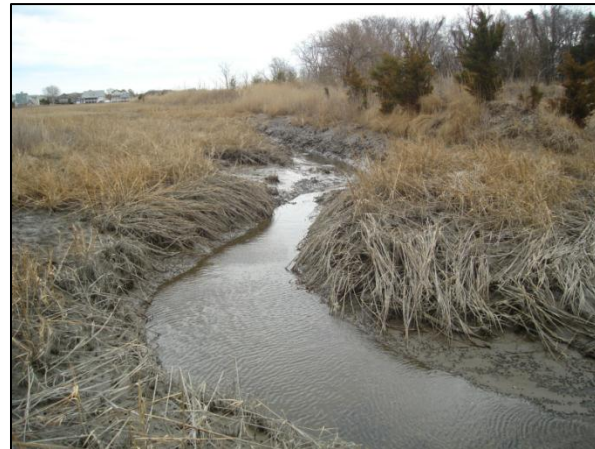
Ditch approximately 200 ft. south of C.H. Mason Way that connects the Lewes ditch system to the Rehoboth Canal (LB_01)

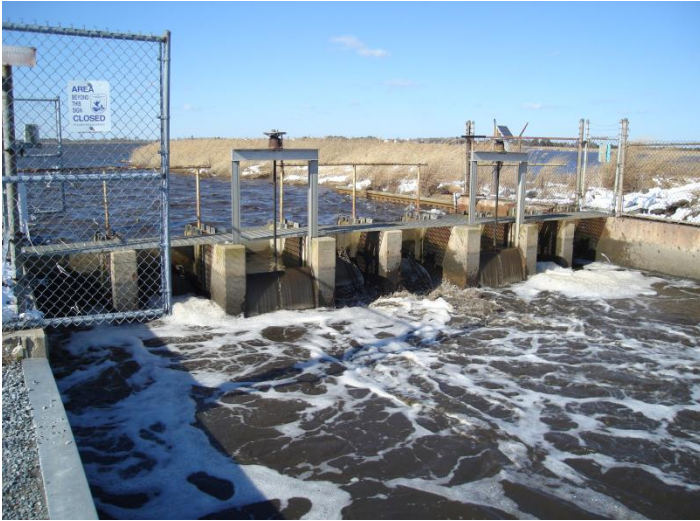
Figure D.25: Petersfield Ditch water control structure north of Broadkill Rd. "Route 16" (US Army Corps of Engineers will consider this in the marsh restoration effort)

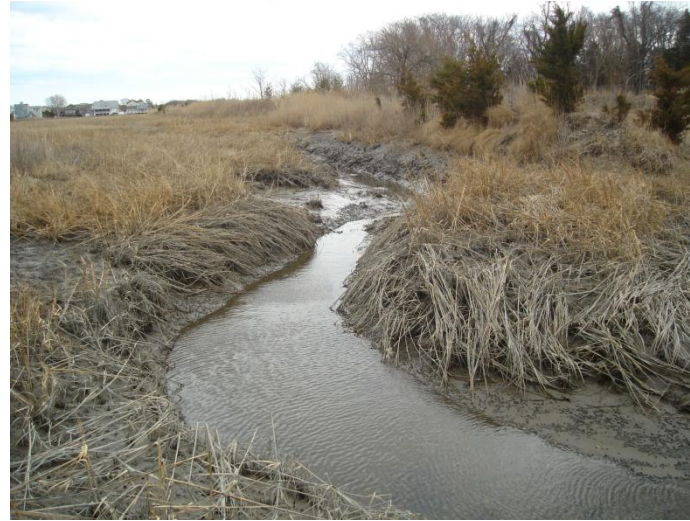
Figure D.26: Ditch approximately 200 ft. south of C.H. Mason Way that connects the Lewes ditch system to the Rehoboth Canal (LB_01)

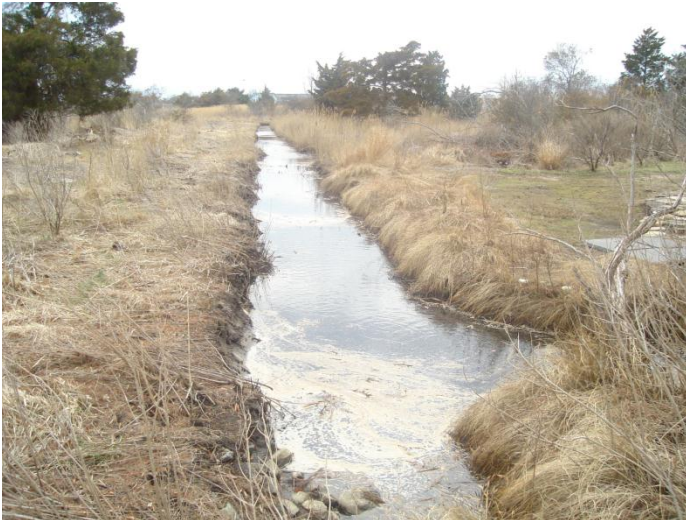
Figure D.27: Ditch south of Rehoboth Ave. that runs parallel to Cedar Ave. (LB_01)

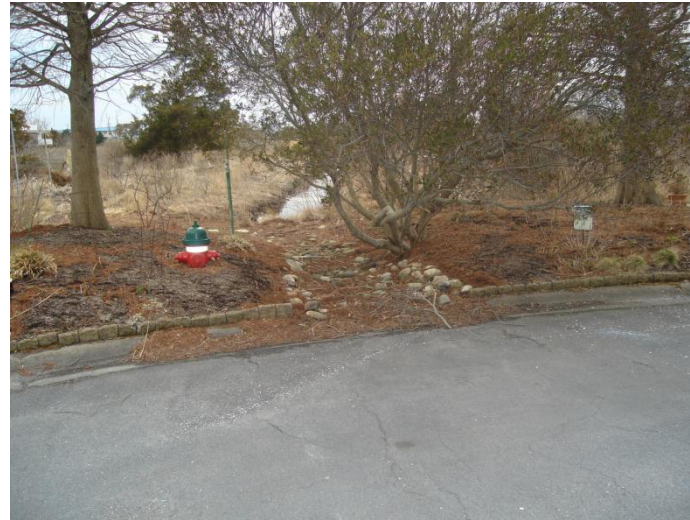
Figure D.28: Stone outfall from Rehoboth Cul-de-sac to the ditch that runs parallel to Cedar Ave. (LB_01)

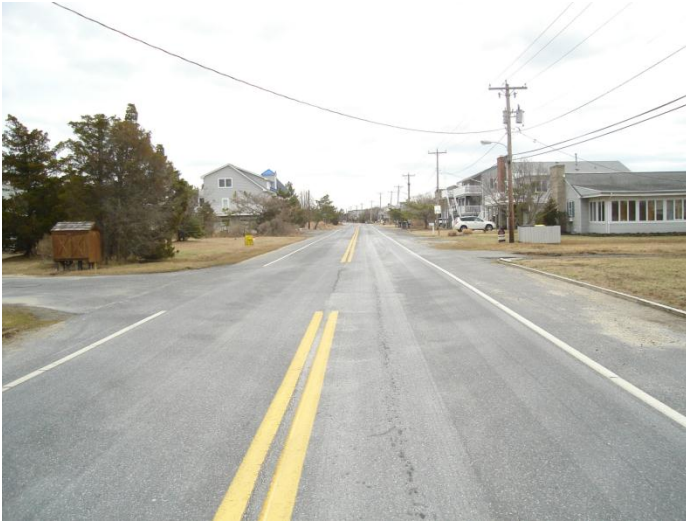
Figure D.29: Cedar Ave. is developed but has no storm drain conveyance system, resulting in frequent flooding (LB_02)

Solution ID	Community	Proposed Project Location	Recommendation
LB_02	City of Lewes	Cedar Ave. from Maine Ave. to Massachusetts Ave.	Install 1.5 miles of storm drain pipe system under Cedar Ave. from Maine Ave. to Massachusetts Ave. with at-grade drainage inlets at each corner of intersections with side streets. Install drainage pipes at side streets south of Cedar Ave. (e.g., Odessa Ave.) to convey flow to existing drainage ditches as needed for adequate drainage. Install backflow prevention on the ditch side of all pipes. Connect to existing drainage structures unless they are deemed inoperable.
LB_03	City of Lewes	Market St. and Midland Ave.	Install approximately 700 feet of storm drain pipe system under Midland Ave. to the existing outfall. Install at-grade drainage inlets at each corner of street intersections, and at-grade drainage inlets in low areas as necessary to reduce ponding. Upgrade the storm drain pipe south of Midland Ave. and clean out the ditch that flows to Market St. Install approximately 600 feet of storm drain pipe on Cedar Ave. from Savannah Rd. to Market St. and connect to the Midland Ave. storm drainage system. Install approximately 2,500 feet of storm drain pipe under Market St. from Bay Ave. to the existing inlets at Anglers Rd. (and connect to the previous systems described). Upgrade storm drain pipe to canal, and install backflow prevention on the canal side of the pipe. Install or clean out roadside ditches from Anglers Rd. to Massachusetts Ave. and close the existing culvert that connects the western Lewes ditch system to the Market St. ditch system.

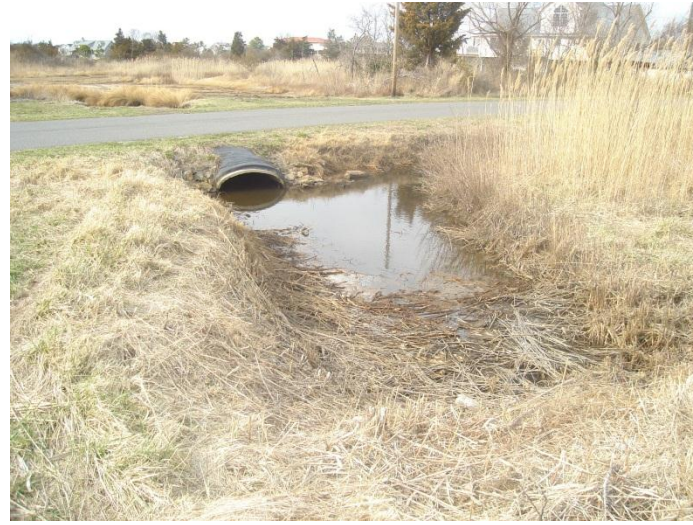
Figure D.30: Ditch crossing Market St. 600 ft. north of Anglers Rd. with evidence of water flowing from canal into the Market St. ditch system (LB_03)

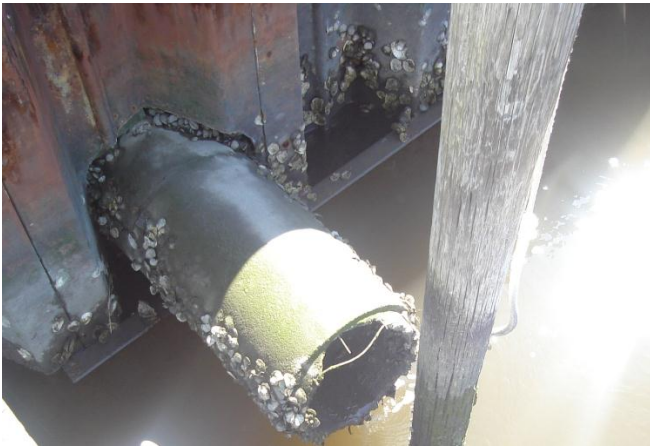
Figure D.31: The existing Savannah Rd. storm drain conveyance system outfalls to a 24 inch concrete pipe that is below the high water elevation (LB_04)

was also recommended at Lewes beach to prevent backwater associated with Lewes Rehoboth Canal from flooding the community (LB_04).

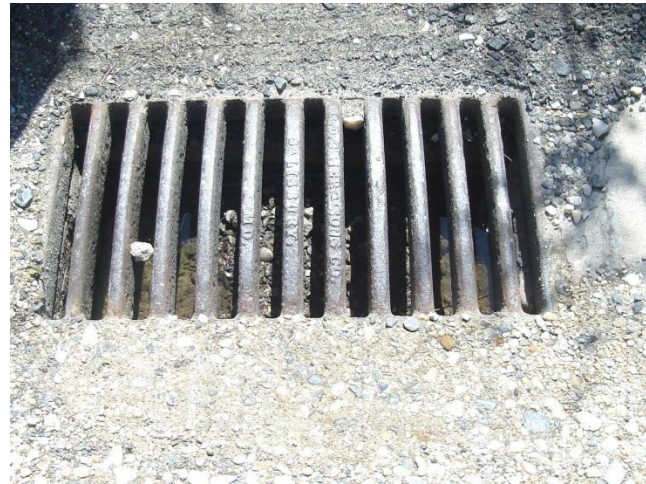
Figure D.32: Grate inlet full of debris in the alley south of Market St. (LB_14)

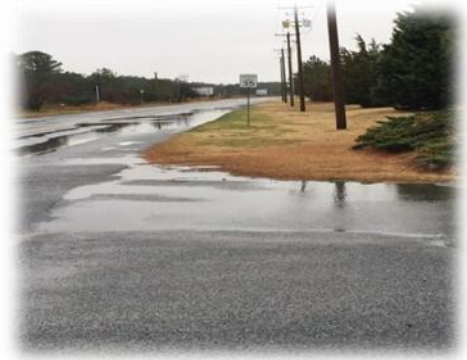
According to the questionnaire responses, water ponds at the intersection of Cape Henlopen Drive and Fort Lewes Court, as well as in the west-bound travel lane of Cape Henlopen Drive, and these areas flood several times a year. During field investigation, a sump was observed at the edge of pavement near the northwest side of the Fort Lewes entrance, where there is inadequate drainage. Flooding occurs along Cape Henlopen Drive because the adjacent lawn areas are higher than the edge of pavement, thereby trapping water on the paved surface. A storm drain system collects runoff near the Fort Lewes development entrance and discharges on the south side of Cape Henlopen Drive. Neither area has either adequate open channel or a closed storm drain to convey stormwater runoff away from the affected areas. Figure 1 and the photographs at right show the existing site conditions.

Existing pavement sump located between the edge of pave and driveway entrance

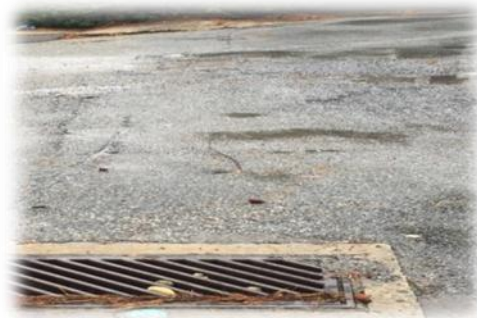
Existing storm drain inlets at Fort Lewes

Design solutions at site LB_18 will involve stormwater conveyance improvements at the sump location of Fort Lewes Court and grading and drainage improvements along the impacted area of Cape Henlopen Drive. Storm drain improvements will consist of constructing one 24-inch x 24-inch standard Delaware Department of Transportation (DelDOT) D-4 inlet box placed in line with the existing 12-inch reinforced concrete pipe (RCP) storm drain and a Type-6 frame and grate to collect localized runoff from the existing low point on the west side of the Fort Lewes development entrance.

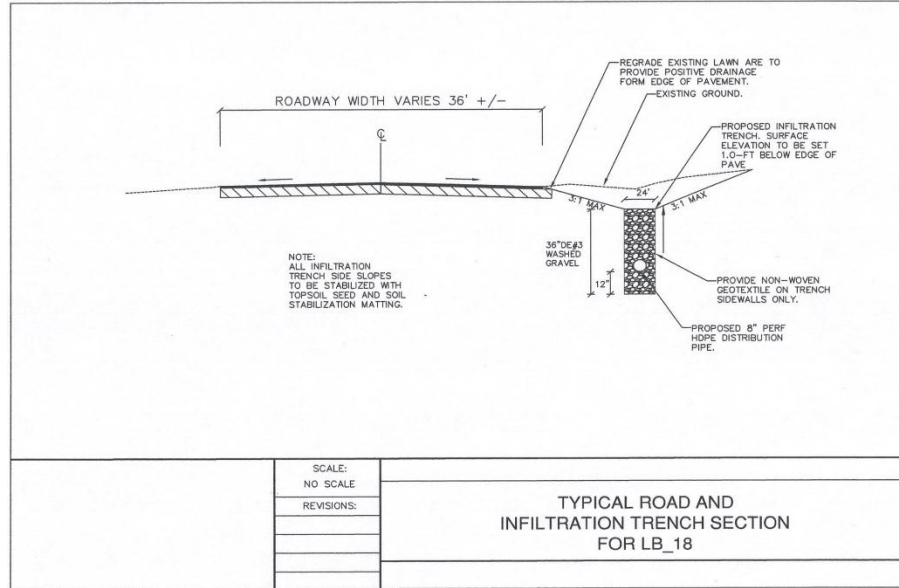
Figure 3: Proposed road and infiltration trench cross section A-A

In conjunction with the proposed storm drain modification, a 125-foot long x 2-foot wide x 3-foot deep trench drain will be constructed parallel to Cape Henlopen Drive. The trench drain will be excavated to provide a surface elevation 1 foot below the existing edge of pavement. All trench sidewalls will be wrapped in non-woven geotextile and filled with DE #3 washed gravel. The trench drain will also have a 6-inch perforated high-density polyethylene (HDPE) pipe placed 1 foot above the trench bottom to help distribute water within the system and enhance infiltration. The underdrain will also be connected to the proposed inlet to aid in dewatering the area under heavy rainfall conditions. Regrading of the existing road shoulder will be required to provide positive drainage from existing paved surfaces to the infiltration facility. All side slopes of the proposed trench drain will be constructed no steeper than 3:1 (H:V) and stabilized with vegetation to provide water quality benefits and to prevent erosion. See Figure 2 for proposed site layout and detailed notes. Figure 3 shows the proposed road and infiltration trench cross section.
